In their letter, 28<sup>th</sup> May 2021, Cambridgeshire County Council LLFA have requested the following further Information be provided in respect of the proposed outfall for surface water.

A walk over visit was carried out on the 7<sup>th</sup> June 2021 to determine the above.

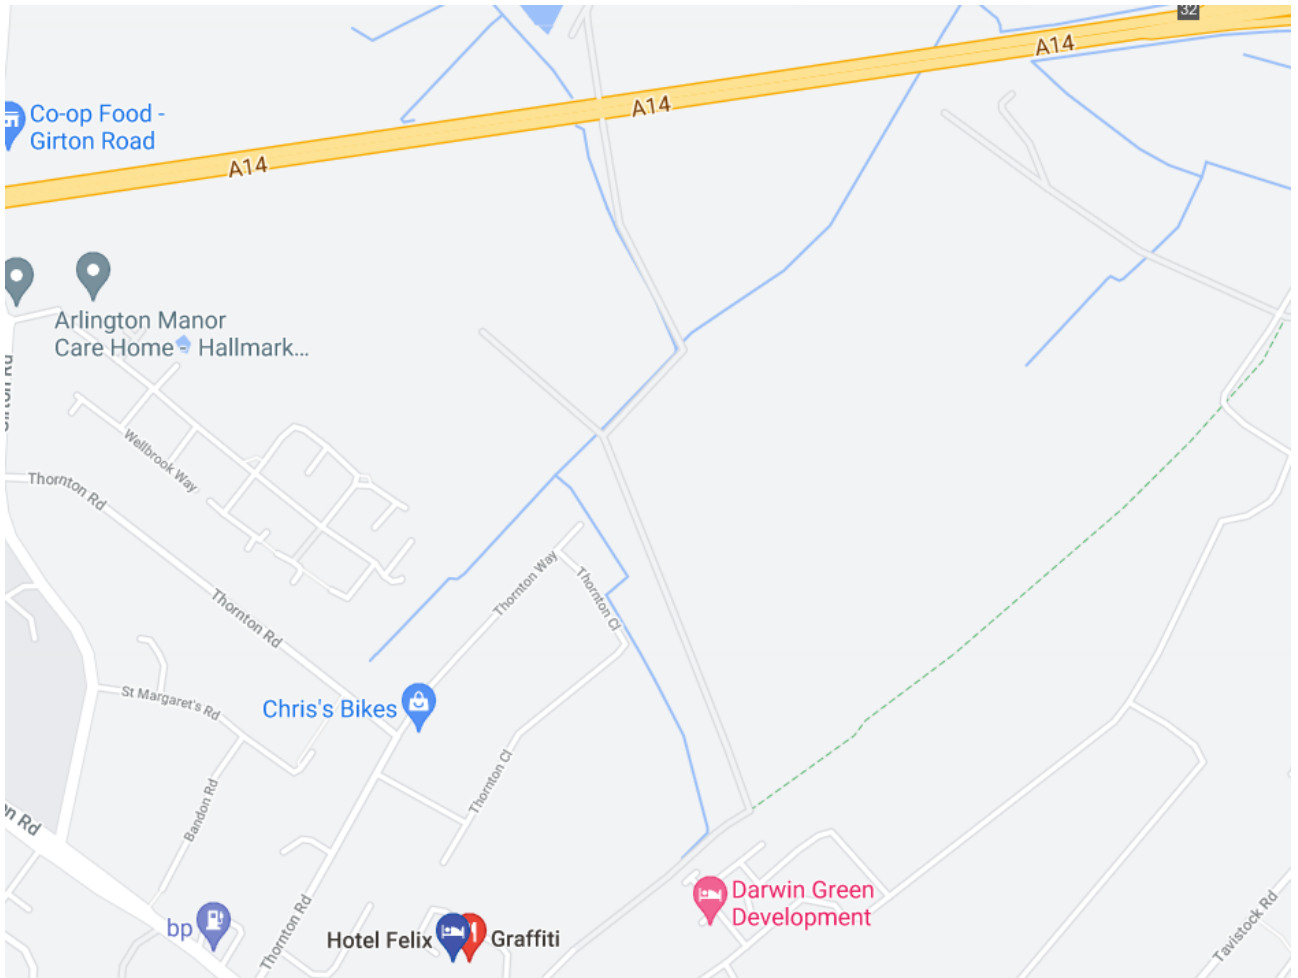
FIG 1. WIDER CONTEXT

The watercourse was found to run from the known discharge point at Whitehouse Lane and follows the line of the mapped drainage which ultimately flows under the A14, as shown in the wider context map in fig 1.

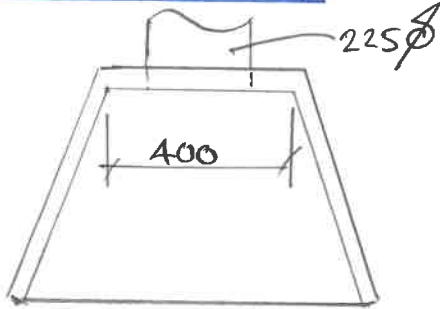
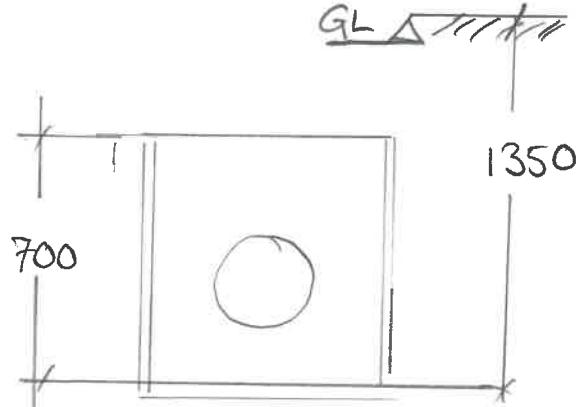
HEAD WALL @ 'A'

Whilst the existing outfall pipe from the site to watercourse is somewhat over grown, it is considered to be functioning at the current time to drain the site as there are no reports of flooding. It is proposed that that this pipe will be thorough cleaned and jetted in due course with some localised clearing of the watercourse at point of discharge.

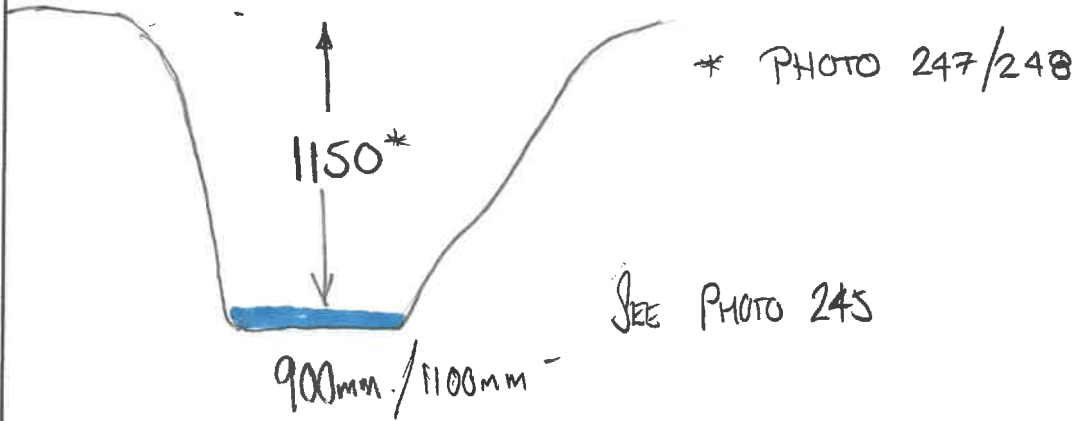
CROSS SECTION @ 'A'

A plan showing the walked route and locations of photographs is shown on page 4. Page 5 provides details of the cross section of the watercourse in two locations where safe access was possible. This shows there is a considerable cross section width and depth to the watercourse which is currently used to drain the development site an unattenuated rate.
