Former Hotel Felix, Cambridge

REBUTTAL PROOF OF EVIDENCE

STRUCTURAL REPORT – ARC ENGINEERS

PROJECT	HOTEL FELIX WHITEHOUSE LANE, CAMBRIDGE, CB3 0LX
PROJECT NUMBER	20 106
CLIENT	CASSEL HOTELS (CAMBRIDGE) LTD
REPORT DATE	OCTOBER 2022

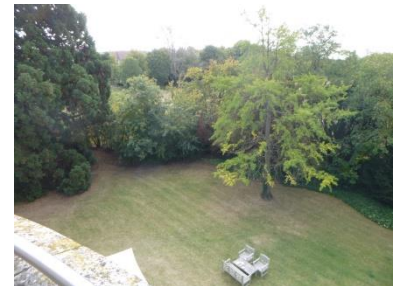
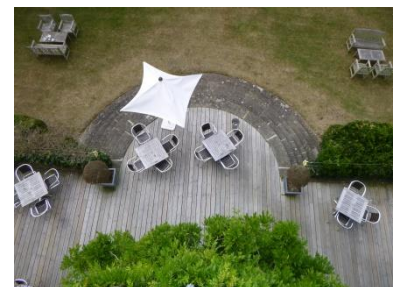
A noted feature of the grounds is the very large Wellingtonia tree, approximately 17 metres from the southern corner of the original building and 8 metres from the corner of the 2002 extension.

This tree, on account of its size, species and age, will have a high water demand and the foundations of the building will be well within its zone of influence.

These calculated depths are not unduly onerous and the foundations of the original and extended parts of the building are likely to reach this depth or greater, and so the risk of damage due to ground movement caused by this tree alone would not be considered to be severe.

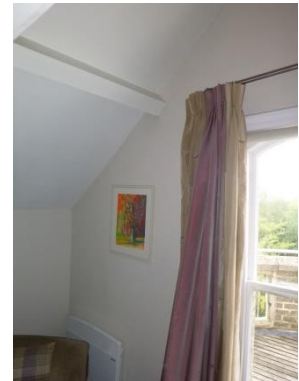
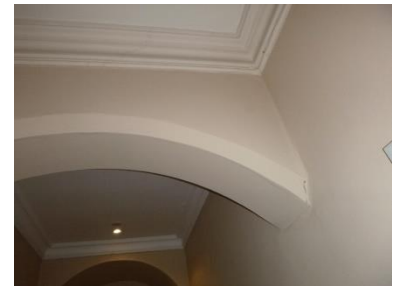
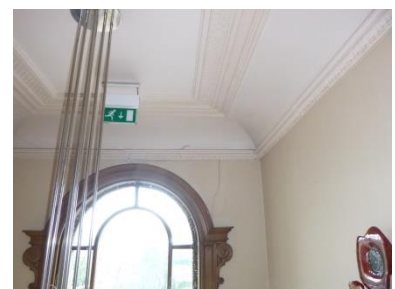
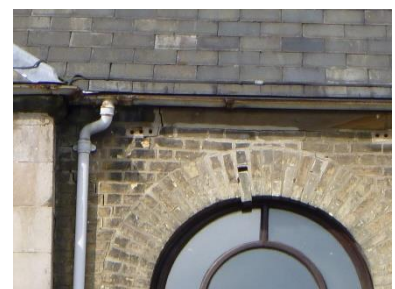
On the first floor, the central stairwell had a series of separation cracks along the SE-NW long axis of the stairwell, culminating in the tall arched window above the stairwell.

The internal face of this arch was cracked and a length of coving at ceiling level was in danger of falling away. This presents an immediate hazard to the occupants and will need to be taken down before it falls.

On the outside of this arch, one of the brick voussoirs of the arch had dropped, indicating that the springing points of the arch had spread apart due to one part of the building moving away from the other.

In this case, beyond the NW side of the stairwell is the 2002 infill extension, which will have been built on a new foundation following the removal of the small trees on the site (see appendix).

In the meantime, urgent repairs should be put in hand to remove the loose coving from over the stairwell. Ad-hoc repairs to the decor may be carried out in the meantime to maintain the indoor environment in the hotel.

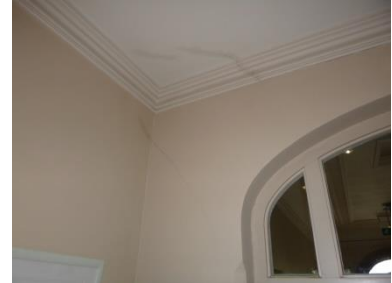
On the ground floor, there was cracking in the newly-applied plasterboard lining of the wall beneath the landing of the main staircase, which had been installed as recently as November 2018 and had been repaired and redecorated in the interim.

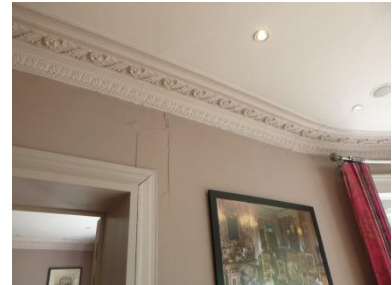
In the lounge bar, there was widespread cracking in the ceiling and at the wall coverings.

In the basement, there was less obvious damage but there were instances of cracking and minor movement at floor level and the heads of doorways.

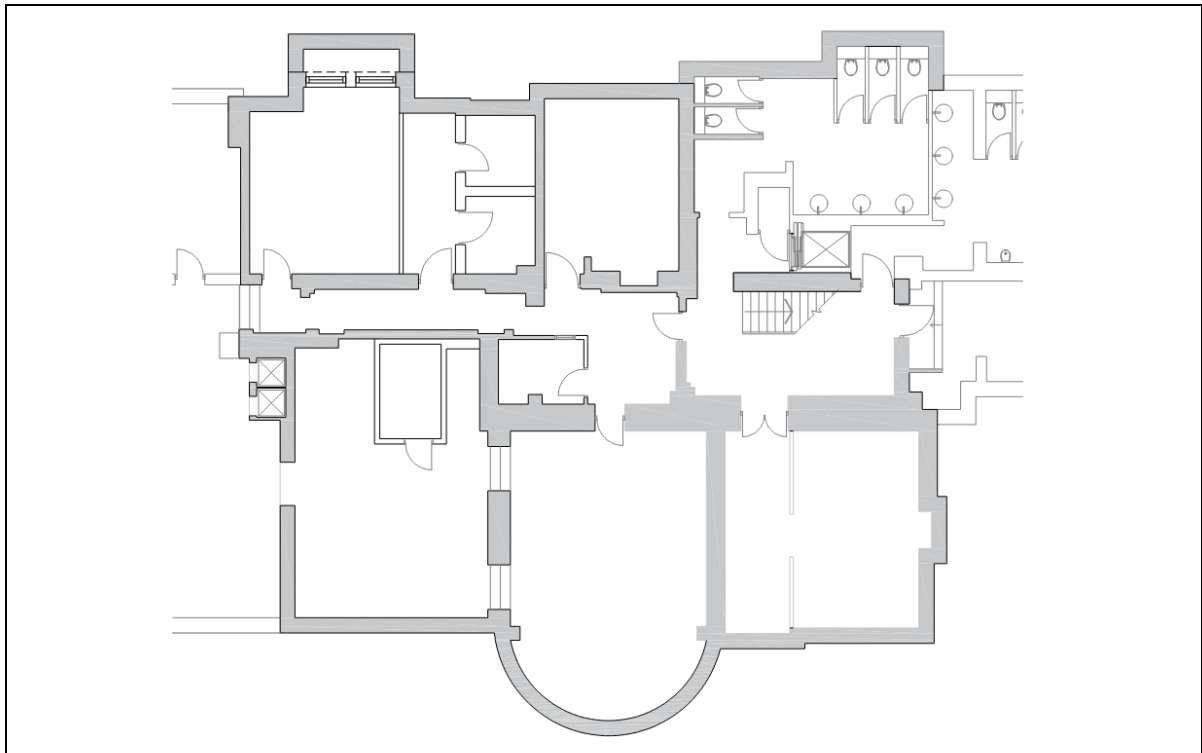
Above - Fig 1. Extent of required underpinning

At the present time, the most expedient way of stabilising the building against further issues due to the interaction of the soil conditions with the surrounding landscaping would be to underpin the principal walls of the main original building. The extent of this underpinning is shown in fig.1 below.

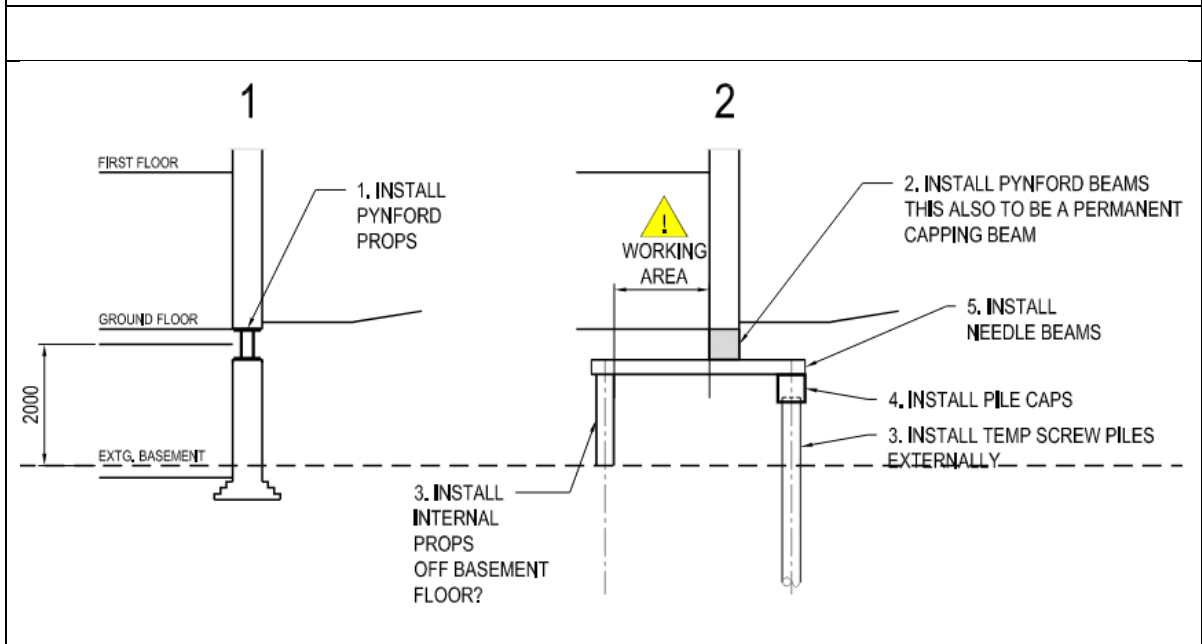
Above - Fig 2. (part 1) Potential sequence to facilitate, underpinning, waterproofing, reducing basement floor level

Fig.2 shows a possible sequence of works that would facilitate underpinning works, installation of suitable waterproofing and lowering the basement floor slab level to facilitate a suitable internal height for commercial activities and associated services. As can be appreciated, this will be a costly and time consuming piece of work.

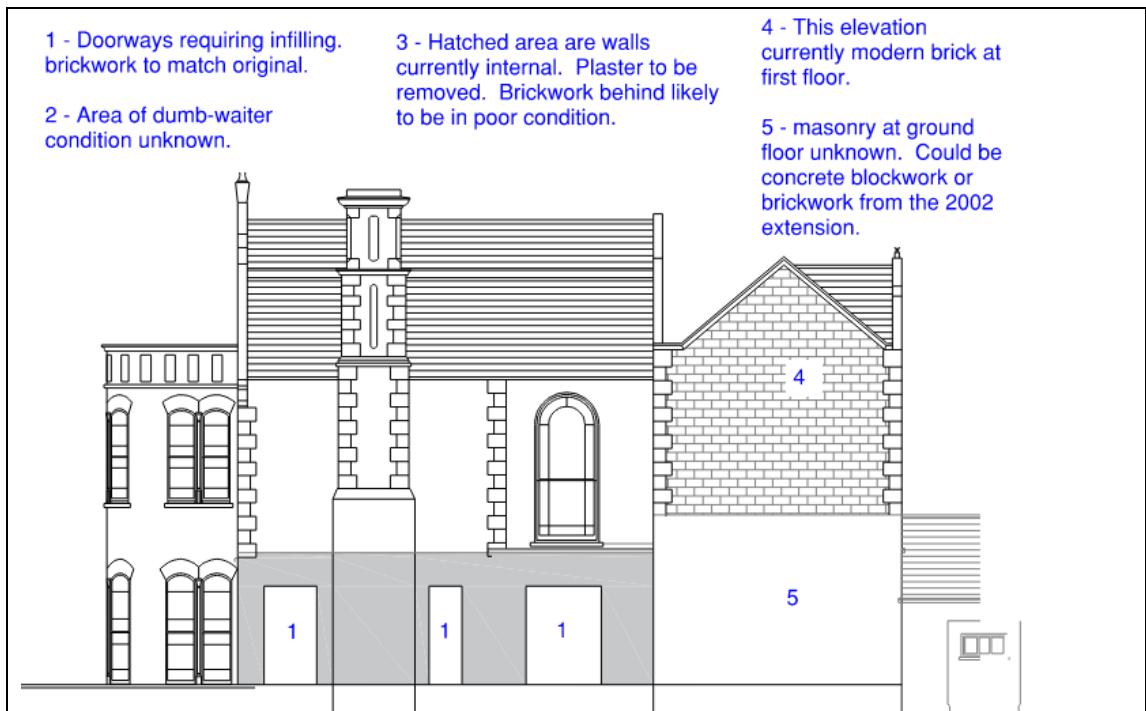
Fig 2 – Area of original east elevation that will require significant work if extensions are removed.

It should also be noted that, if the ground floor extensions were to be removed from the east and west elevations, there would be substantial amounts of making-good required. These areas are shown in fig 2 & 3 below.

What were previously external, brick faced walls would have been plastered when enclosed in the 2002 extension works. It would be extremely difficult to restore these areas to their original gault-brick finish without substantial rebuilding.
