## SITE HYDROGRAPH

# LNAPL THICKNESS OVER TIME

**FH GREAT SHELFORD LTD**

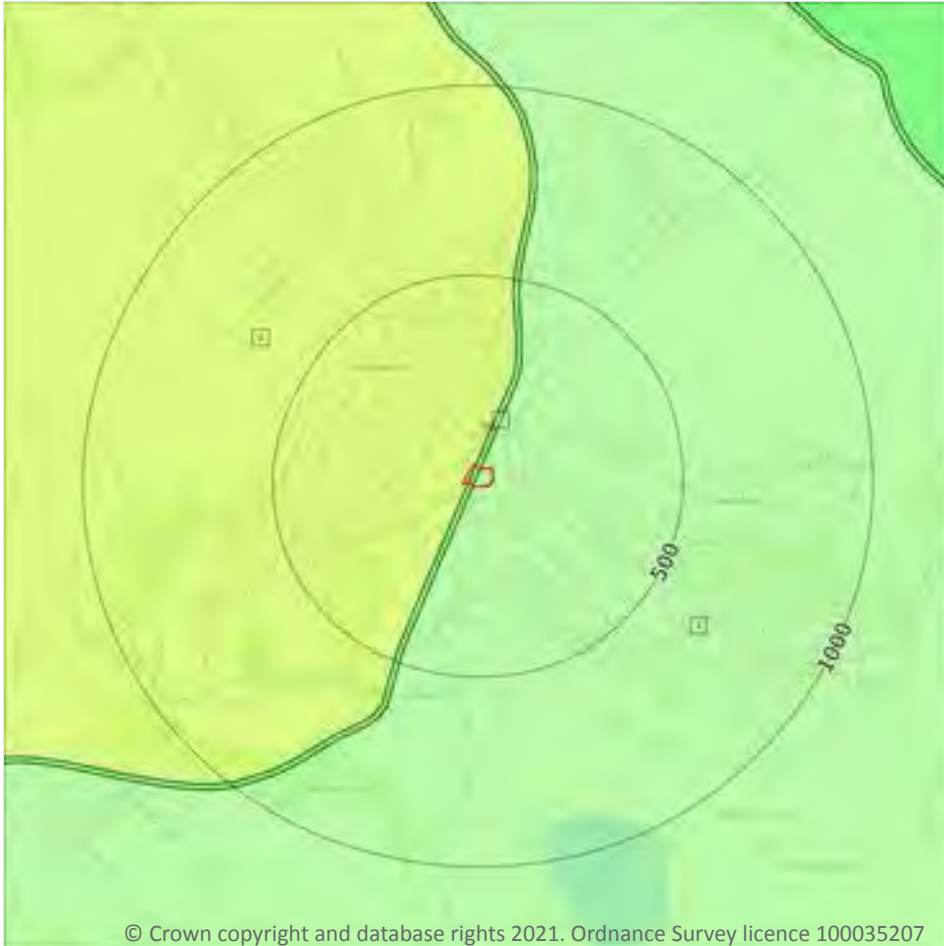
## Geology 1:10,000 scale - Bedrock

- Site Outline
- Search buffers in metres (m)
- .... Bedrock faults and other linear features (10k)
- Bedrock geology (10k)  
Please see table for more details.

Features are displayed on the Geology 1:10,000 scale - Bedrock map on **page 77**

ID	Location	LEX Code	Description	Rock age
1	On site	ZZCH-CHLK	Zig Zag Chalk Formation - Chalk	Cenomanian Age
2	On site	WMCH-CHLK	West Melbury Marly Chalk Formation - Chalk	Cenomanian Age
3	On site	TTST-CHLK	Totternhoe Stone Member - Chalk	Cenomanian Age

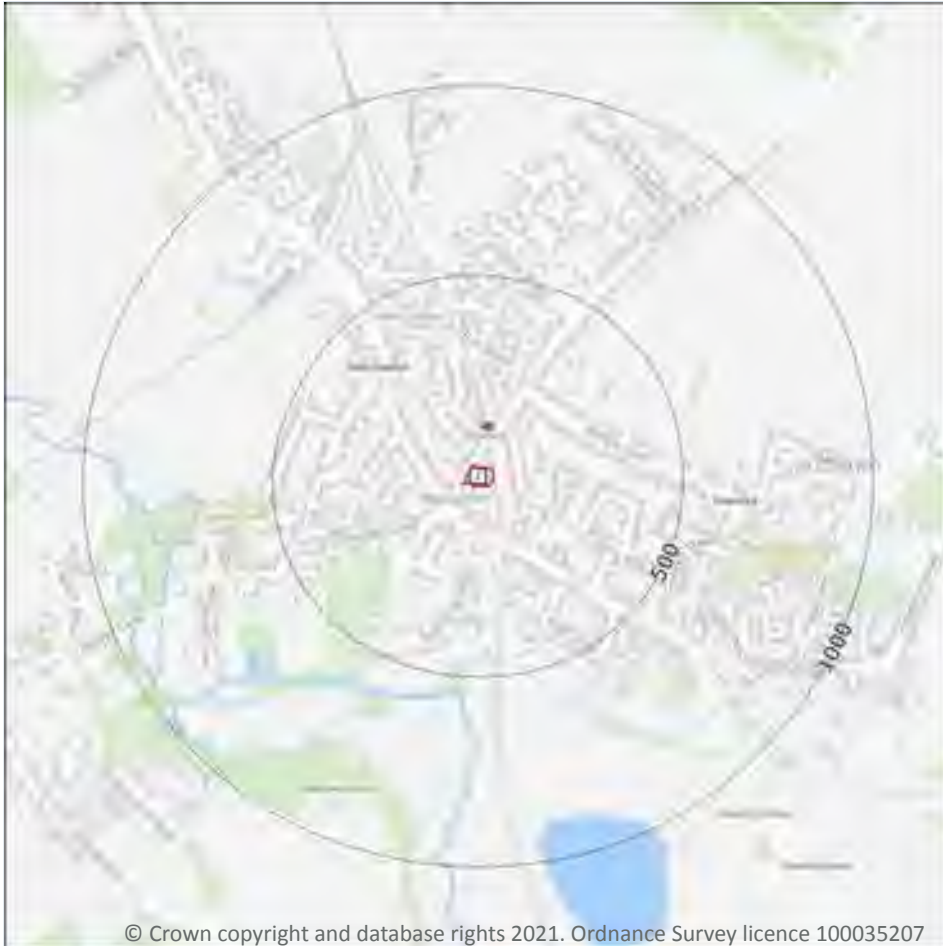
## 15 Geology 1:50,000 scale - Availability

- Site Outline
- Search buffers in metres (m)

- Geological map tile

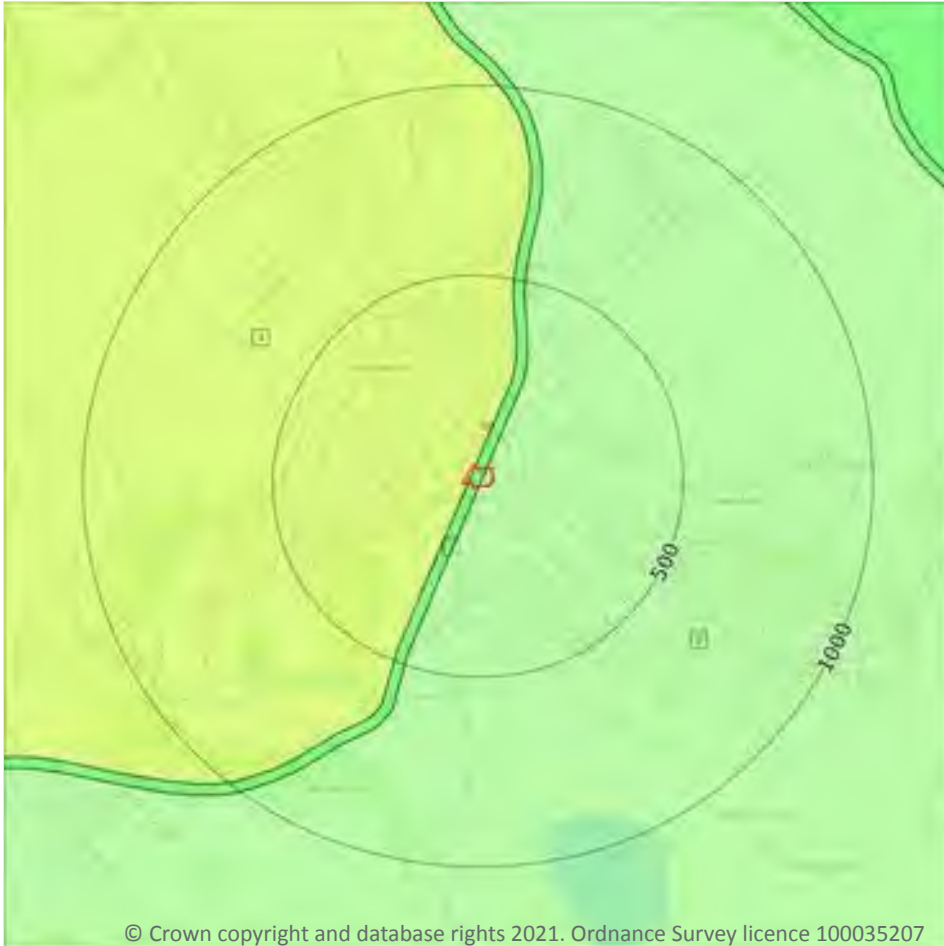
## Geology 1:50,000 scale - Bedrock

- Site Outline
- Search buffers in metres (m)
- Bedrock faults and other linear features (50k)
- Bedrock geology (50k)  
Please see table for more details.

Features are displayed on the Geology 1:50,000 scale - Bedrock map on **page 83**

ID	Location	LEX Code	Description	Rock age
1	On site	TTST-CHLK	TOTTERNHOE STONE MEMBER - CHALK	CENOMANIAN
2	On site	ZZCH-CHLK	ZIG ZAG CHALK FORMATION - CHALK	CENOMANIAN
3	On site	WMCH-CHLK	WEST MELBURY MARLY CHALK FORMATION - CHALK	CENOMANIAN

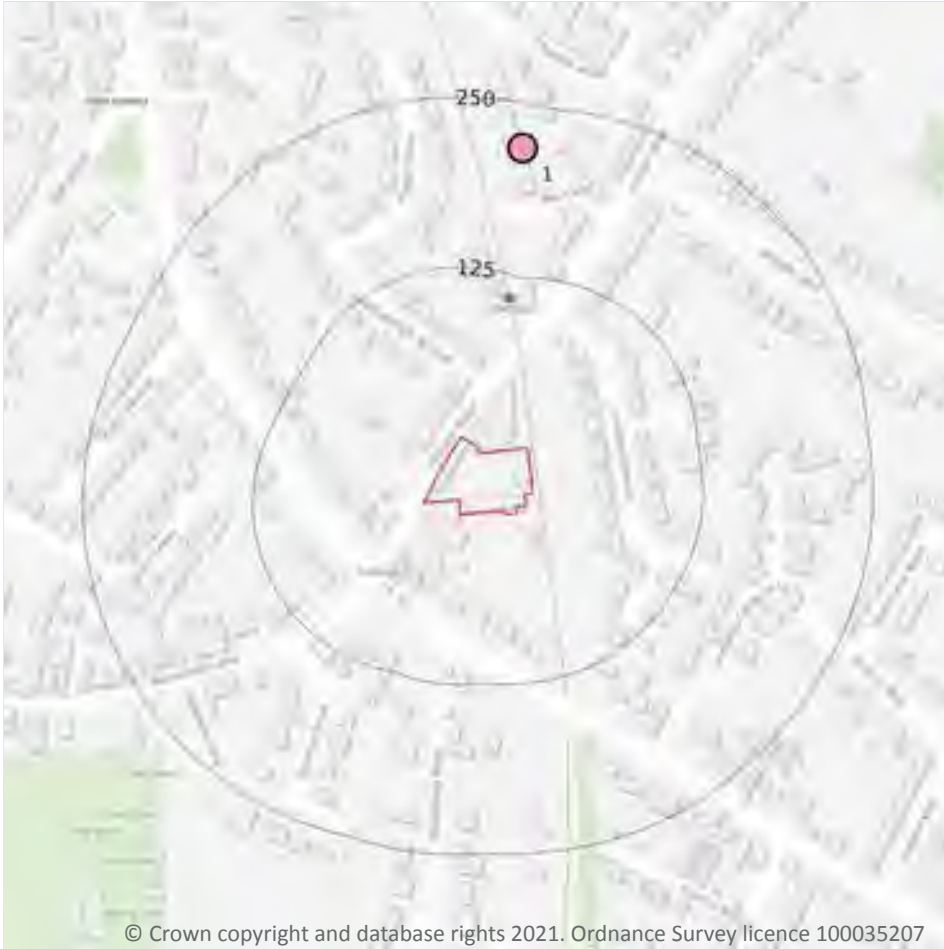
## 16 Boreholes

Features are displayed on the Boreholes map on **page 85**

ID	Location	Grid reference	Name	Length	Confidential	Web link
1	217m N	546520 252350	FLOUR MILL STATION ROAD, GREAT SHELFORD	85.34	N	<a href="#">542586</a>

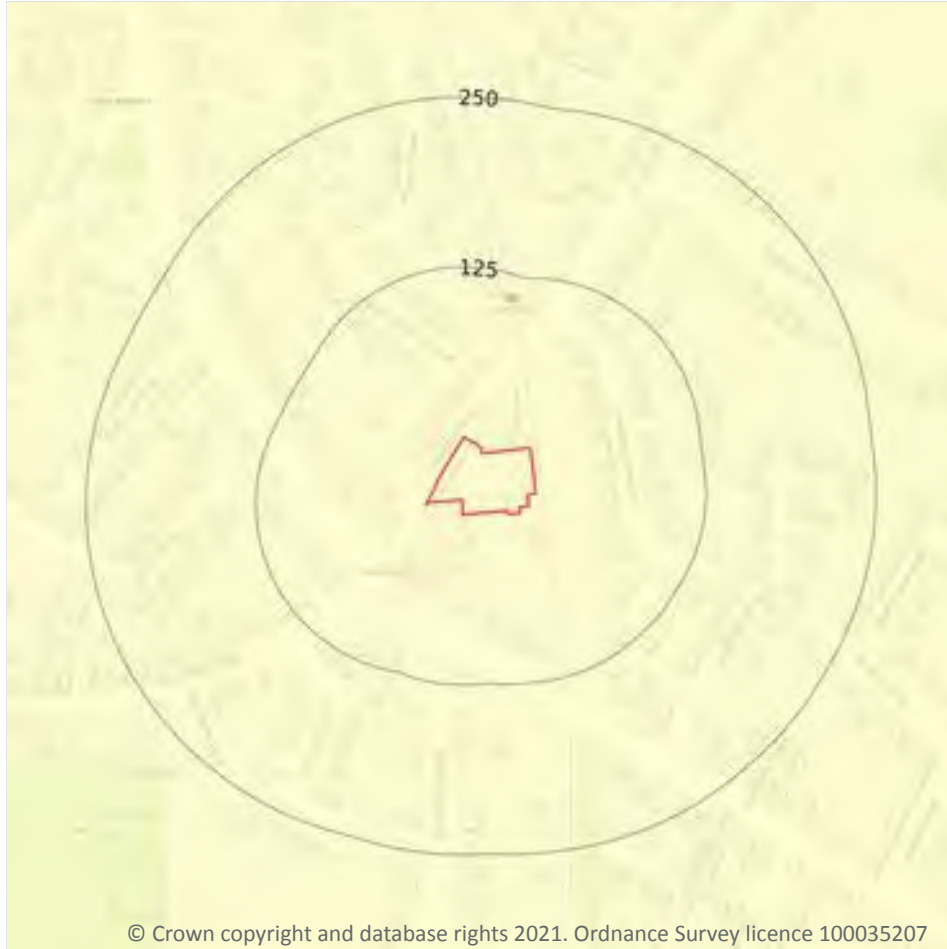
## 17 Natural ground subsidence - Shrink swell clays

Features are displayed on the Natural ground subsidence - Shrink swell clays map on **page 86**

Location	Hazard rating	Details
On site	Negligible	Ground conditions predominantly non-plastic.

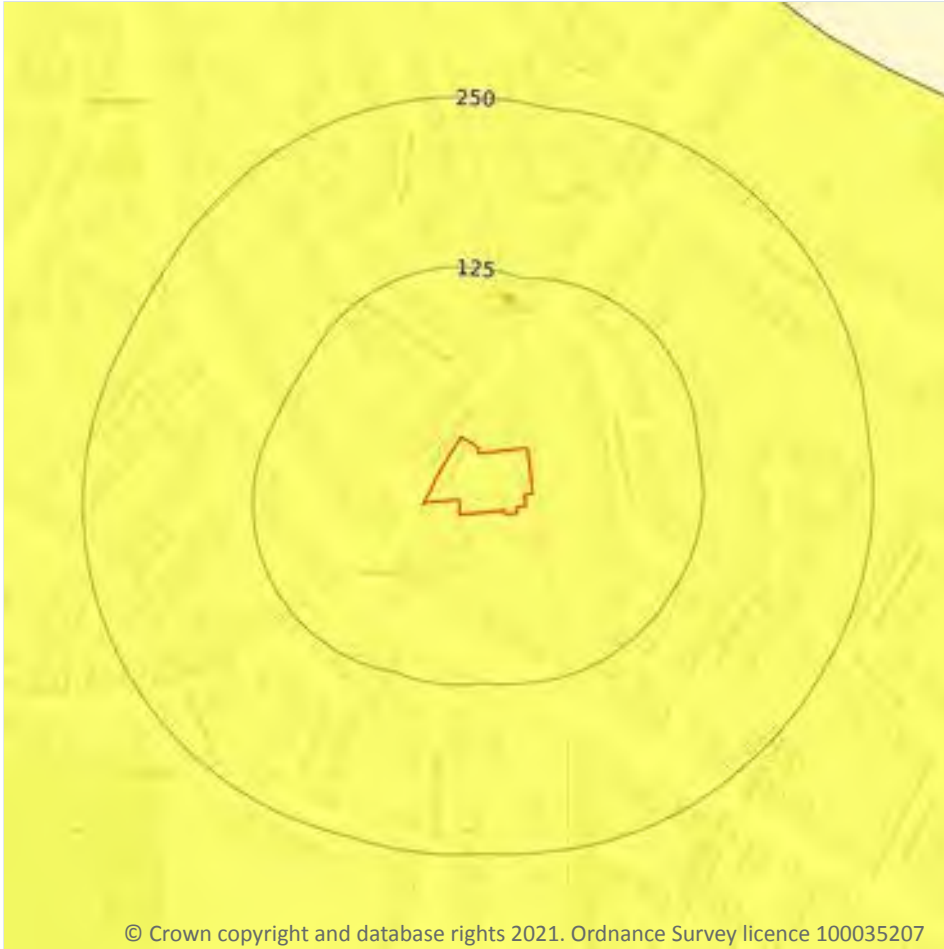
## Natural ground subsidence - Running sands

Features are displayed on the Natural ground subsidence - Running sands map on **page 87**

Location	Hazard rating	Details
On site	Very low	Running sand conditions are unlikely. No identified constraints on land use due to running conditions unless water table rises rapidly.

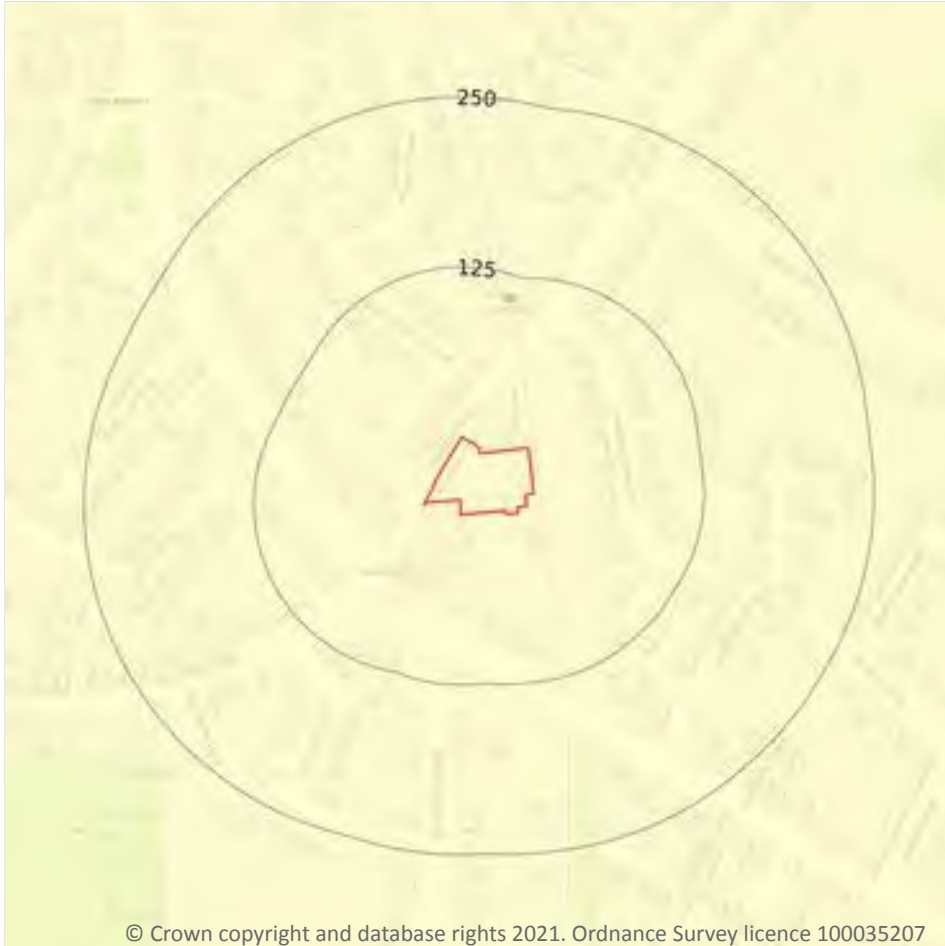
## Natural ground subsidence - Compressible deposits

Features are displayed on the Natural ground subsidence - Compressible deposits map on **page 88**

Location	Hazard rating	Details
On site	Negligible	Compressible strata are not thought to occur.

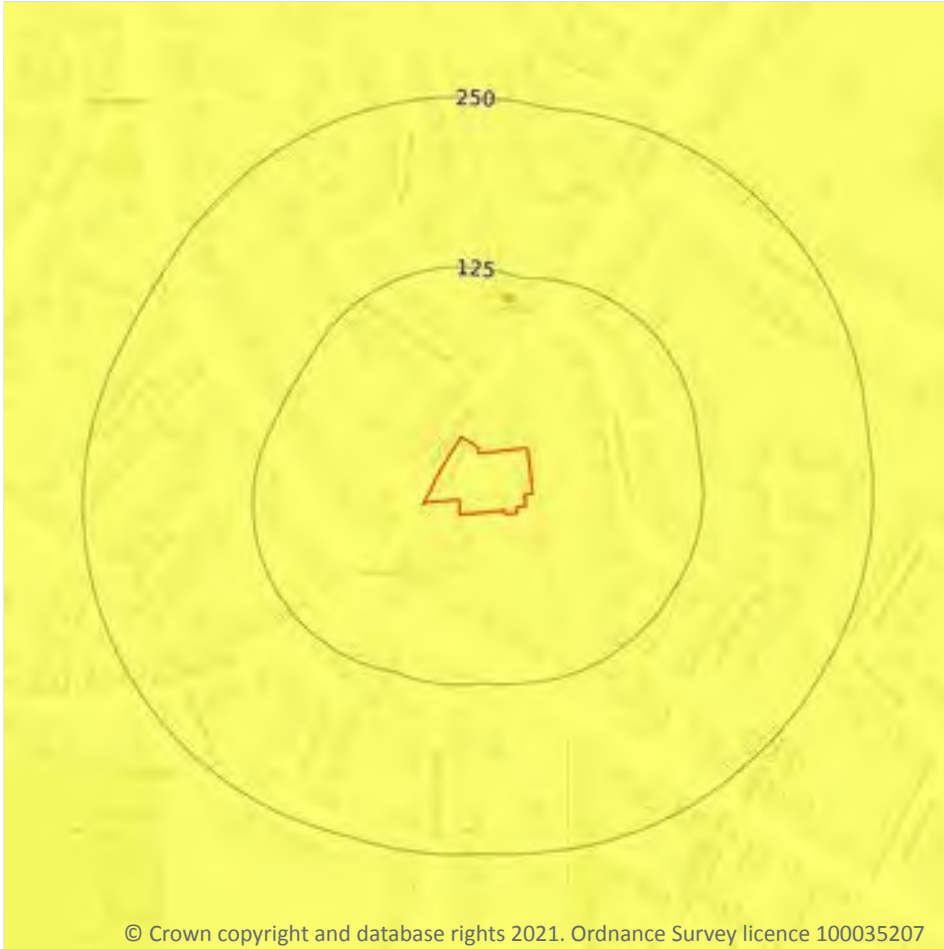
## Natural ground subsidence - Collapsible deposits

Features are displayed on the Natural ground subsidence - Collapsible deposits map on **page 89**

Location	Hazard rating	Details
On site	Very low	Deposits with potential to collapse when loaded and saturated are unlikely to be present.

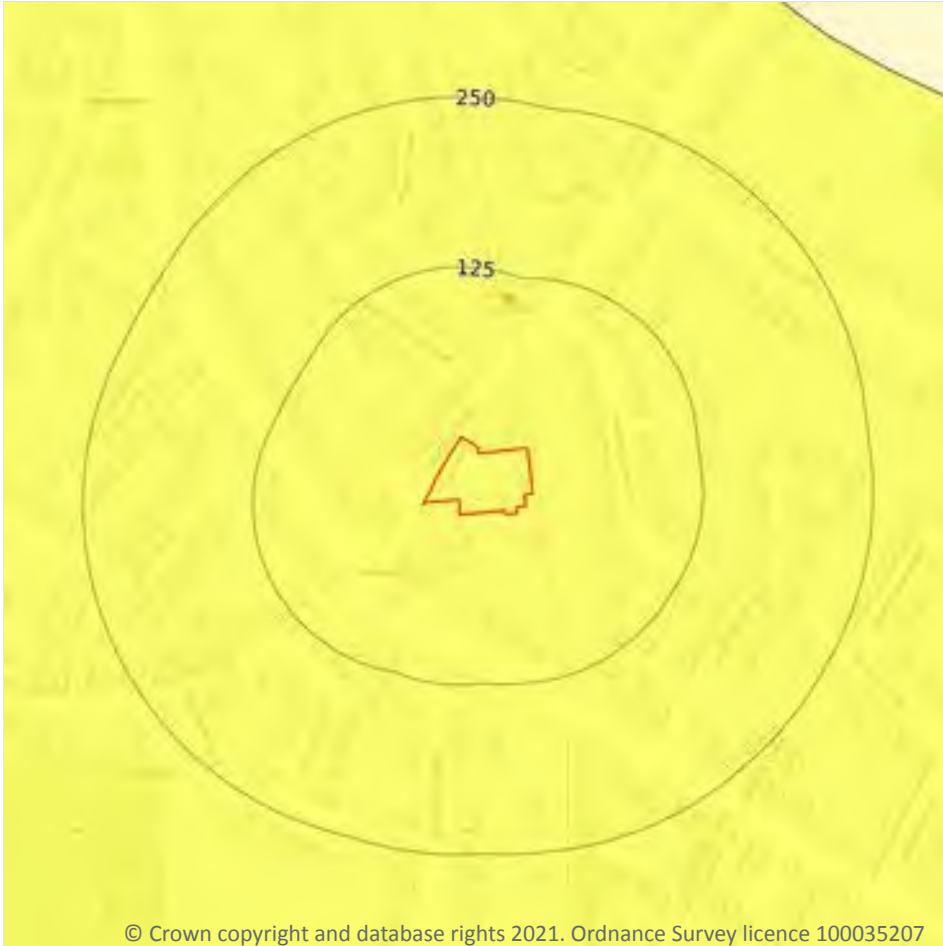
## Natural ground subsidence - Landslides

Features are displayed on the Natural ground subsidence - Landslides map on **page 90**

Location	Hazard rating	Details
On site	Very low	Slope instability problems are not likely to occur but consideration to potential problems of adjacent areas impacting on the site should always be considered.

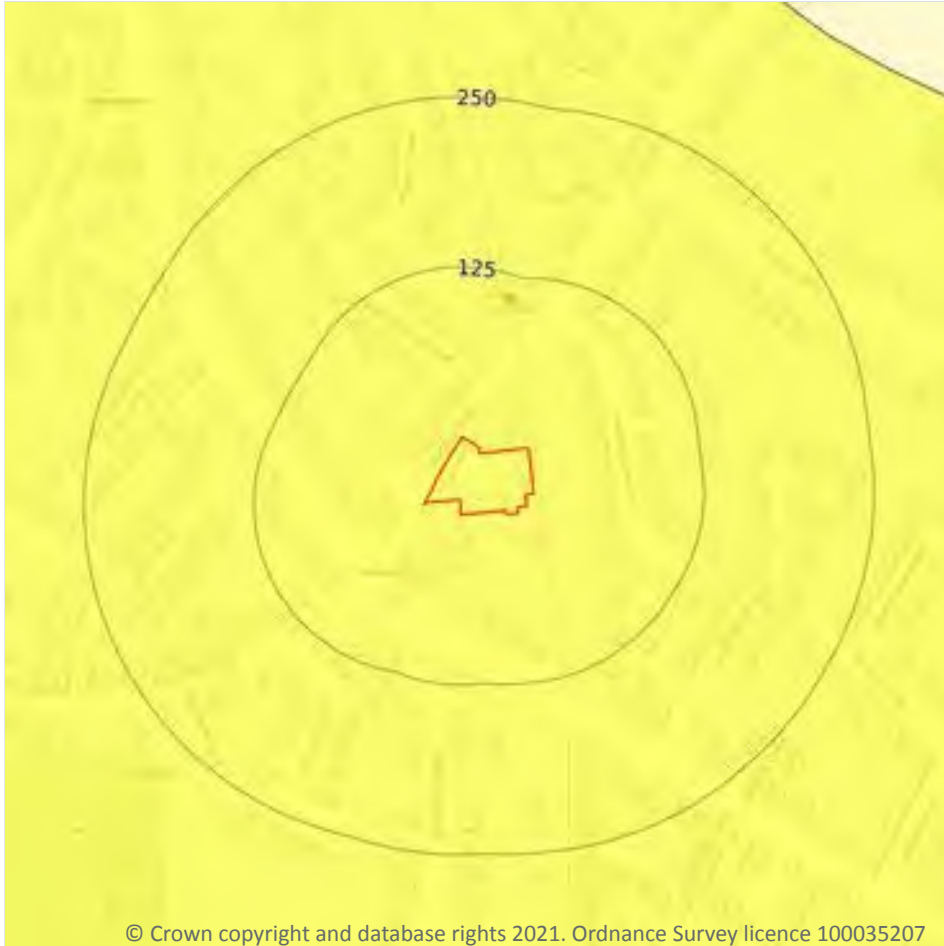
## Natural ground subsidence - Ground dissolution of soluble rocks

Features are displayed on the Natural ground subsidence - Ground dissolution of soluble rocks map on **page 91**

Location	Hazard rating	Details
On site	Very low	Soluble rocks are present within the ground. Few dissolution features are likely to be present. Potential for difficult ground conditions or localised subsidence are at a level where they need not be considered.

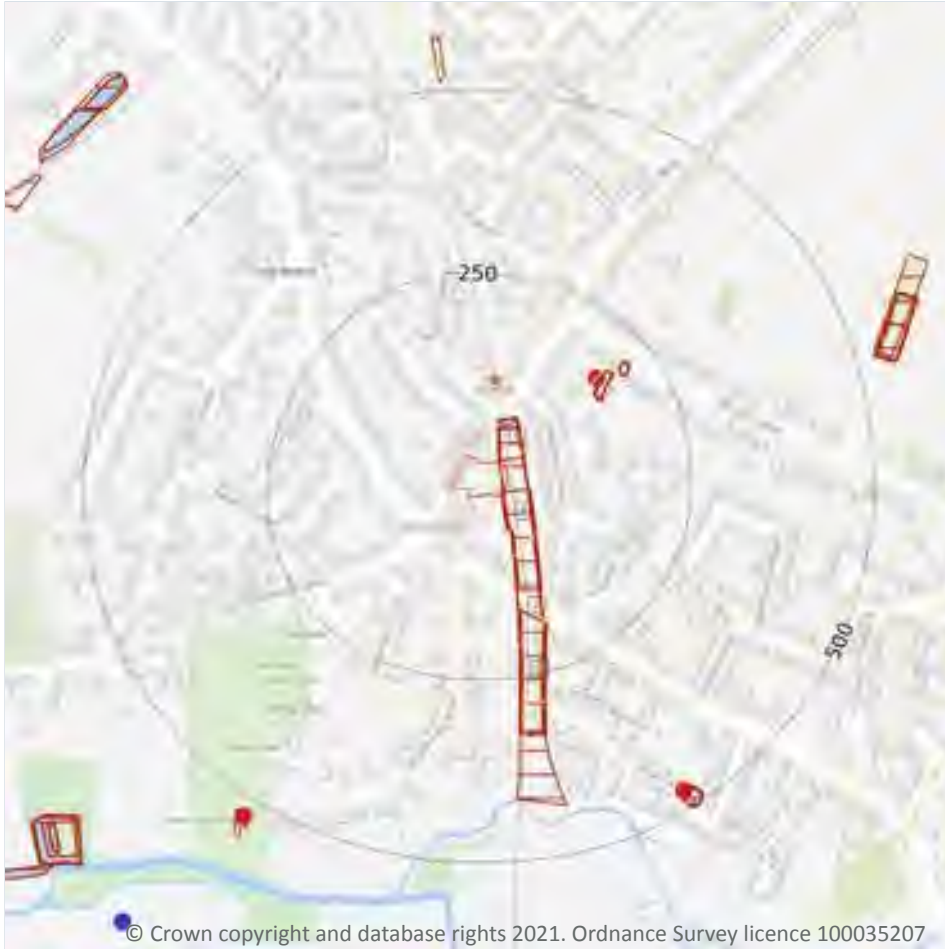
## 18 Mining, ground workings and natural cavities

Features are displayed on the Mining, ground workings and natural cavities map on **page 93**

ID	Location	Details	Description
D	168m NE	Name: The Limes Gravel Pits Address: Stapleford, CAMBRIDGE, Cambridgeshire Commodity: Sand & Gravel Status: Ceased	Type: A surface mineral working. It may be termed Quarry, Sand Pit, Clay Pit or Opencast Coal Site Status description: Site which, at date of entry, has ceased to extract minerals. May be considered as Closed by operator. May be considered to have Active, Dormant or Expired planning permissions by Mineral Planning Authority
F	475m SE	Name: Stapleford Gravel Pit Address: Stapleford, CAMBRIDGE, Cambridgeshire Commodity: Sand & Gravel Status: Ceased	Type: A surface mineral working. It may be termed Quarry, Sand Pit, Clay Pit or Opencast Coal Site Status description: Site which, at date of entry, has ceased to extract minerals. May be considered as Closed by operator. May be considered to have Active, Dormant or Expired planning permissions by Mineral Planning Authority

ID	Location	Name	Commodity	Class	Likelihood
1	On site	Not available	Chalk	A	<b>Sporadic underground mining of restricted extent may have occurred. Potential for difficult ground conditions are unlikely and localised and are at a level where they need not be considered</b>
-	650m W	Not available	Chalk	A	Sporadic underground mining of restricted extent may have occurred. Potential for difficult ground conditions are unlikely and localised and are at a level where they need not be considered

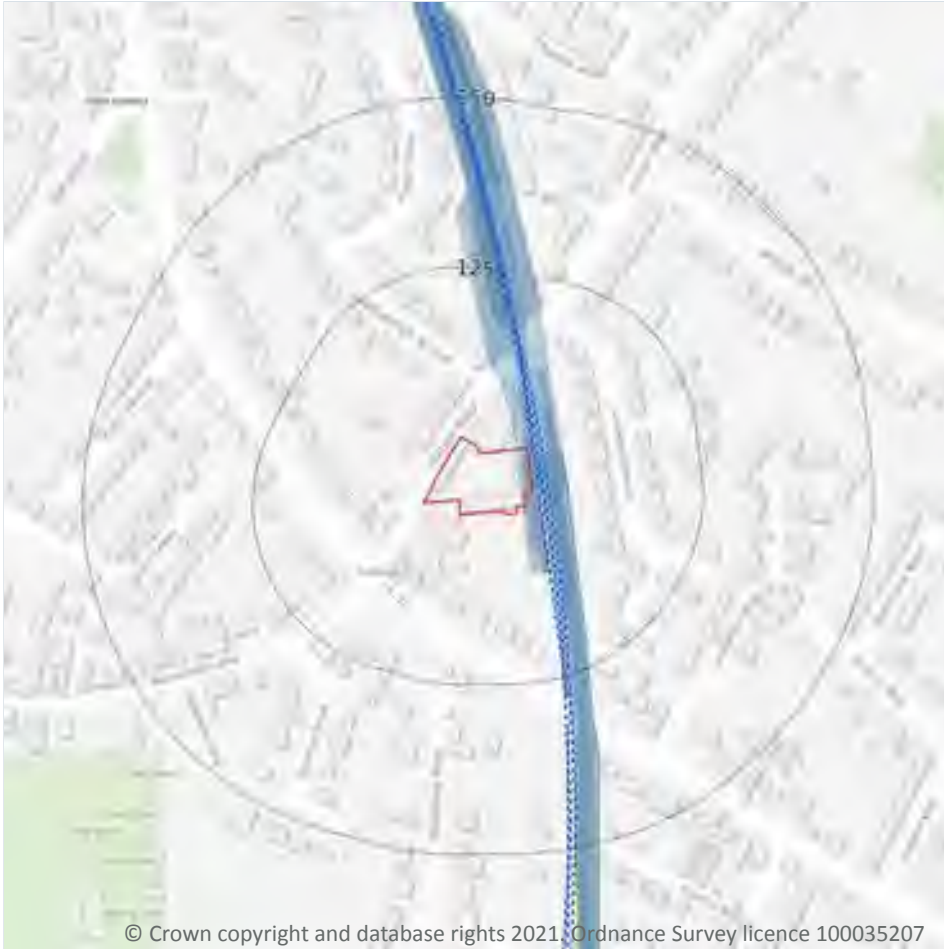
## 21 Railway infrastructure and projects

- Site Outline
- Search buffers in metres (m)**
- C1 Crossrail 1 Stations
- Crossrail 1 Route
- Crossrail 1 Worksites
- C2 Crossrail 2 Stations
- Crossrail 2 Route
- Crossrail 2 Worksites
- Crossrail 2 Safeguarding
- Crossrail 2 Headhouses
- Railway stations
- ⋯ Active railways
- ⋯ Active tunnels
- ⋯ Abandoned railways
- Historic railways
- Historic tunnels
- Underground stations
- Underground Lines
- Royal Mail tunnels
- HS2 optimised route
- HS2 Stations
- HS2 Depots
- HS2 Surface Safeguarding
- HS2 Subsurface Safeguarding

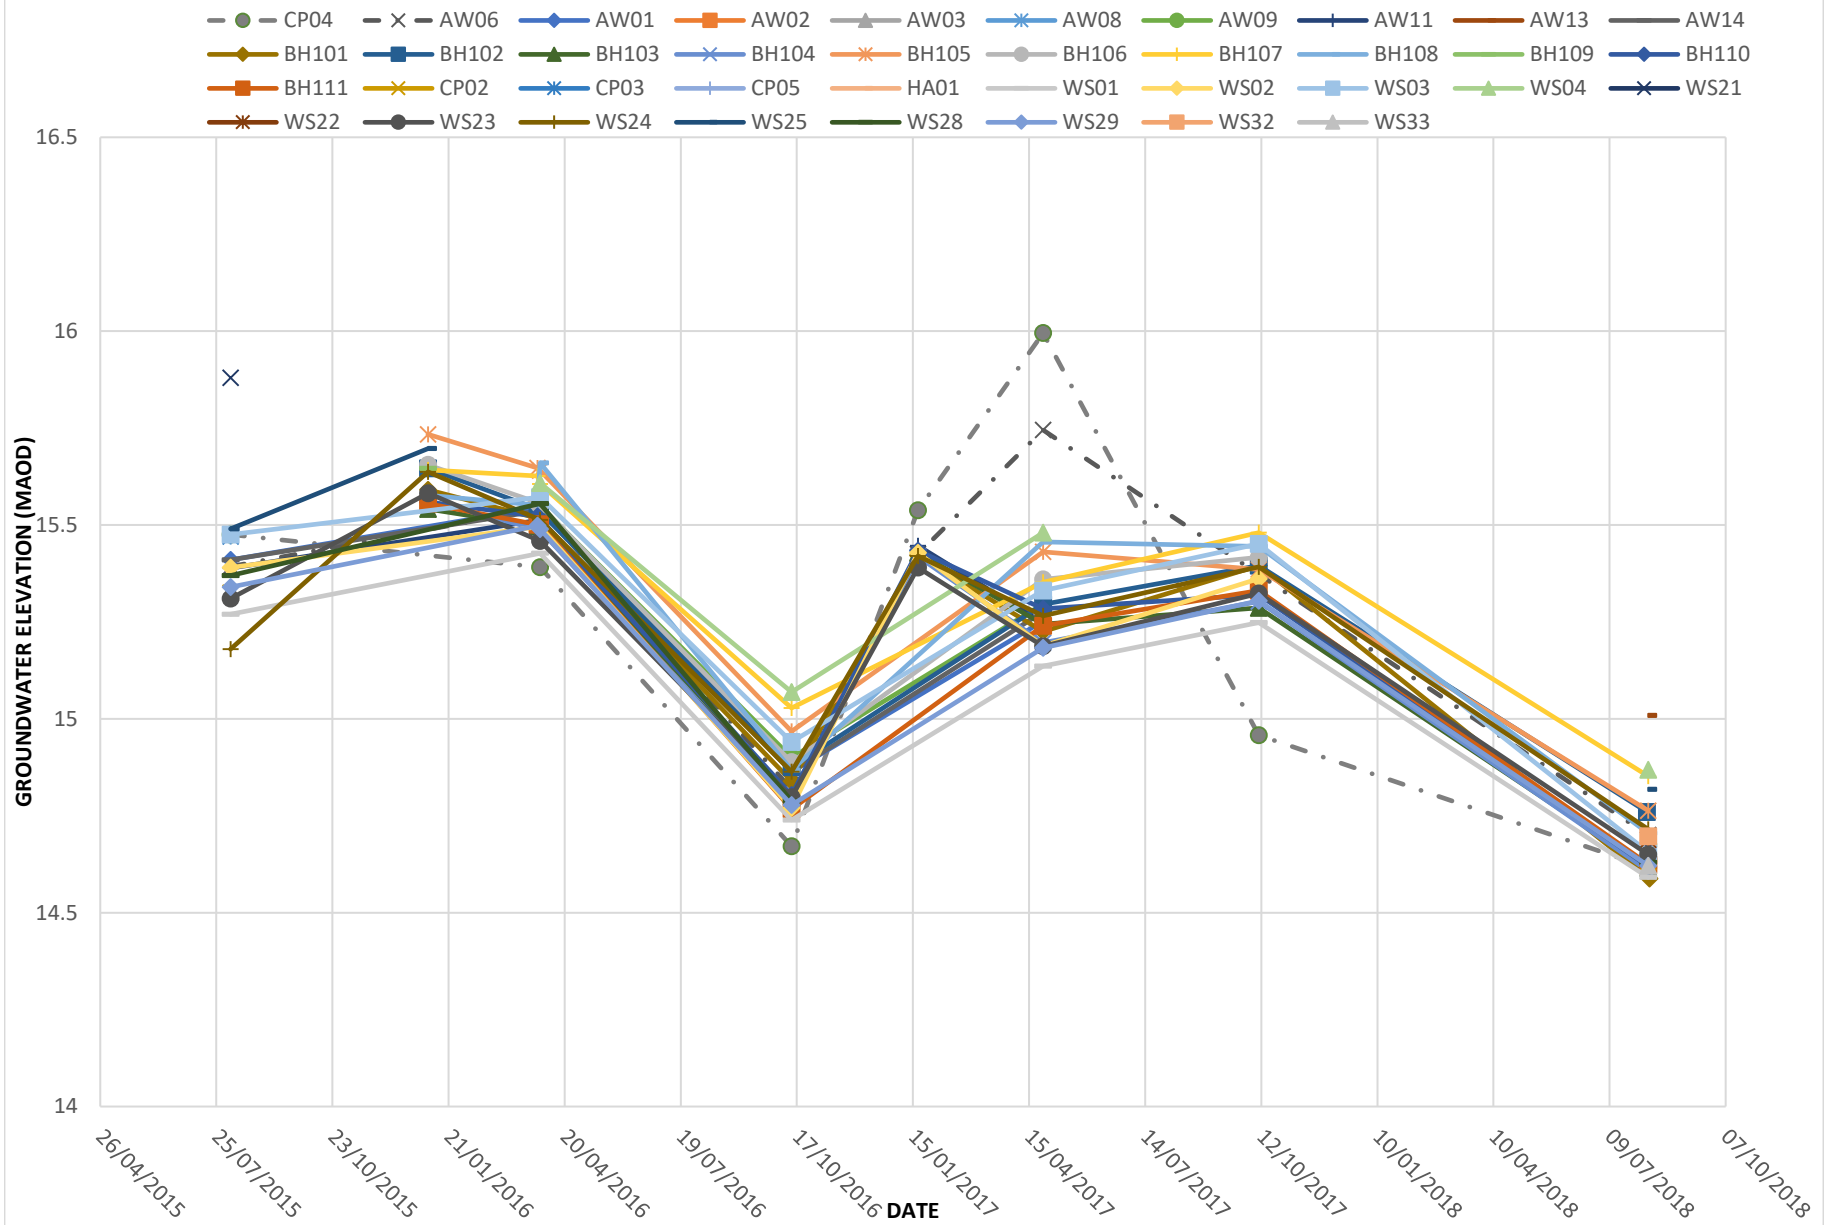
BH Ref	Ground Elevation	Date	Groundwater Level	GW Elevation
WS25	17.97	08/08/2018	3.152	14.818
WS28	19.04	05/08/2015	3.67	15.37
WS28	19.04	01/04/2016	3.485	15.555
WS28	19.04	13/10/2016	4.252	14.788
WS28	19.04	26/04/2017	NR	-
WS28	19.04	08/08/2018	4.41	14.63
WS29	17.96	05/08/2015	2.62	15.34
WS29	17.96	30/03/2016	2.462	15.498
WS29	17.96	01/04/2016	2.471	15.489
WS29	17.96	13/10/2016	3.182	14.778
WS29	17.96	26/04/2017	2.777	15.183
WS29	17.96	10/10/2017	2.656	15.304
WS29	17.96	08/08/2018	3.339	14.621
WS32	19.76	08/08/2018	5.063	14.697
WS33	19.22	08/08/2018	4.599	14.621

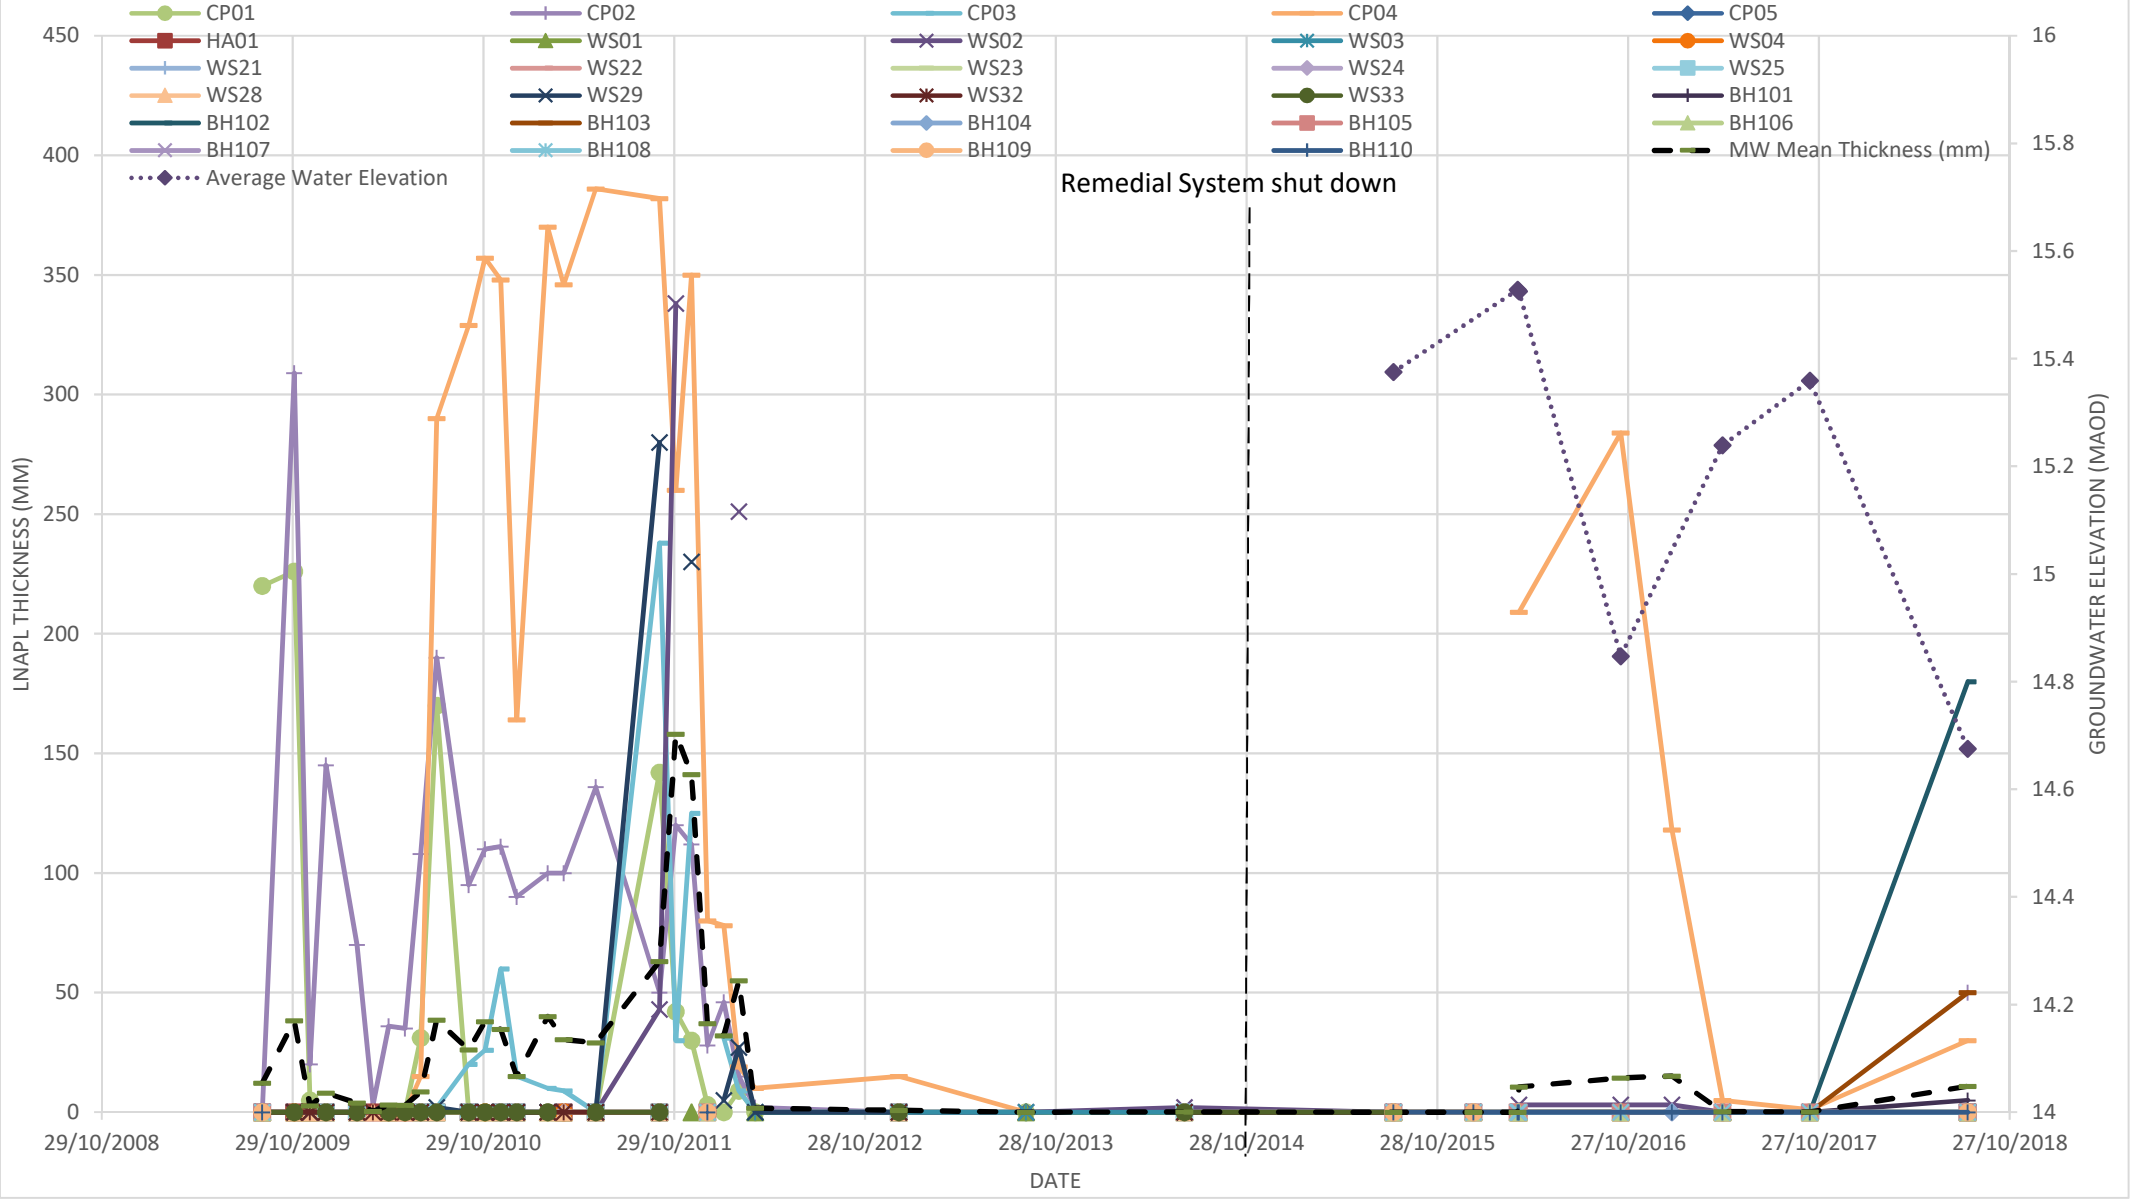
Pre & During Remediation																			
Well ID		01/09/2009	01/11/2009	01/12/2009	01/01/2010	01/03/2010	01/04/2010	01/05/2010	01/06/2010	01/07/2010	01/08/2010	01/10/2010	01/11/2010	01/12/2010	01/01/2011	01/03/2011	01/04/2011	01/06/2011	01/10/2011	01/11/2011	01/12/2011
Remediation Wells	AW01	0	0	0	0	0	0	0	0	0		0	0	0	0	0	0	0	0	0	
	AW02	0	0	3	13	0	0		0	0			0					0			
	AW03	0	0	0	0	0	0	0	0	0			0		0			0	0	0	
	AW04	30	1	1	2	0	1	5	0	0			0		0			0	0	5	
	AW05	40	39	0	2	0	0	2	0	0			0		0			0	0	0	
	AW06	40	13	0	0	0	0	0	0	0			0		0			0	0	100	
	AW07	0	0	0	0	0	0	0	0	0			0		0			0	0	3	
	AW08	20	147	0	0	0	0	0	0	0	0							0	12	20	
	AW09	10	2	1	0	0	1	8	1	6			0						0	10	
	AW10	0	0	0	0	0	0	0	0	0			0		0			0	0	50	
	AW11	0	0	0	0	0	1	0	0	0			0		0			0	5	20	
	AW12	0	0	0	0	0	0	0	0	0			0		0			0	0	0	
	AW13	0	0	0	0	0	0	0	0	10	0			72		40			13	20	
	AW14	0	0	0	0	0	0	0	0	0			0		0			0	0	0	
Monitoring Wells	CP01	220	226	5	0	0		0	0	31	170	0	0	0	0	0	0	0	142	42	30

All measured thicknesses in millimetres (mm)  
Wells containing measured LNAPL are highlighted red  
cell blank = Well not monitored
