CHURCHILL RETIREMENT LIVING

2 STATION ROAD, GREAT SHELFORD, CAMBRIDGESHIRE CB22 5LR

DESK STUDY APPRAISAL

April 2021
Report No. CCL03428.CN25

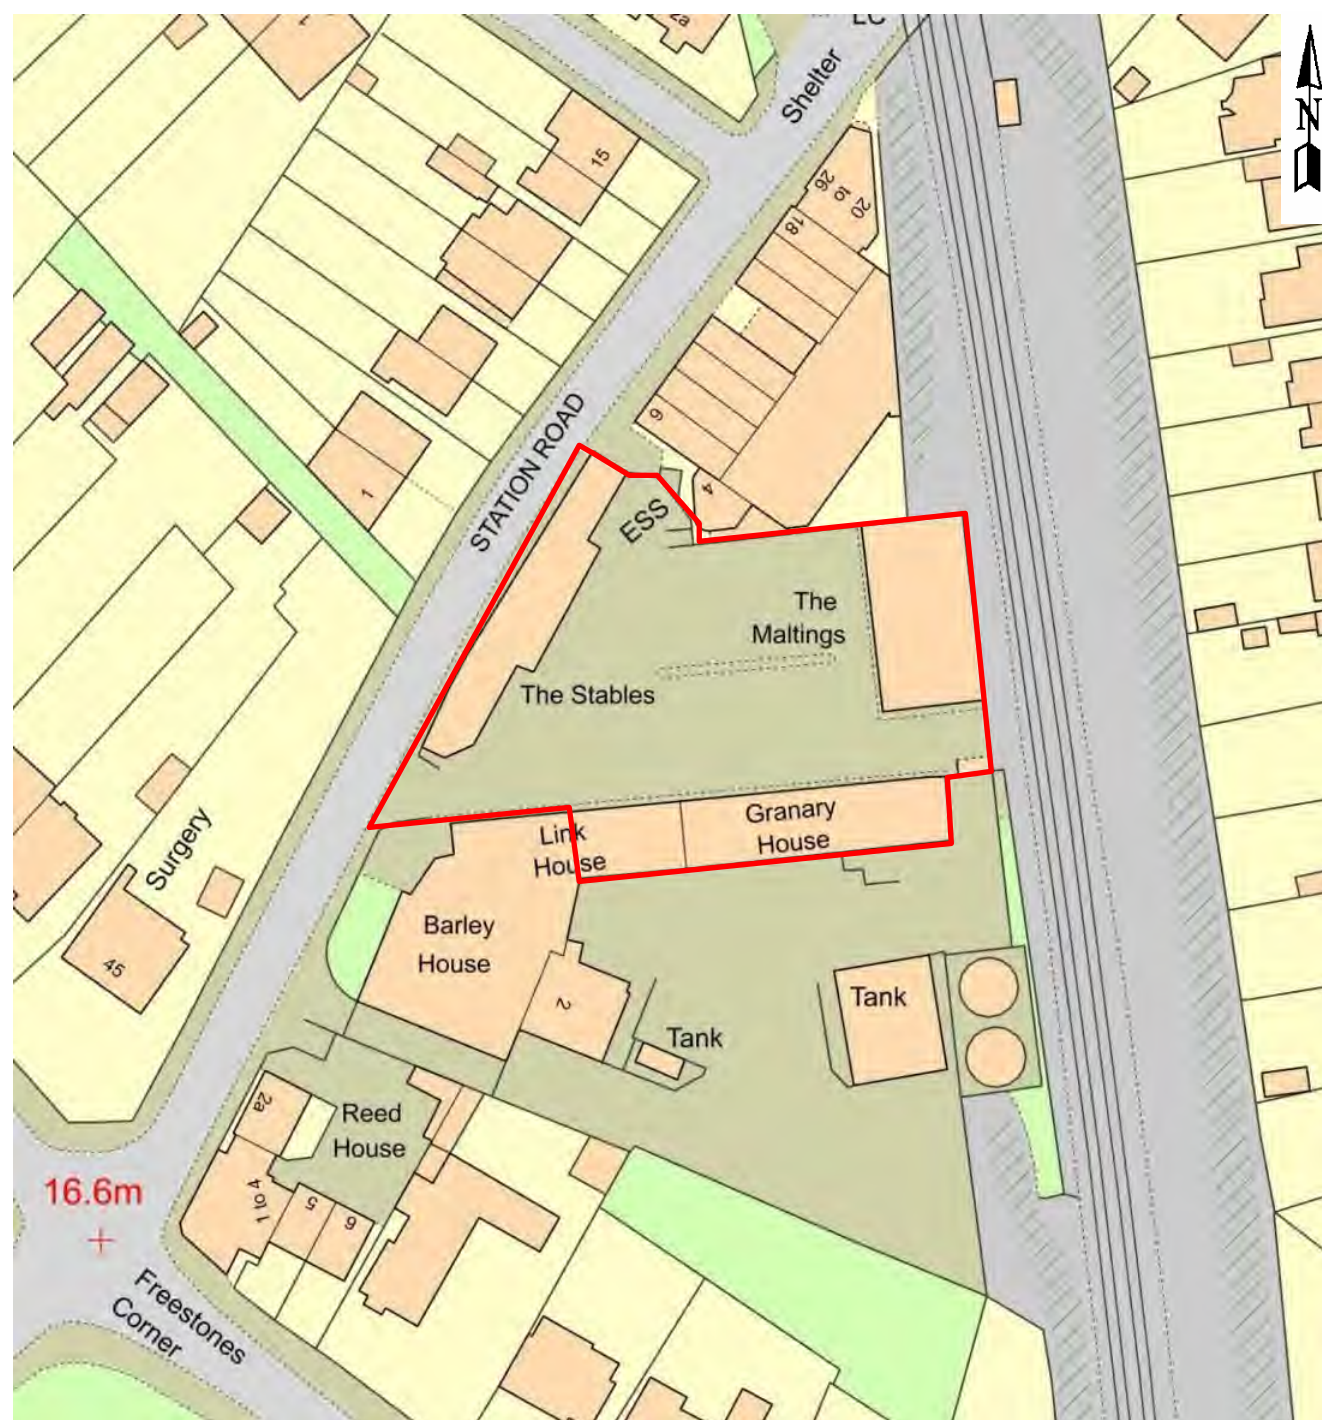
FIGURE 2

SITE PLAN
1:1250

The following site description is based on the current Ordnance Survey Plan, presented as Figure 2, and photographs accessible via internet-based mapping sites. No site reconnaissance has been undertaken by staff from Crossfield Consulting Limited.

The site is irregular in plan and occupies an area of approximately 0.3 ha. The site and the general surrounding areas appear to be sloping gently down to the southwest.

The site includes several separate single storey and up to three-storey office buildings. The building within the eastern part of the site is understood to be associated with offices for a refrigeration and air conditioning company. The office building within the southern part of the site is associated with an advisory company and all the other offices are vacant. The remaining central part of the site is a car park for the surrounding offices and appears to be asphalt surfaced. There are some decorative bushes present within the southeastern corner and trees in the northeastern corner, but vegetation is largely absent from the site. Bushes are also present along the eastern site boundary with the railway.

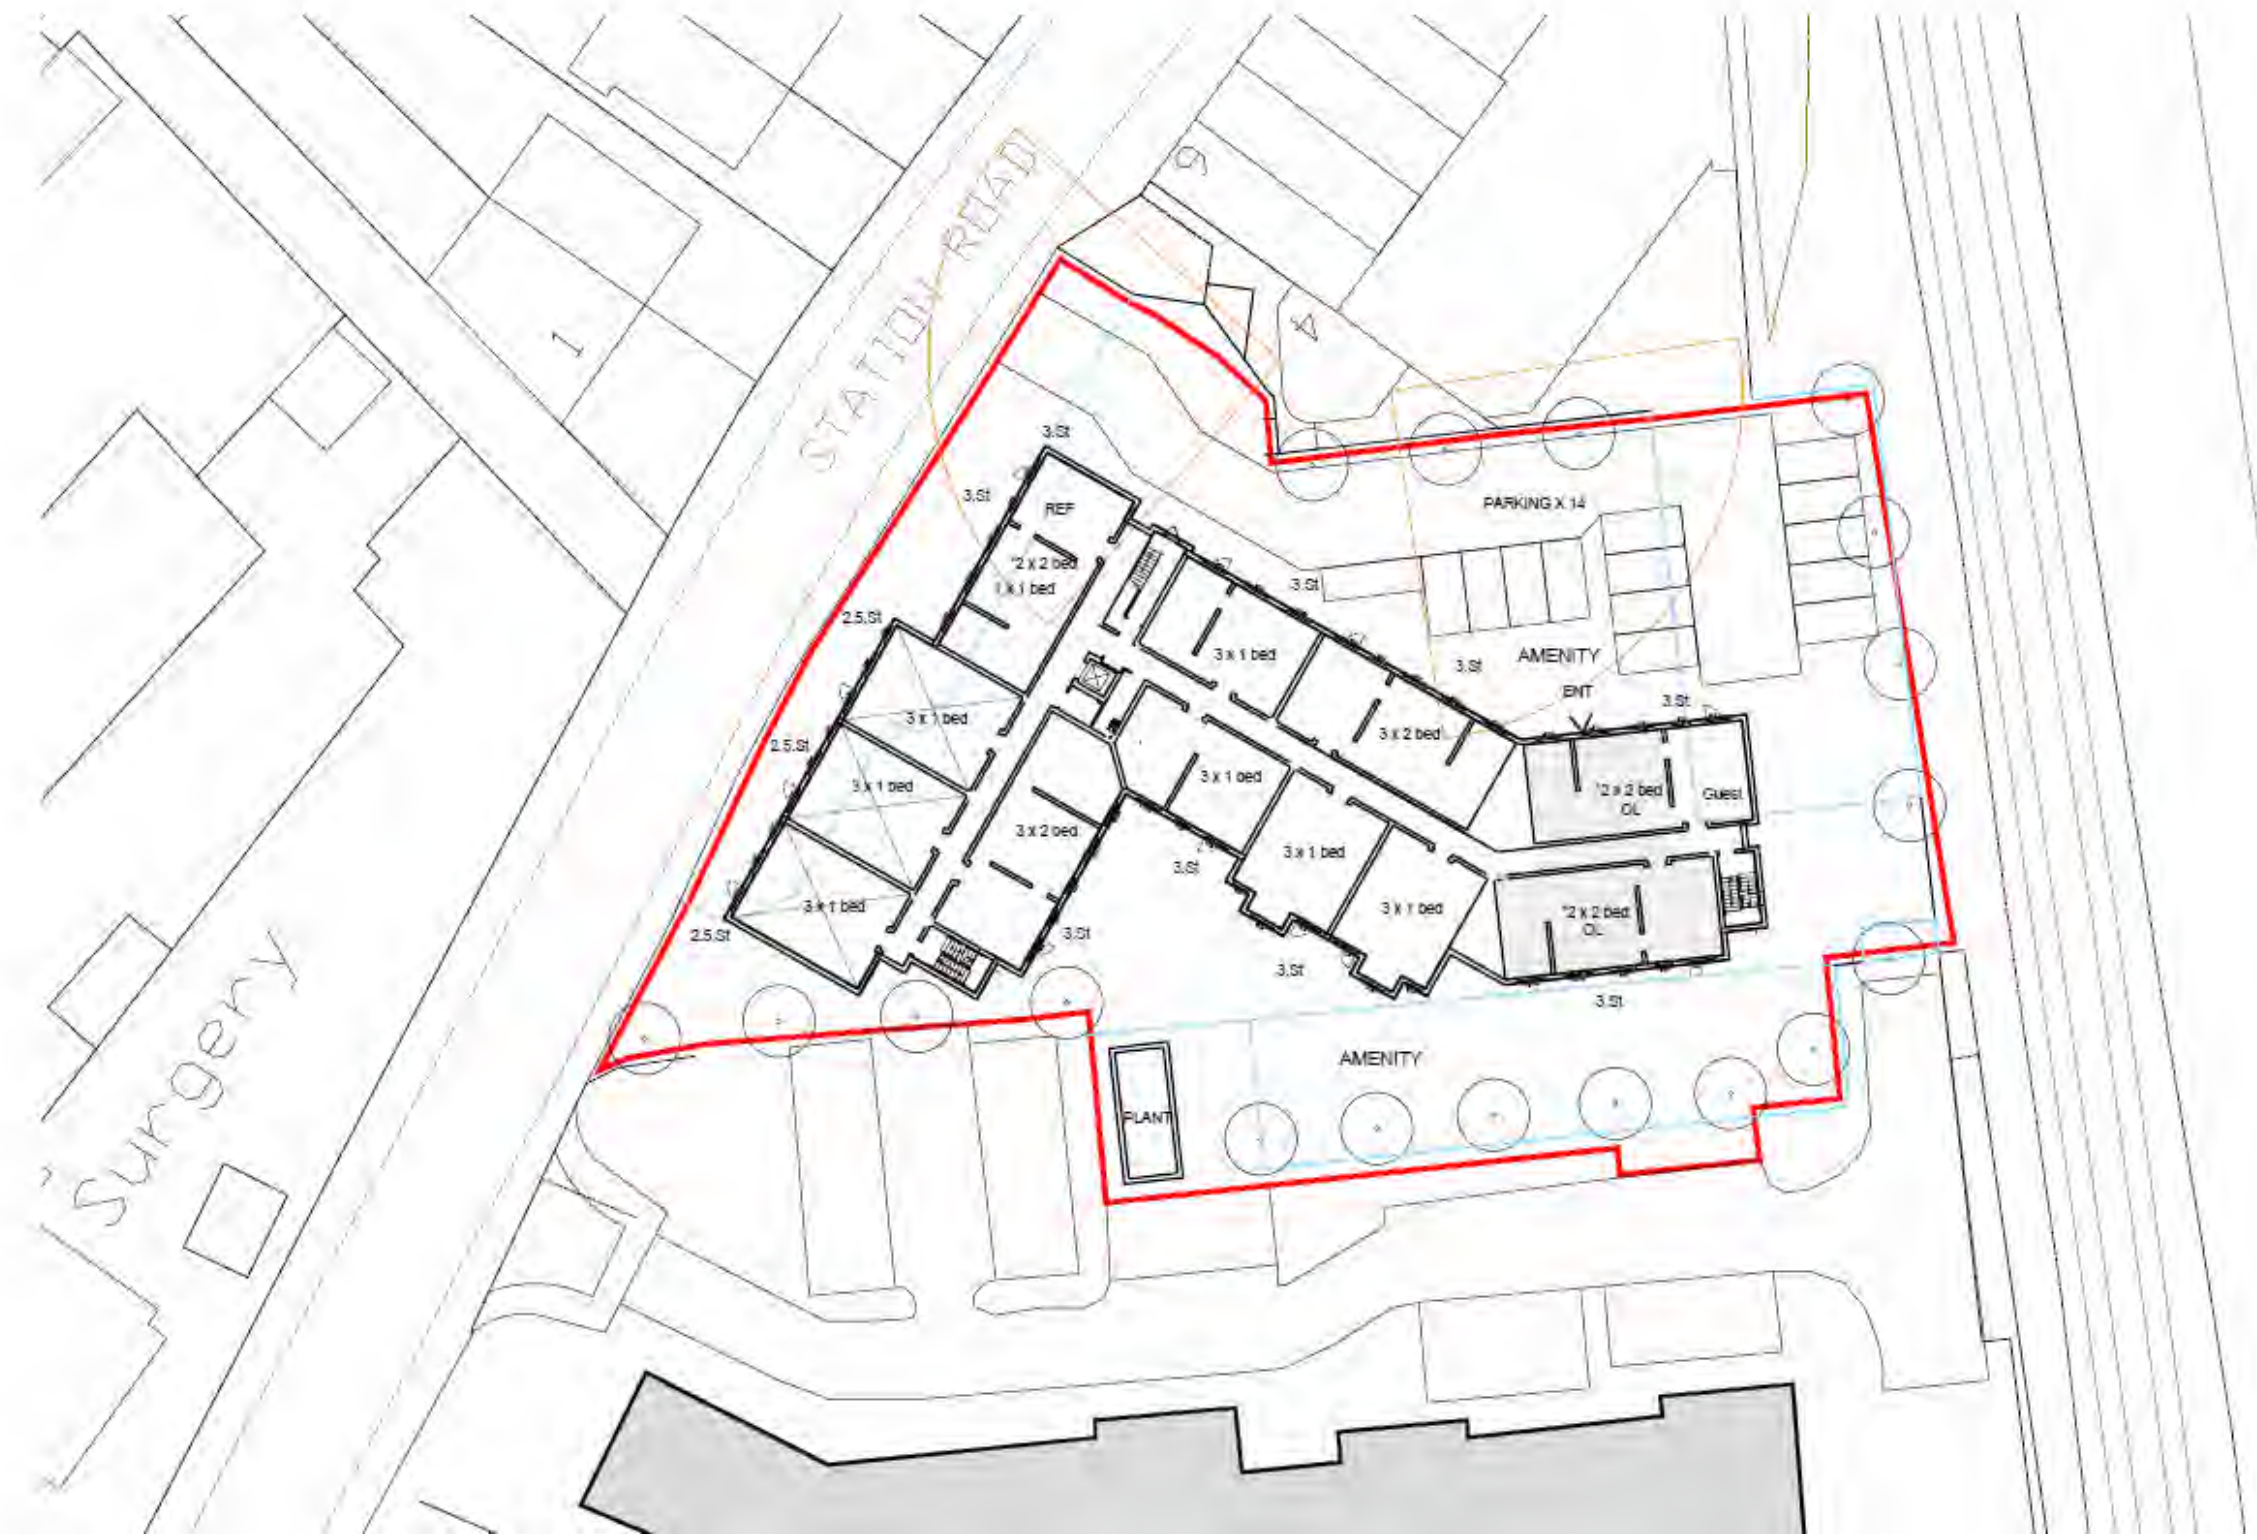
INDICATIVE PROPOSED DEVELOPMENT LAYOUT

It is proposed to develop a site off Station Road, Great Shelford for residential purposes. The site is currently occupied by several commercial properties (predominantly offices) and a car park. It is understood that the proposed development will comprise a three-storey block of apartments together with car parking and managed soft landscaping. Residents will be of retirement age.
