# Kingfisher Pond - Northstowe Hydrogeological Assessment

## Baseline Conceptual Report

FWM8714-RT001-R03-00

March 2021

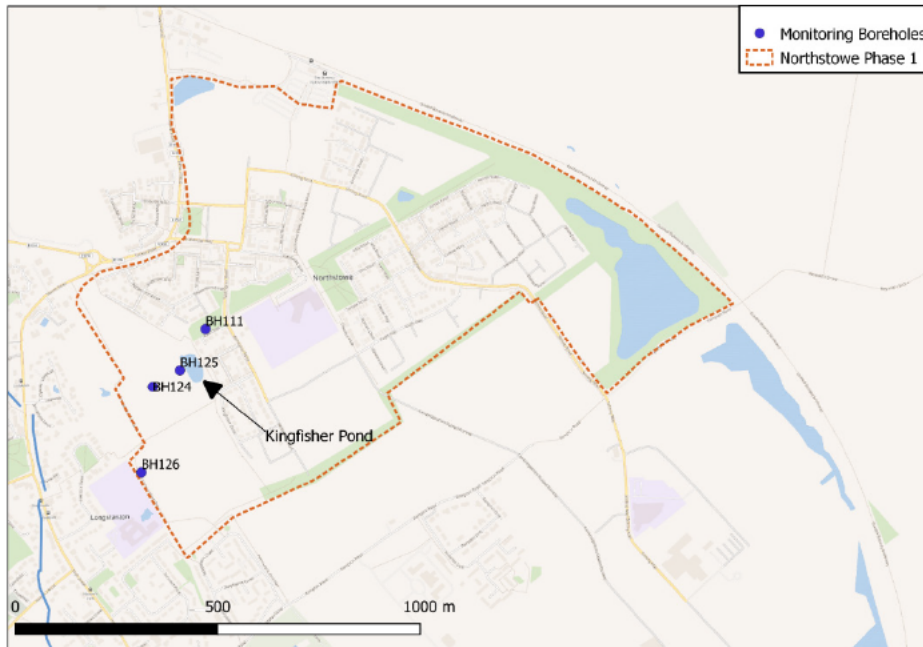
Figure 4.3: Map highlighting locations of boreholes of interest at Northstowe Phase 1

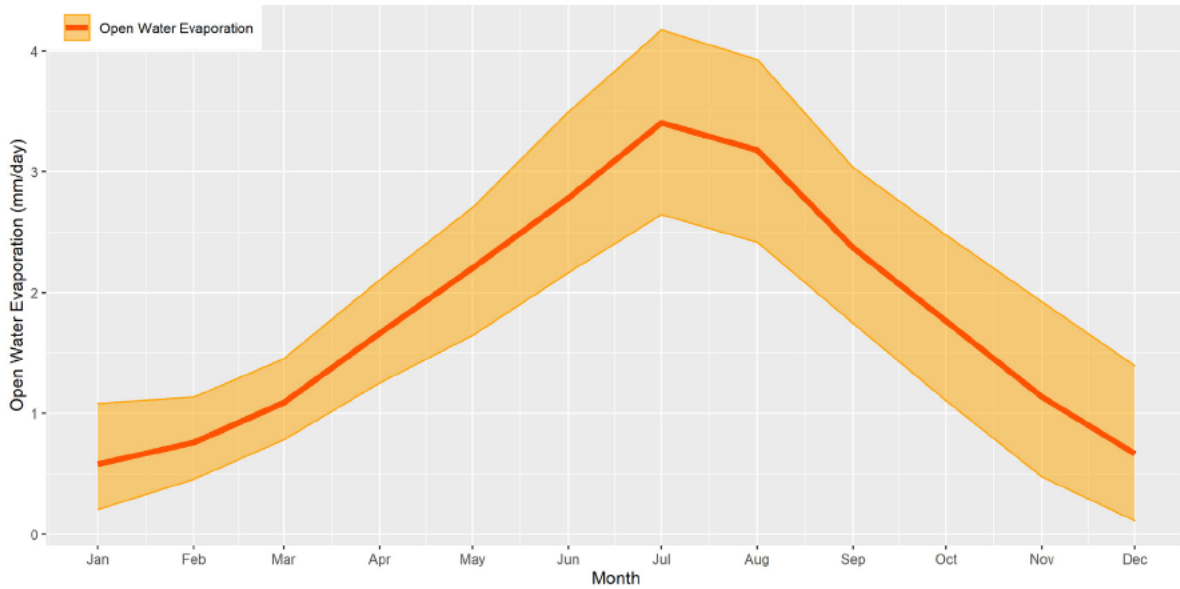
Figure B.3: Monthly profile for the daily average open water evaporation rate derived from potential evapotranspiration at Longstanton . Data from 01/01/1961 to 31/12/2014

Source: CEH potential evapotranspiration Robinson et al., (2020) converted to open water evaporation using monthly factors developed by the Environment Agency (2001). Dark orange line is the median Q50 monthly evaporation. Light orange ribbon is the range of Q25 to Q75 evaporation range.

Figure B.3 shows the average monthly profile for open water evaporation rate. As expected, peak evaporation occurs in summer when the temperature is highest. Figure B.4 shows the annual average open water evaporation. There is no long term trend indicating that open water evaporation is increasing for the period 1961-2014. The average open water evaporation rate is 1.87 mm/d.
