Phase 2: Site Investigation

Hotel Felix, Cambridge

Cassel Hotels (Cambridge) Ltd

PHASE 2 SITE INVESTIGATION REPORT

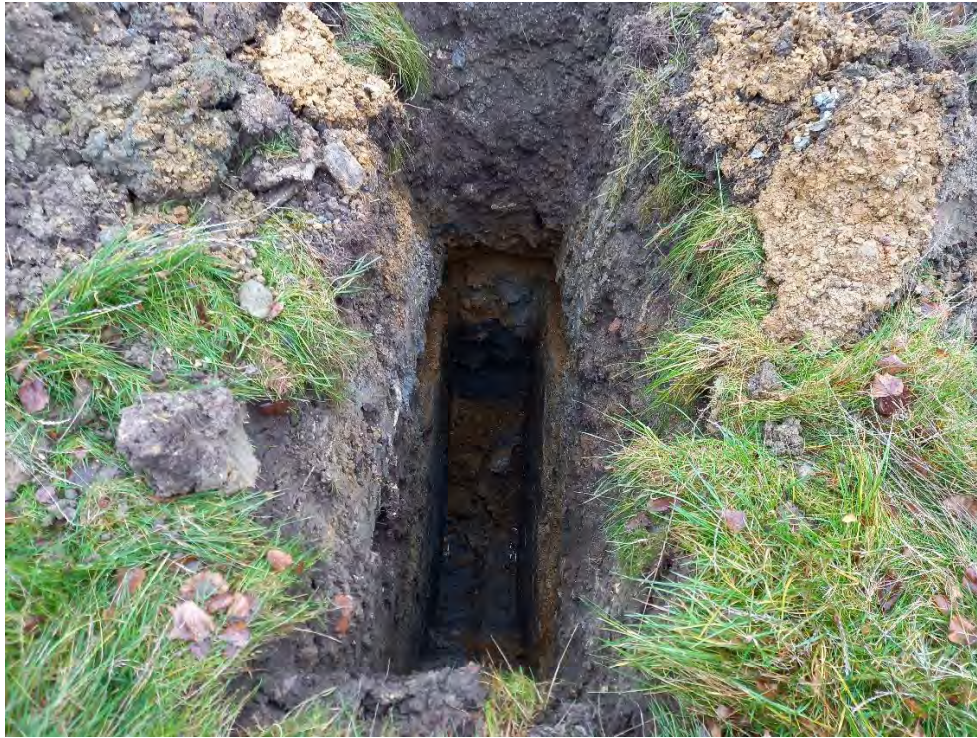
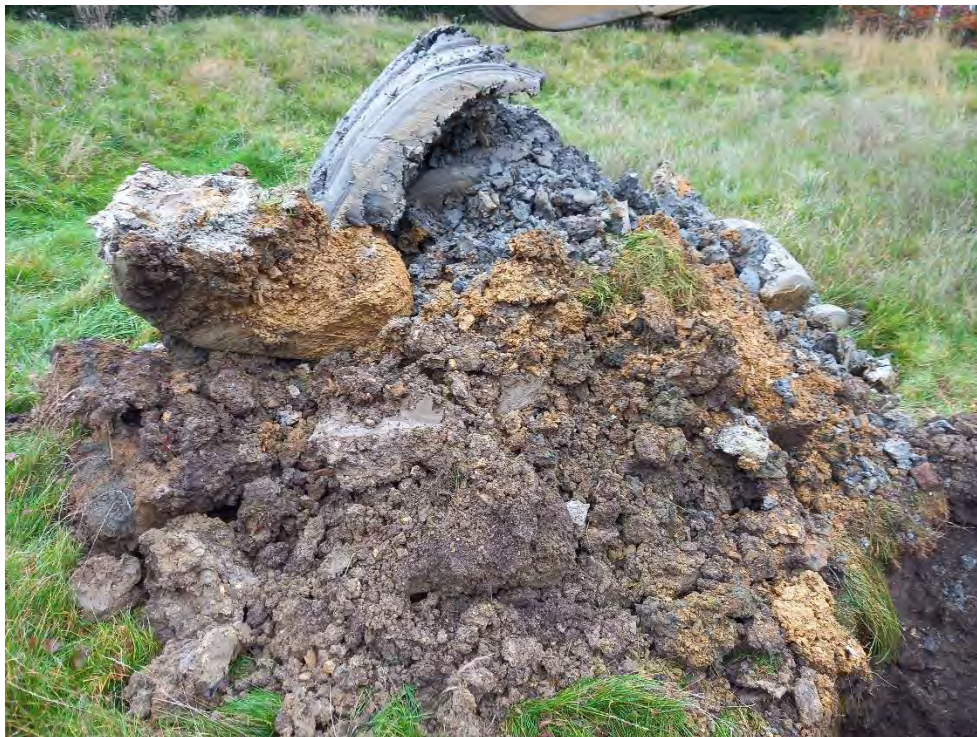
Photo 1: View of TP1 faces.

Photo 2: View of TP1 spoil.

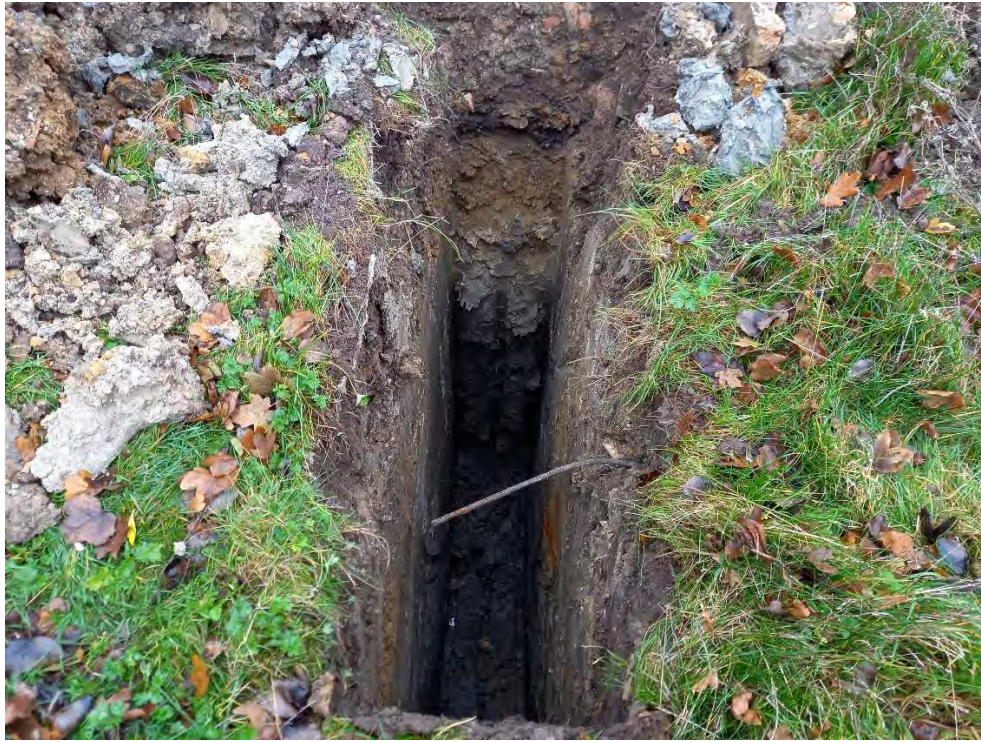
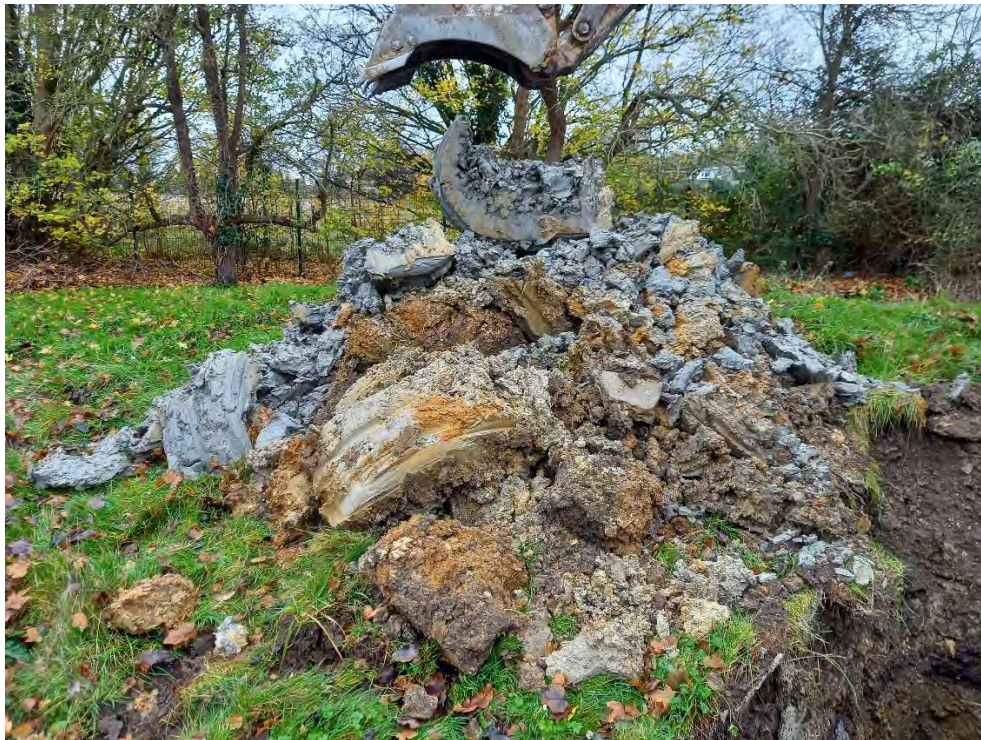
Photo 3: View of TP2 faces.

Photo 4: View of TP2 spoil.

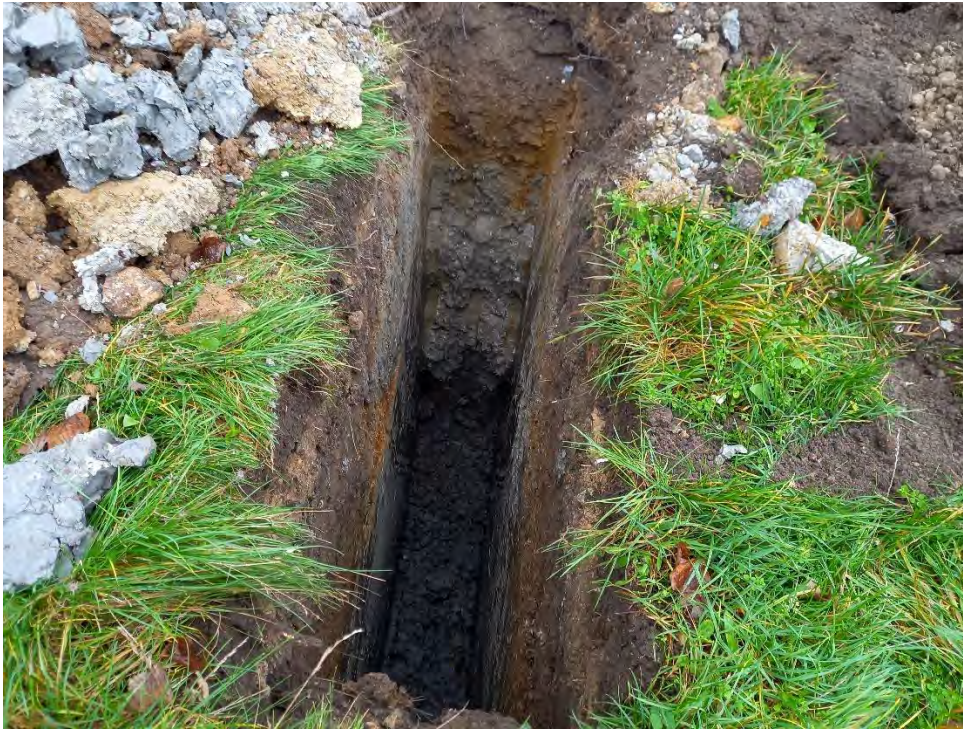
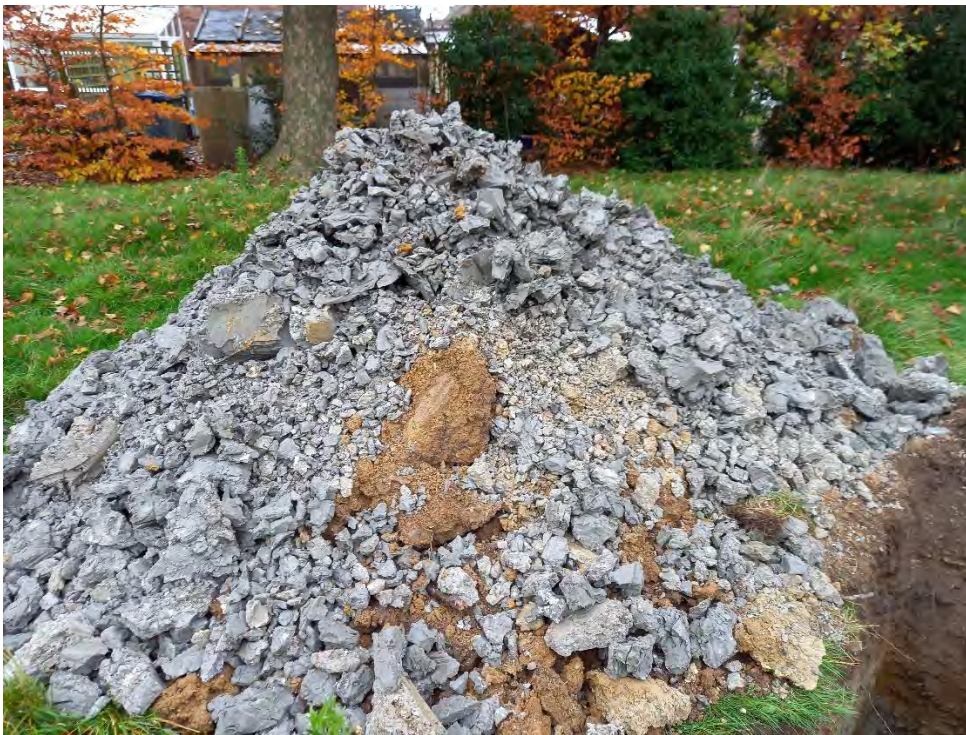
Photo 5: View of TP3 faces.

Photo 6: View of TP3 spoil.

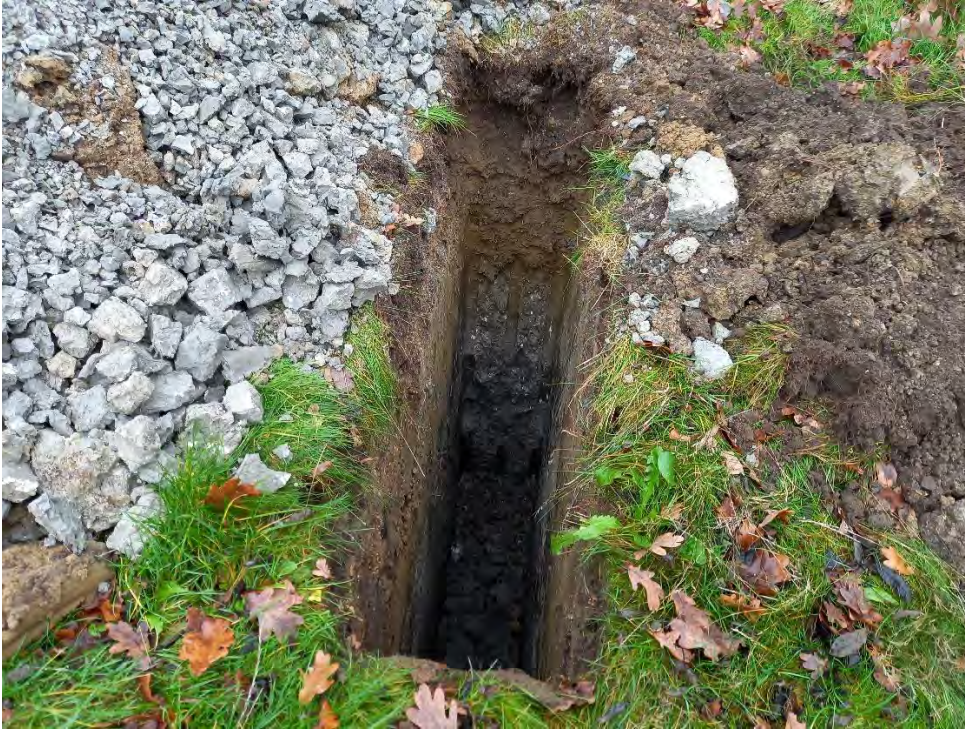
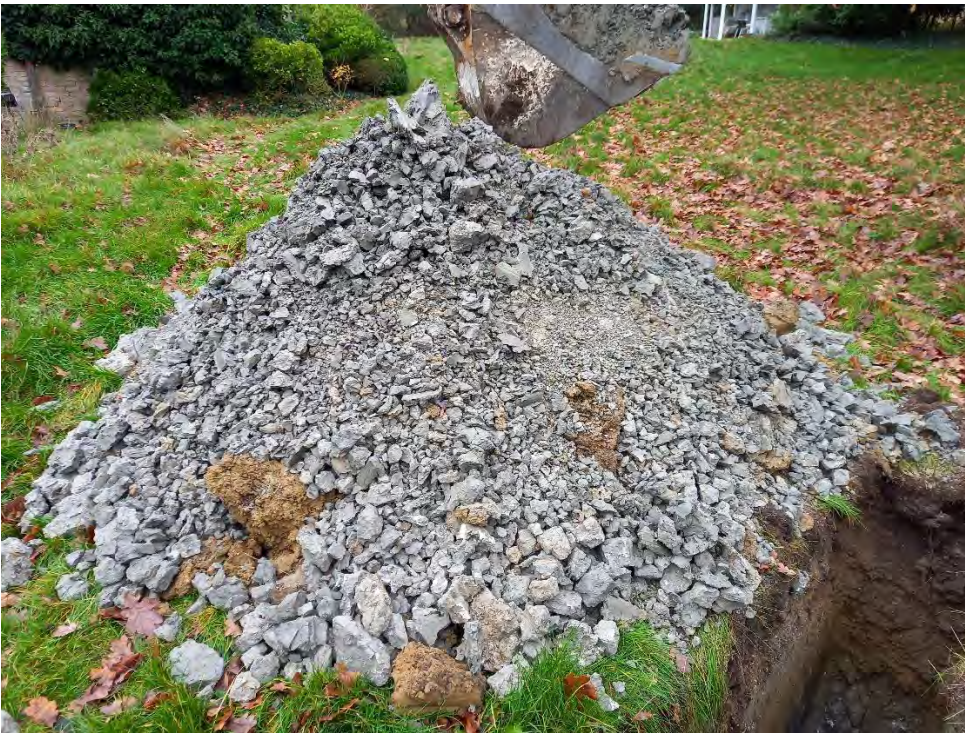
Photo 7: View of TP4 faces.

Photo 8: View of TP4 spoil.

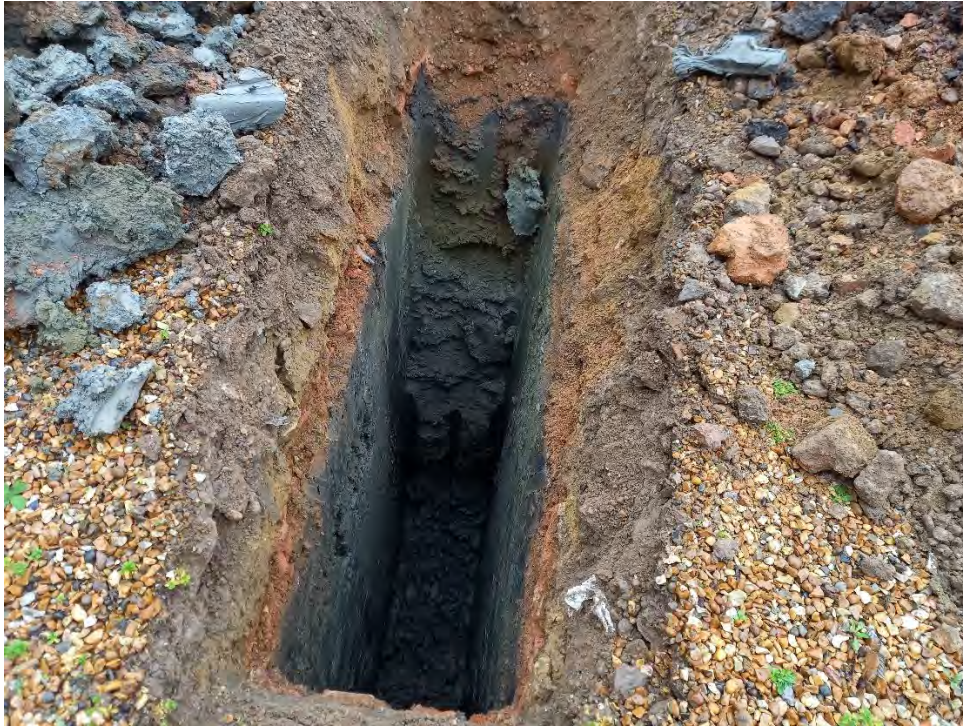
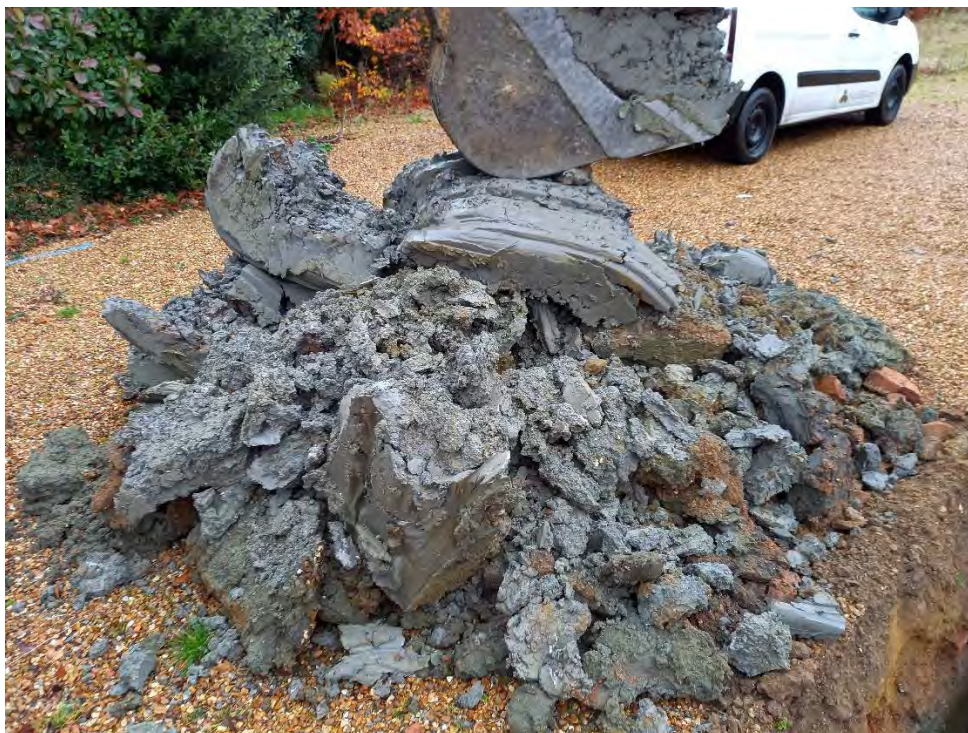
Photo 9: View of TP5 faces.

Photo 10: View of TP5 spoil.

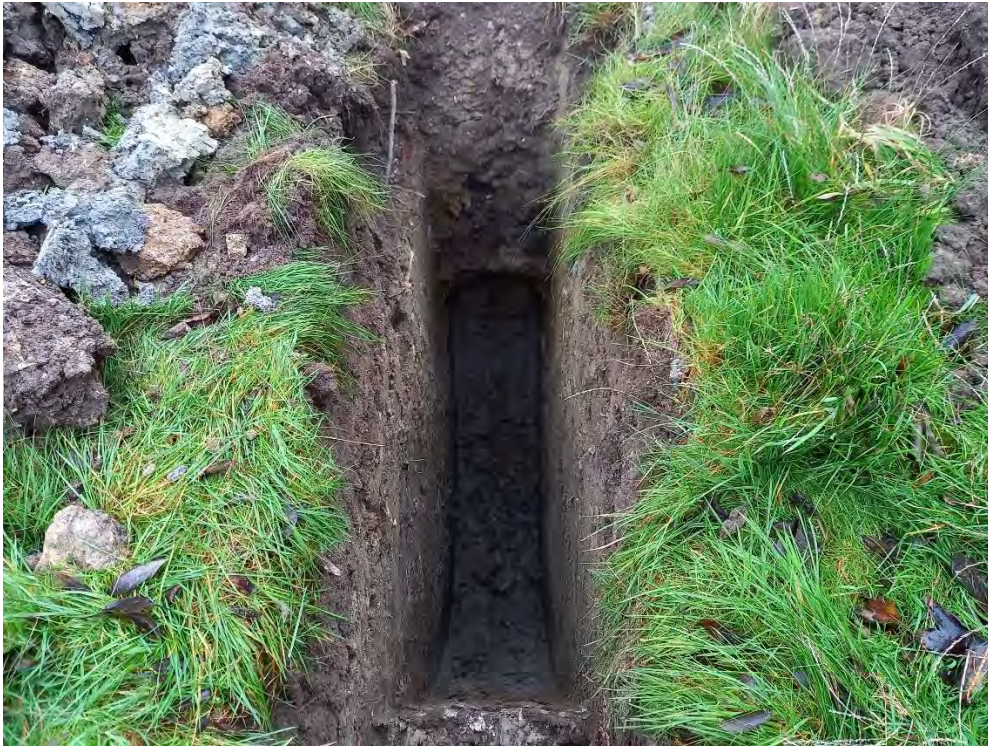
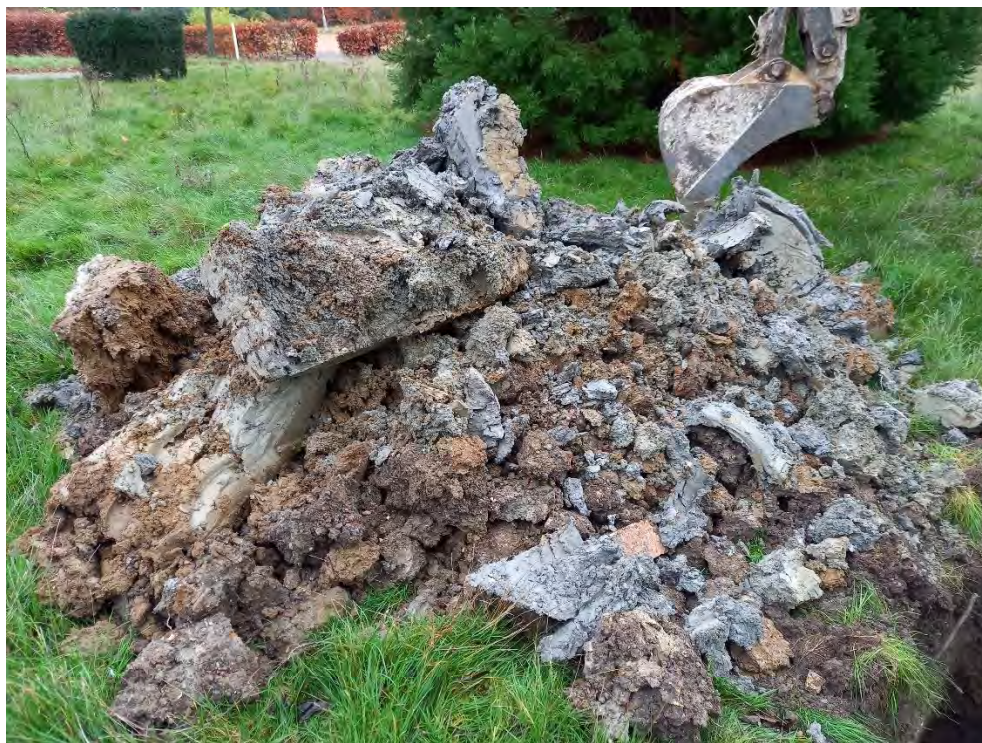
Photo 11: View of TP6 faces.

Photo 12: View of TP6 spoil.

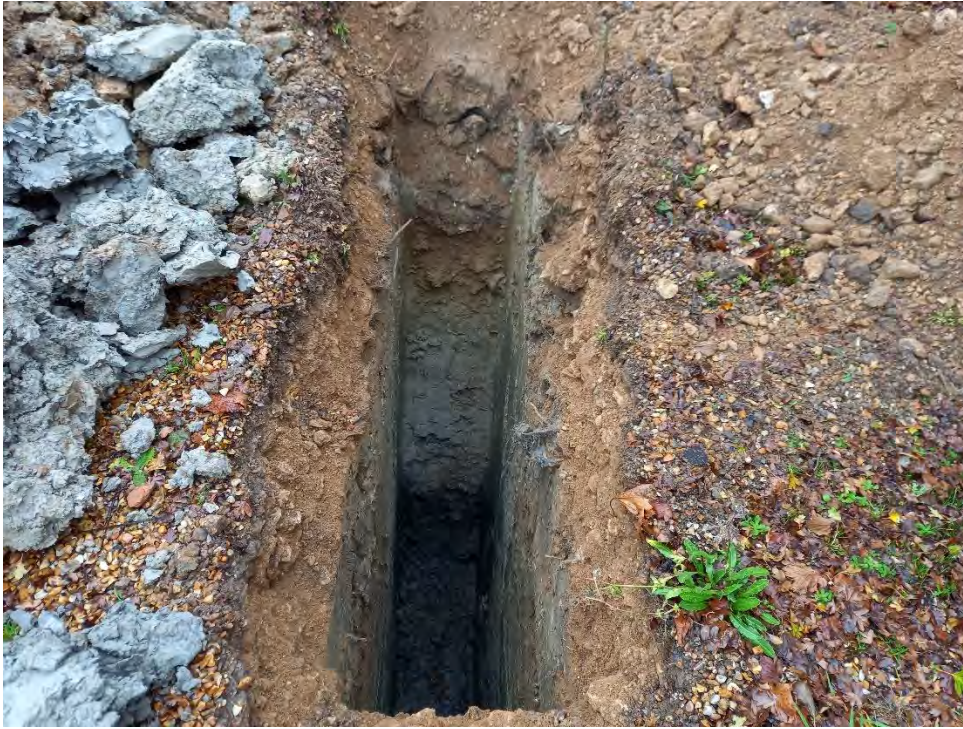
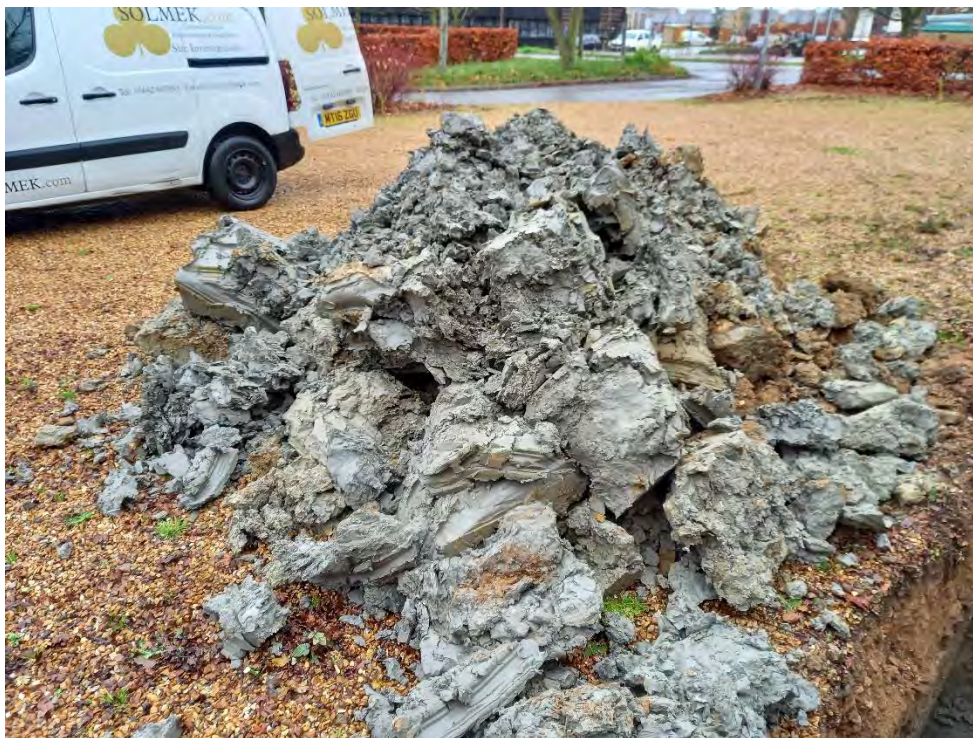
Photo 13: View of TP7 faces.

Photo 14: View of TP7 spoil.

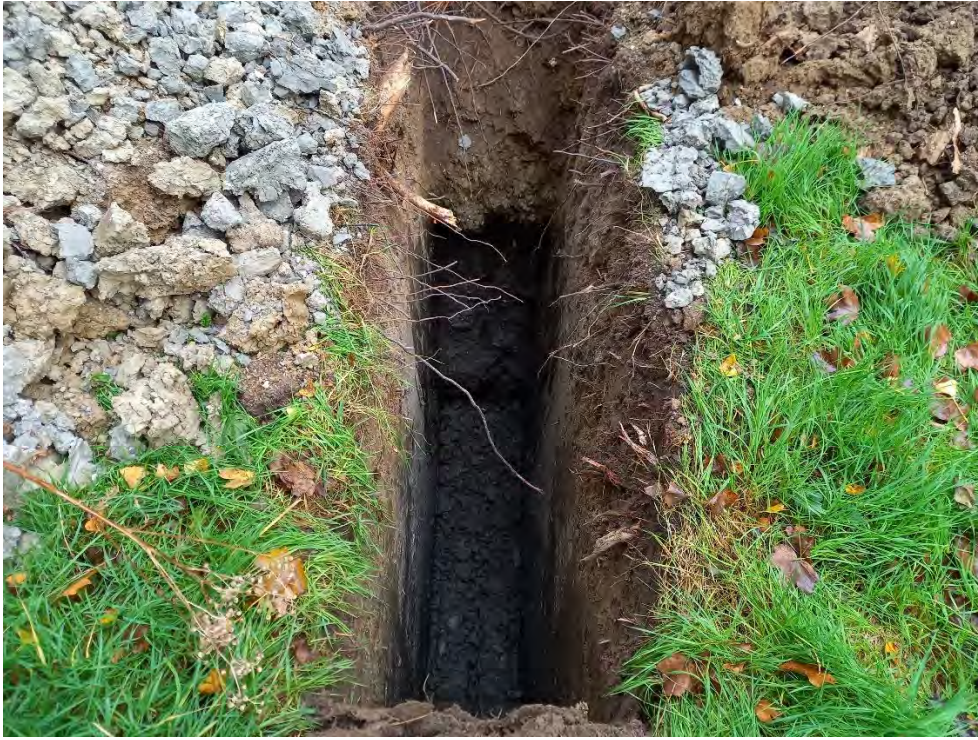
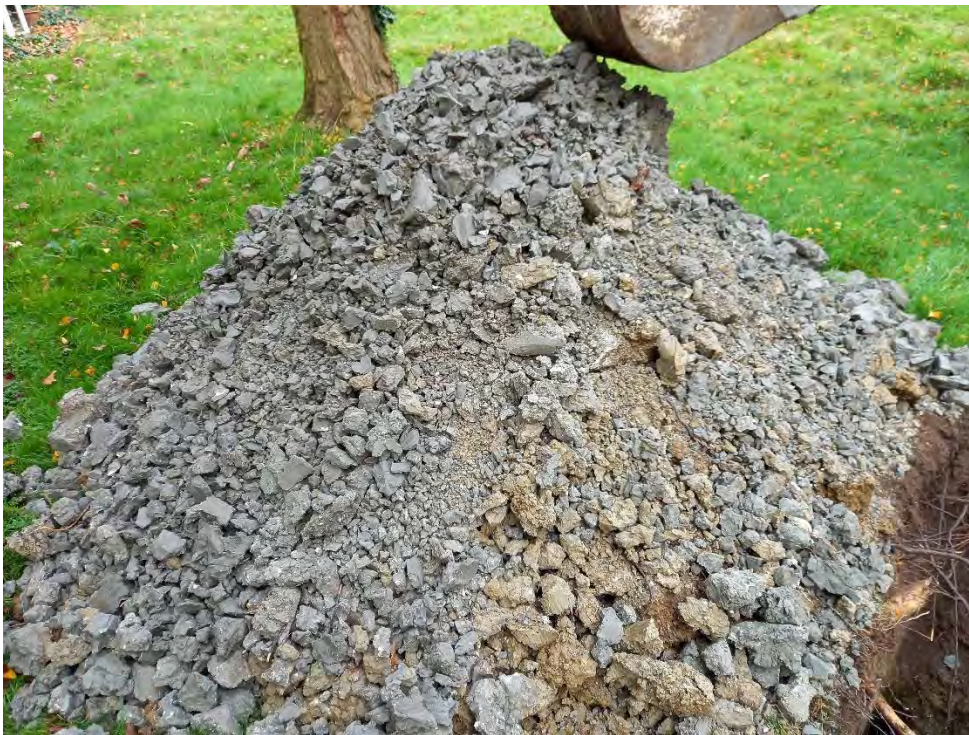
Photo 15: View of TP8 faces.

Photo 16: View of TP8 spoil.

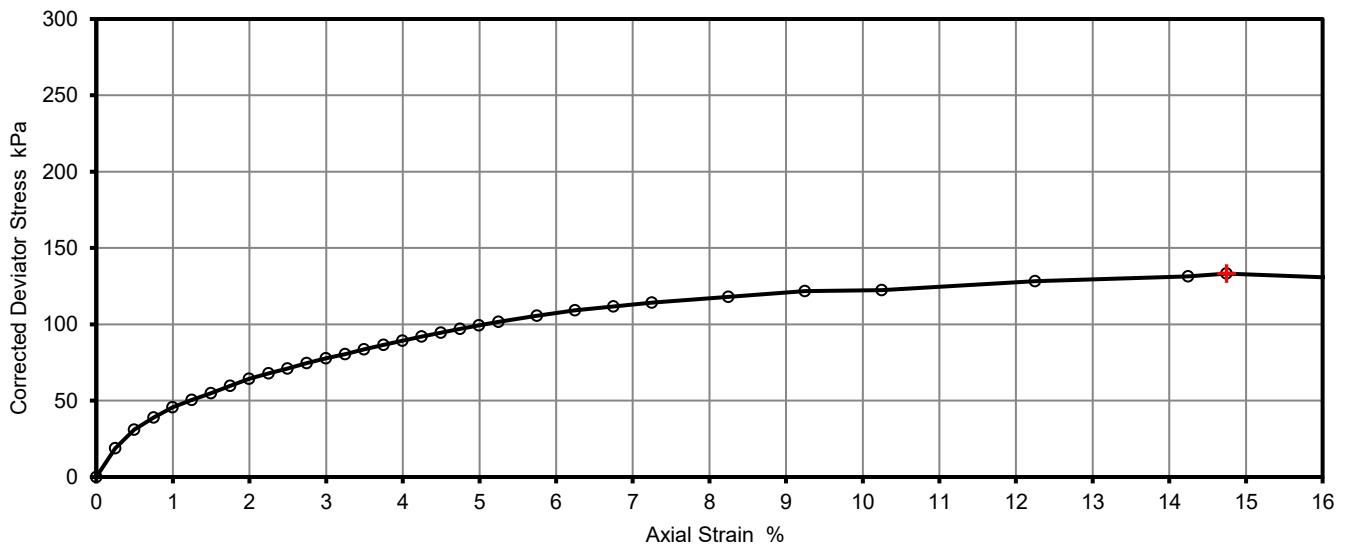
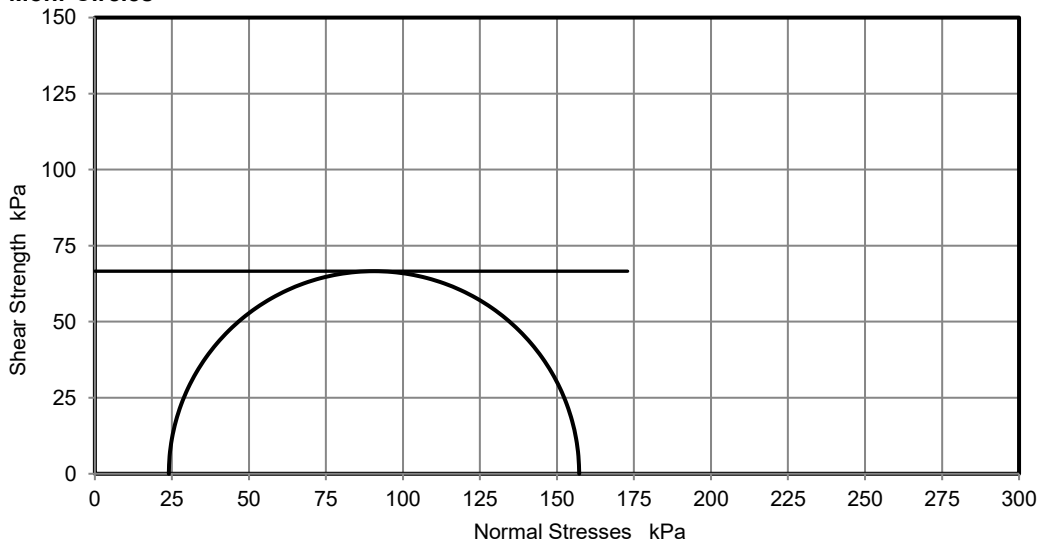
Rate of Strain	1.0	%/min	
Cell Pressure	24	kPa	
At failure	Axial Strain	14.7	%
	Deviator Stress, ($\sigma_1 - \sigma_3$) _f	133	kPa
	Undrained Shear Strength, c_u	67	kPa $\frac{1}{2}(\sigma_1 - \sigma_3)_f$
	Mode of Failure	Compound

Deviator Stress v Axial Strain

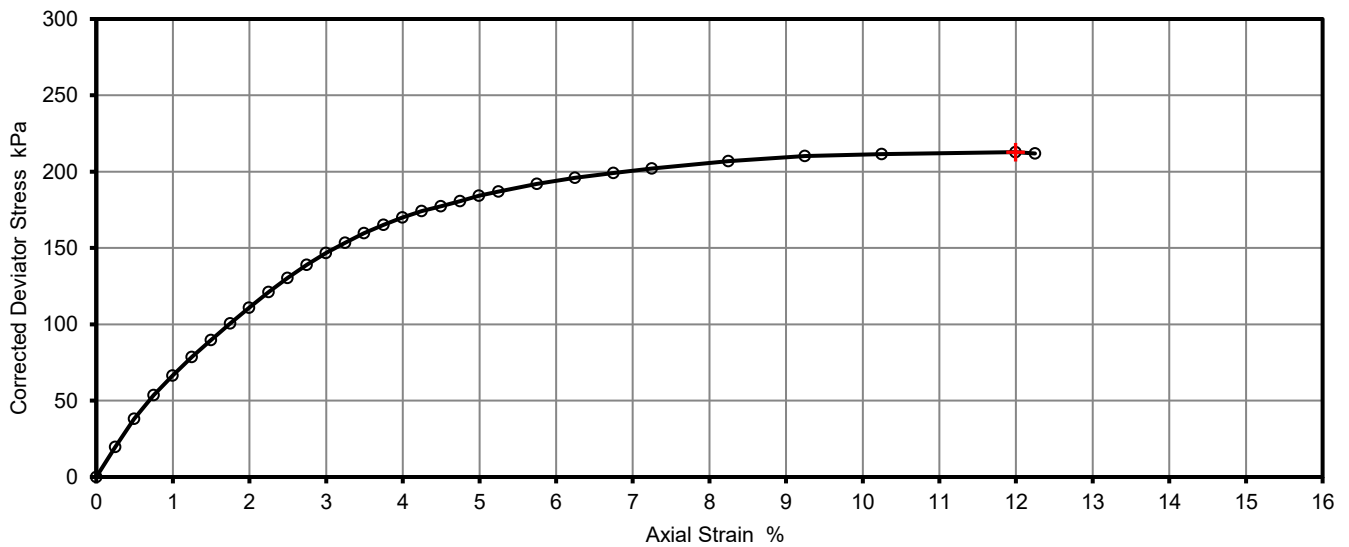
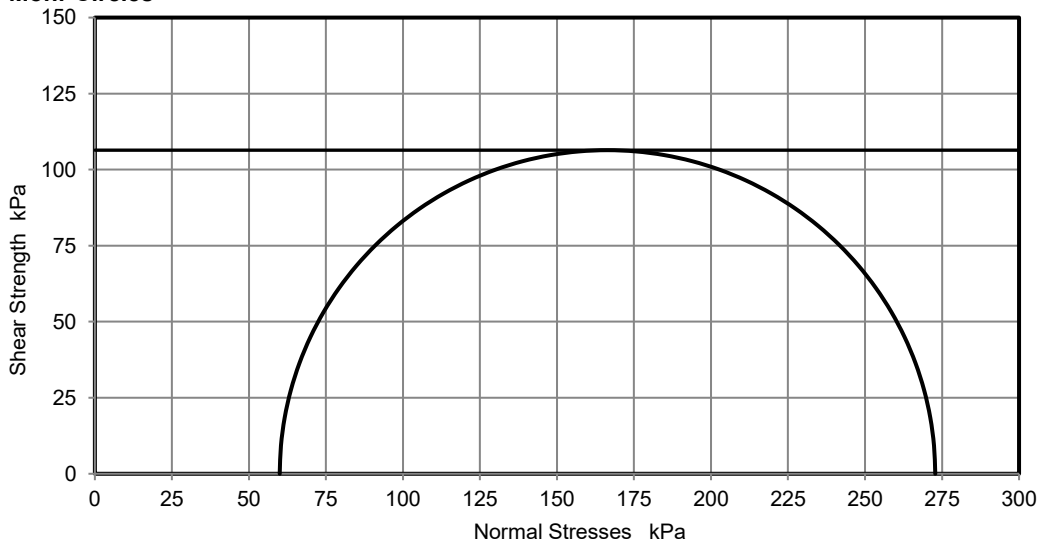
Rate of Strain	1.0 %/min
Cell Pressure	60 kPa
At failure	
Axial Strain	12.0 %
Deviator Stress, ($\sigma_1 - \sigma_3$) _f	213 kPa
Undrained Shear Strength, c_u	106 kPa $\frac{1}{2}(\sigma_1 - \sigma_3)_f$
Mode of Failure	Compound

Deviator Stress v Axial Strain

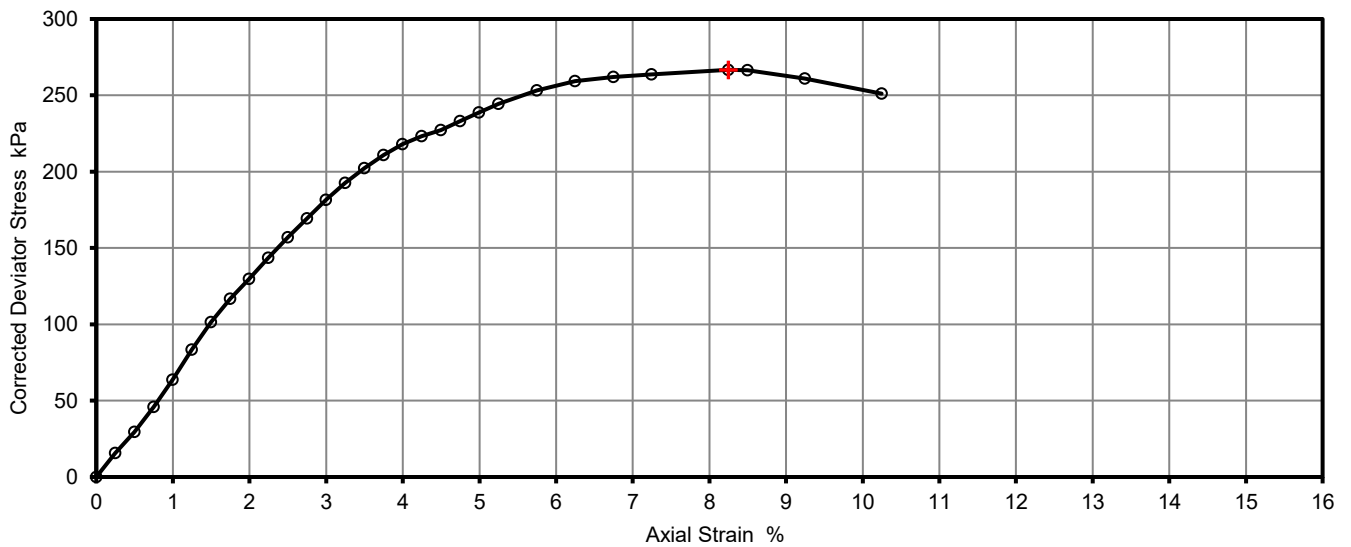
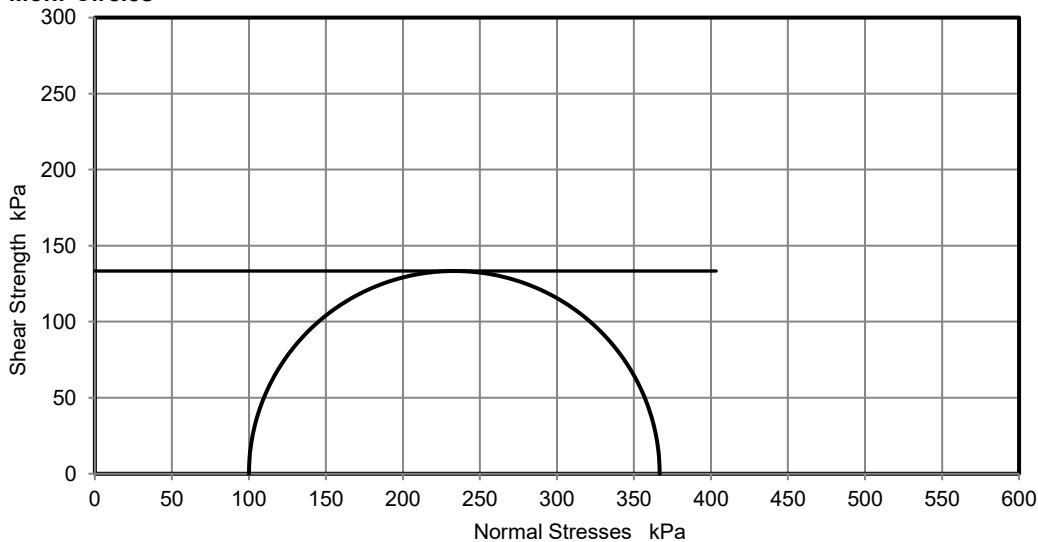
Rate of Strain	1.0 %/min
Cell Pressure	100 kPa
At failure	
Axial Strain	8.2 %
Deviator Stress, ($\sigma_1 - \sigma_3$) _f	267 kPa
Undrained Shear Strength, c_u	133 kPa $\frac{1}{2}(\sigma_1 - \sigma_3)_f$
Mode of Failure	Compound

Deviator Stress v Axial Strain

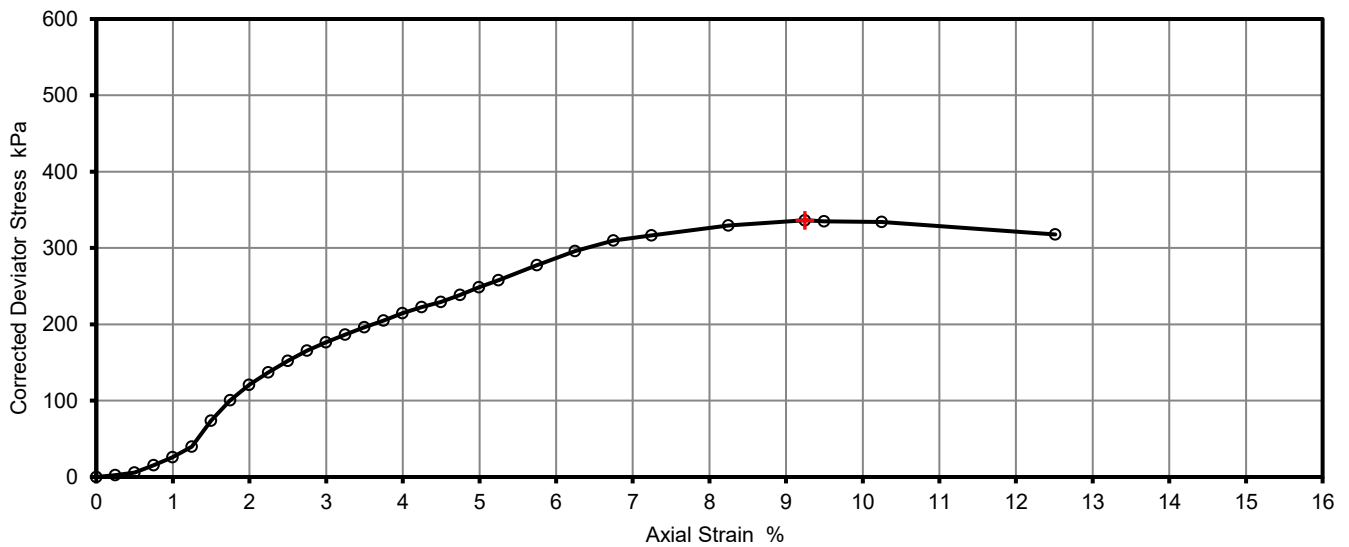
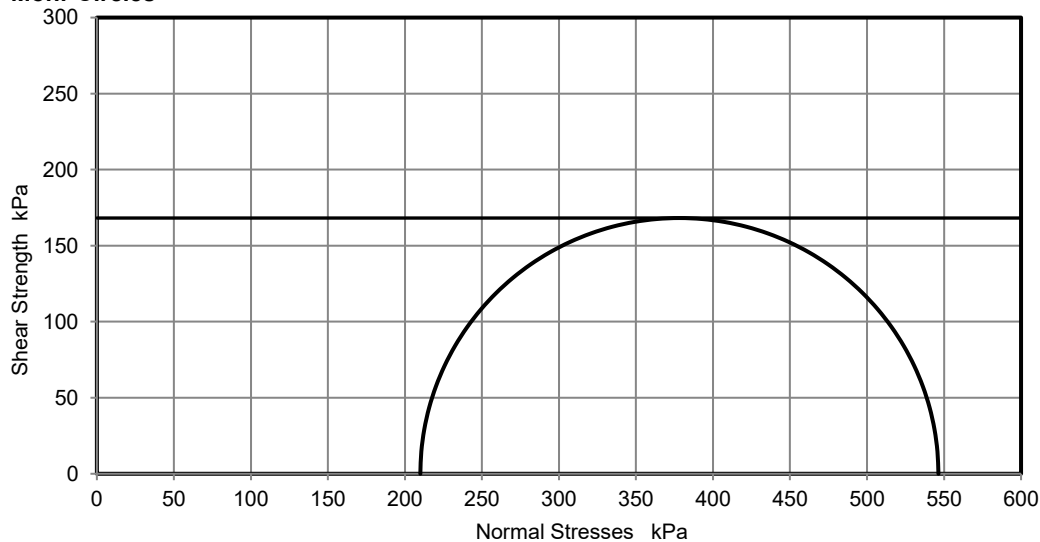
Rate of Strain	1.0	%/min	
Cell Pressure	210	kPa	
At failure	Axial Strain	9.2	%
	Deviator Stress, ($\sigma_1 - \sigma_3$) _f	336	kPa
	Undrained Shear Strength, c_u	168	kPa $\frac{1}{2}(\sigma_1 - \sigma_3)_f$
	Mode of Failure	Compound

Deviator Stress v Axial Strain

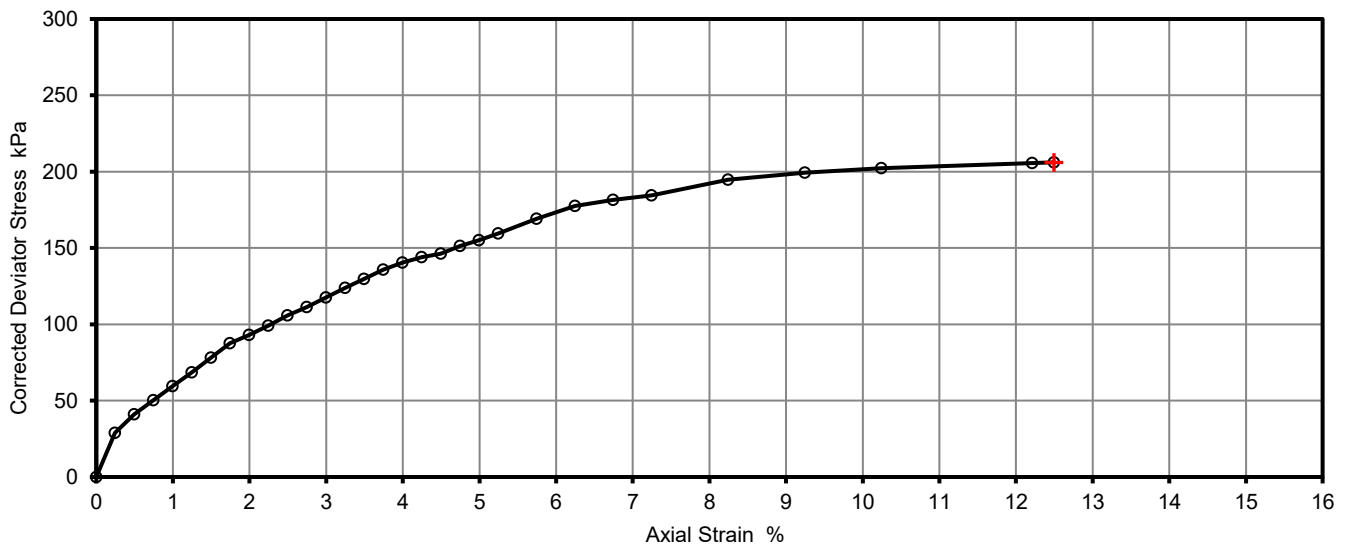
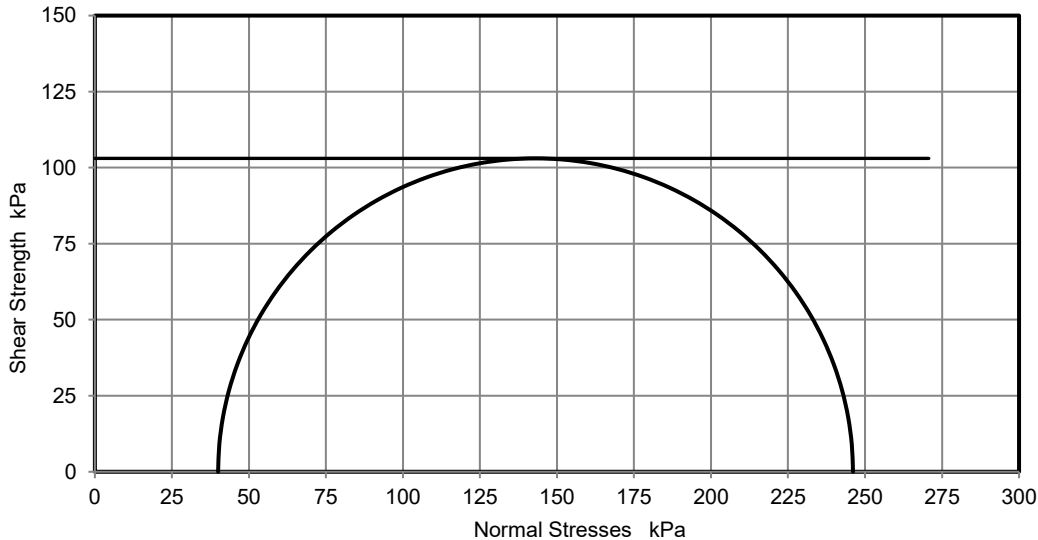
Rate of Strain	1.0 %/min
Cell Pressure	40 kPa
At failure	
Axial Strain	12.5 %
Deviator Stress, ($\sigma_1 - \sigma_3$) _f	206 kPa
Undrained Shear Strength, c_u	103 kPa $\frac{1}{2}(\sigma_1 - \sigma_3)_f$
Mode of Failure	Compound

Deviator Stress v Axial Strain

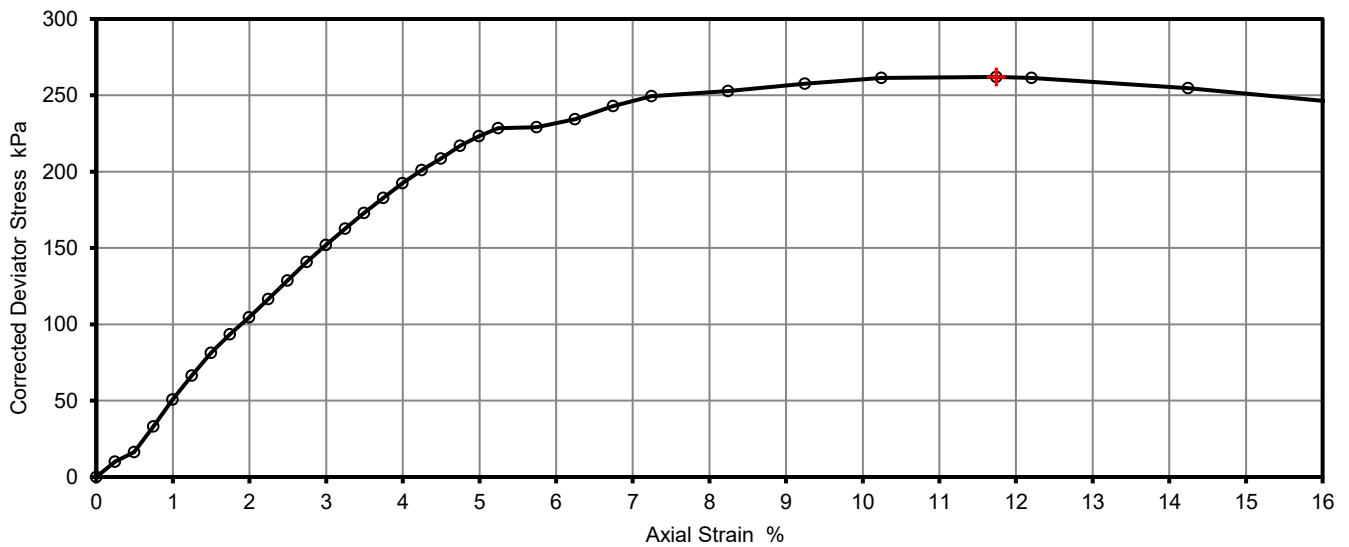
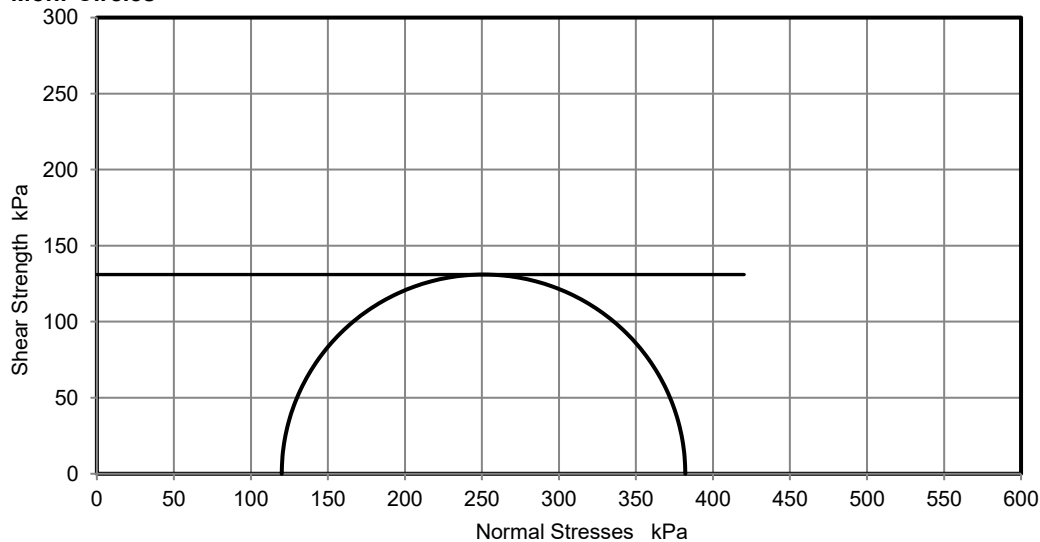
Rate of Strain	1.0	%/min	
Cell Pressure	120	kPa	
At failure	Axial Strain	11.7	%
	Deviator Stress, ($\sigma_1 - \sigma_3$) _f	262	kPa
	Undrained Shear Strength, c_u	131	kPa $\frac{1}{2}(\sigma_1 - \sigma_3)_f$
	Mode of Failure	Compound

Deviator Stress v Axial Strain

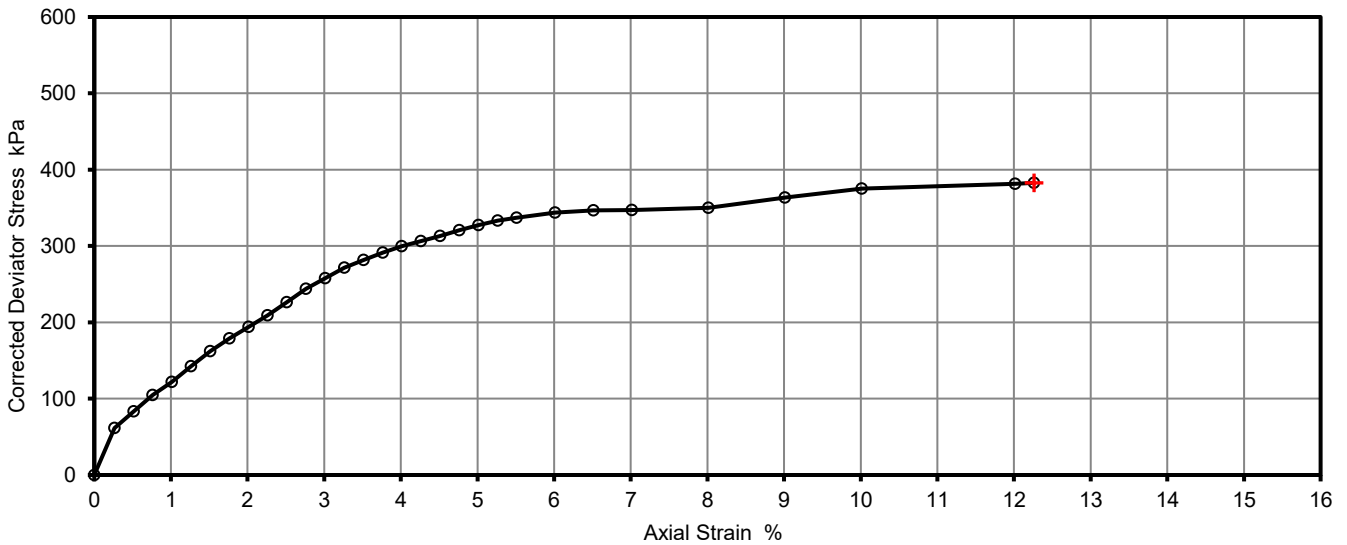
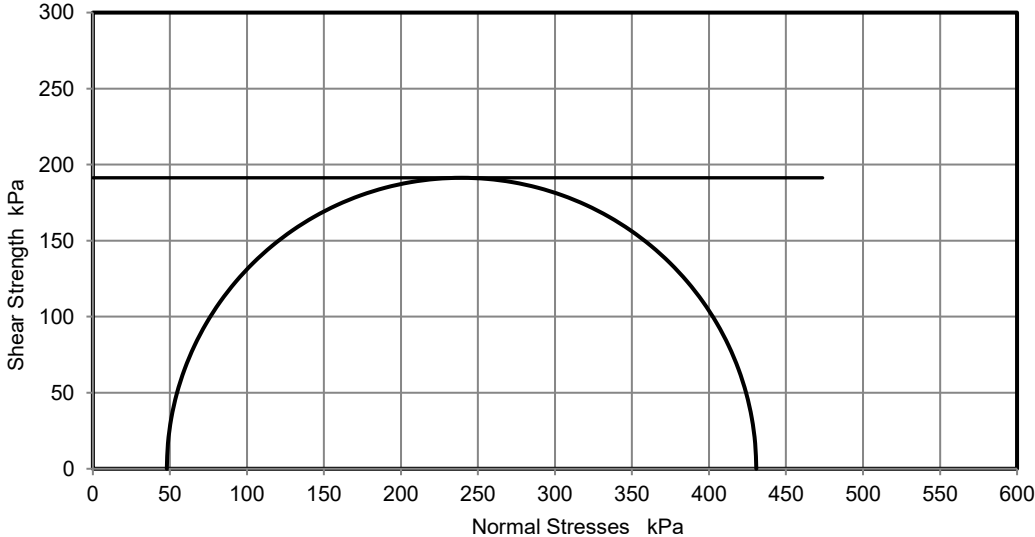
Rate of Strain	1.0 %/min	
Cell Pressure	48 kPa	
At failure	Axial Strain	12.3 %
	Deviator Stress, ($\sigma_1 - \sigma_3$) _f	383 kPa
	Undrained Shear Strength, c_u	191 kPa $\frac{1}{2}(\sigma_1 - \sigma_3)_f$
	Mode of Failure	Compound

Deviator Stress v Axial Strain

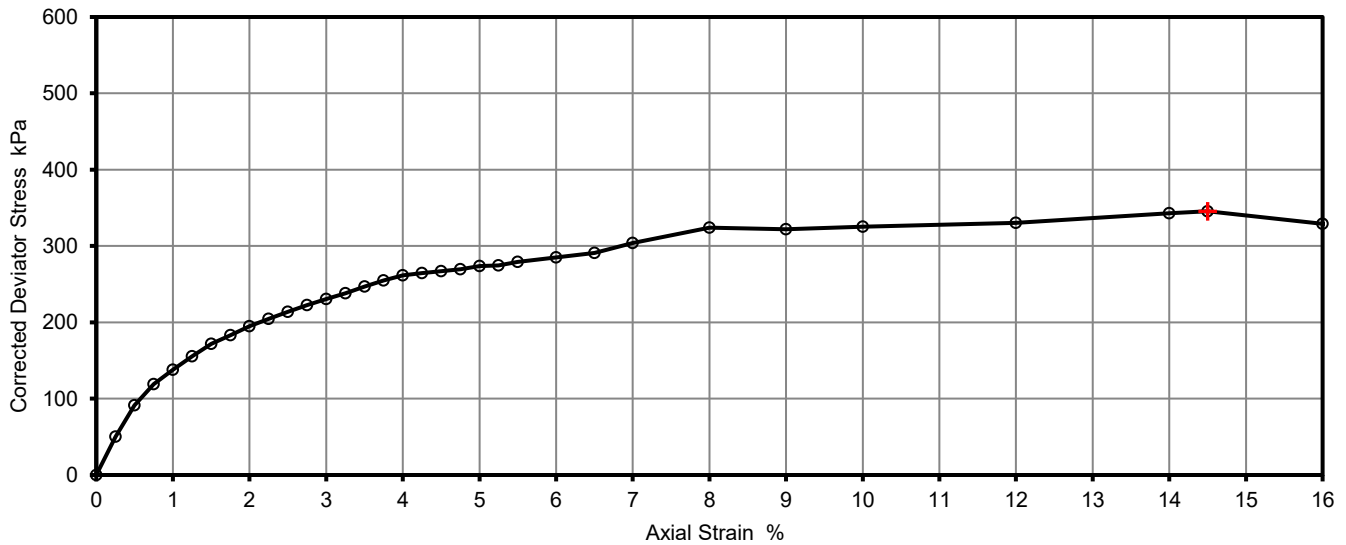
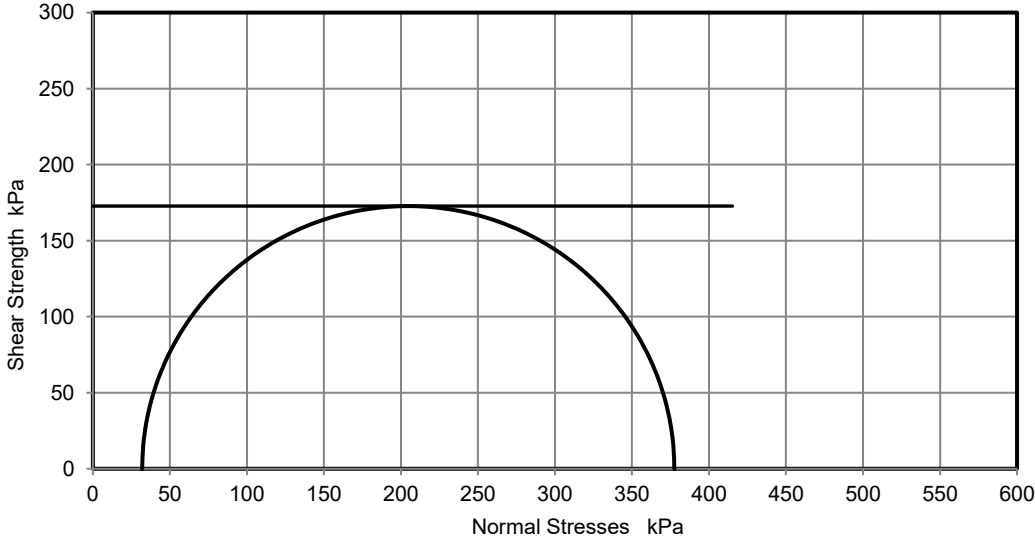
Rate of Strain	1.0 %/min	
Cell Pressure	32 kPa	
At failure	Axial Strain	14.5 %
	Deviator Stress, ($\sigma_1 - \sigma_3$) _f	346 kPa
	Undrained Shear Strength, c_u	173 kPa $\frac{1}{2}(\sigma_1 - \sigma_3)_f$
	Mode of Failure	Compound

Deviator Stress v Axial Strain
