Phase 2: Site Investigation

Hotel Felix, Cambridge

Cassel Hotels (Cambridge) Ltd

PHASE 2 SITE INVESTIGATION REPORT

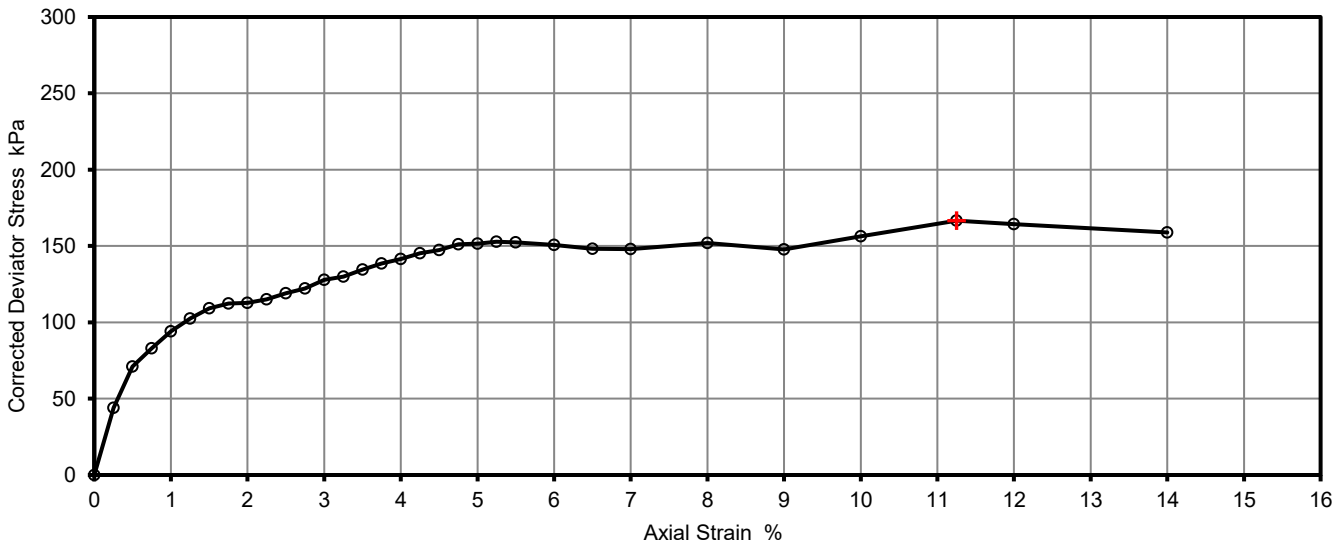
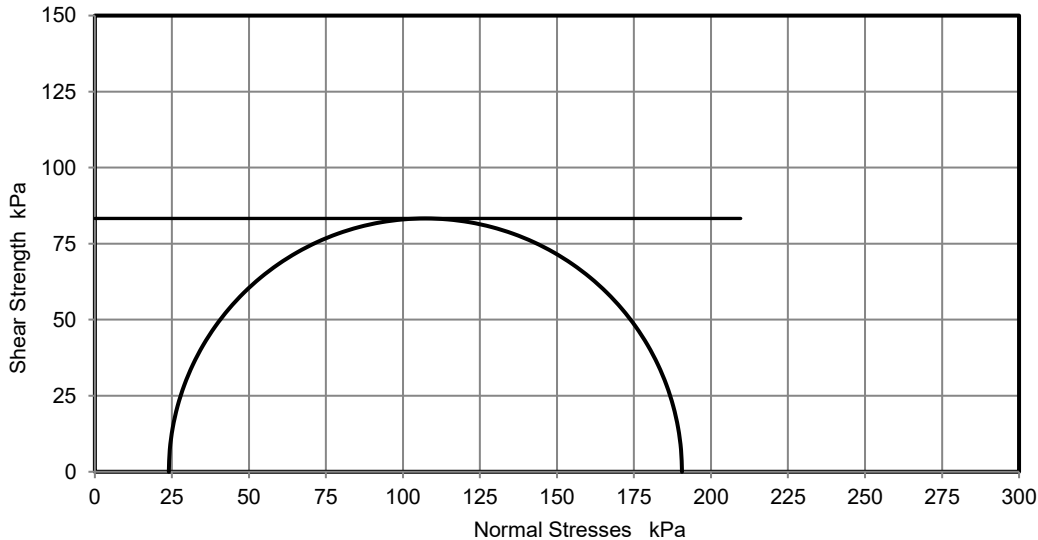
Rate of Strain	1.0 %/min	
Cell Pressure	24 kPa	
At failure	Axial Strain	11.3 %
	Deviator Stress, ($\sigma_1 - \sigma_3$) _f	167 kPa
	Undrained Shear Strength, c_u	83 kPa $\frac{1}{2}(\sigma_1 - \sigma_3)_f$
	Mode of Failure	Plastic

Deviator Stress v Axial Strain

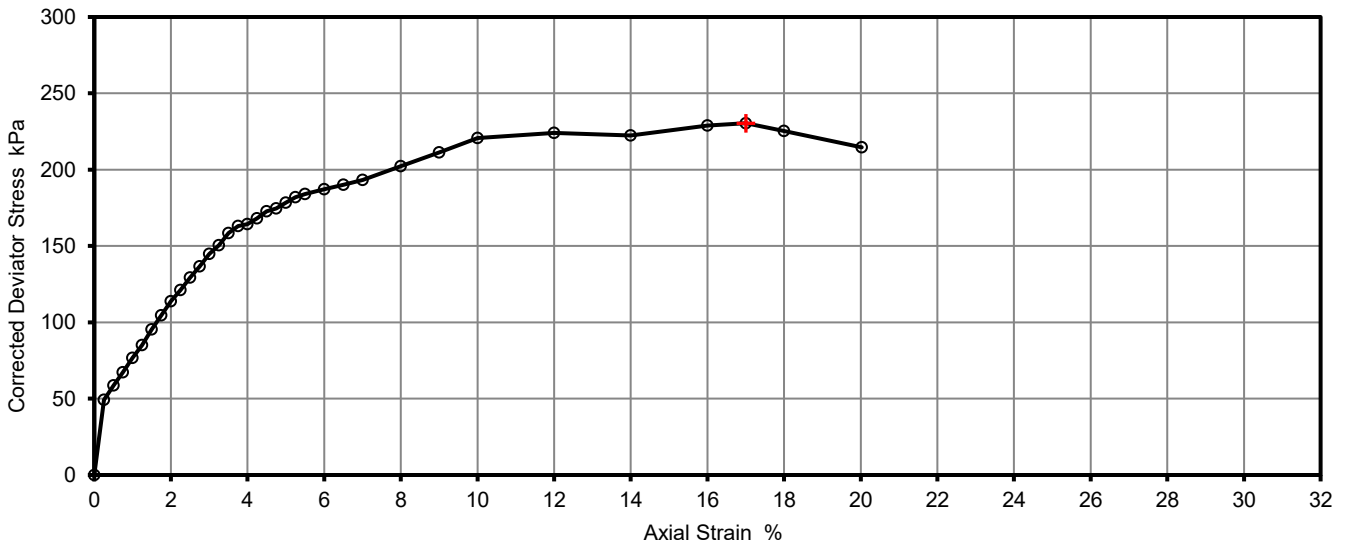
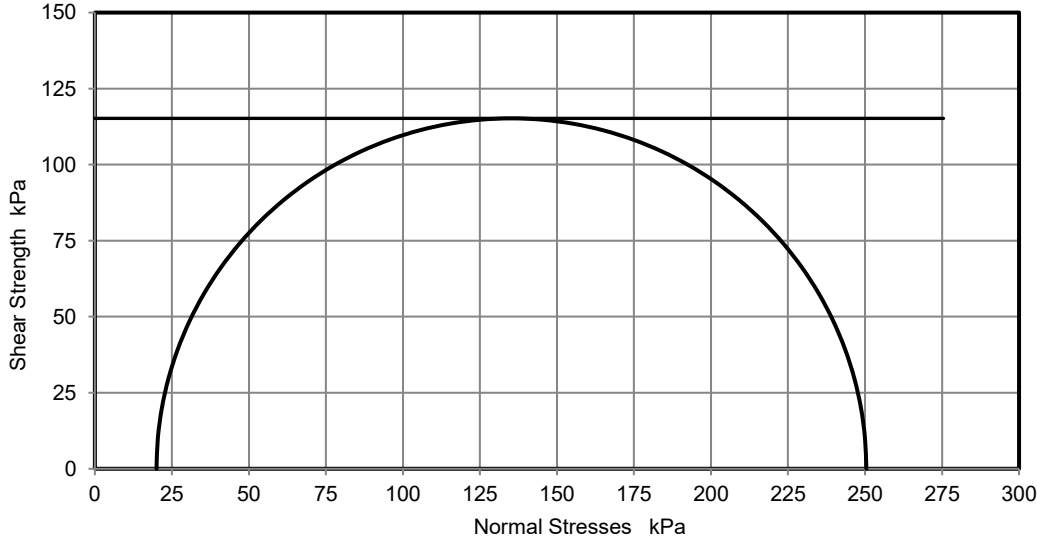
Rate of Strain	1.0 %/min
Cell Pressure	20 kPa
At failure	
Axial Strain	17.0 %
Deviator Stress, ($\sigma_1 - \sigma_3$) _f	230 kPa
Undrained Shear Strength, c_u	115 kPa $\frac{1}{2}(\sigma_1 - \sigma_3)_f$
Mode of Failure	Plastic

Deviator Stress v Axial Strain

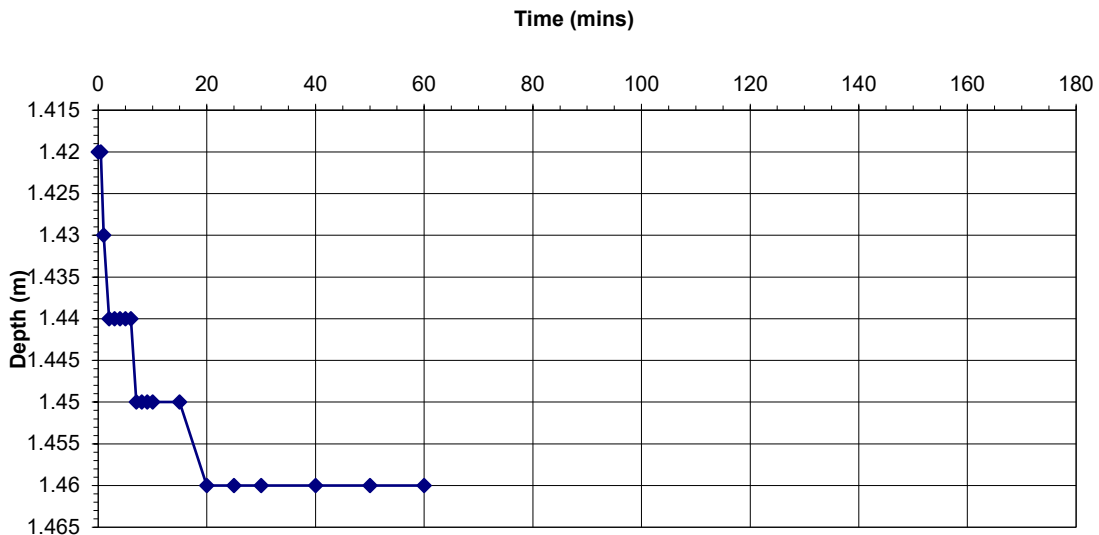
Client: Cassel Hotels (Cambridge) Ltd					
Site: Hotel Felix, Cambridge					
Job No: S201112					
Pit No: TP1		Test No: 1			
CALCULATION OF SOIL INFILTRATION RATE					
Time (min)	Depth (m)	Pit Dimensions	Length (m) =	1.90	
0	1.42		Width (m) =	0.60	
0.5	1.42		Depth (m) =	3.00	
1	1.43				
2	1.44	Depth at start of test (m) =		1.420	
3	1.44	Depth at end of test (m) =		1.460	
4	1.44	75% level (m) =		1.430	
5	1.44	50% Effective Depth		1.560	
6	1.44	25% level (m) =		1.450	
7	1.45				
8	1.45	Base area of pit (m²) =		1.140	
9	1.45	V_{p75-25} (m³) =		0.023	
10	1.45	a_{0.50} (m²) =		8.940	
15	1.45				
20	1.46	From the graph:			
25	1.46	tp 75 (min) =		1	
30	1.46	tp 25 (min) =		15	
40	1.46				
50	1.46	Soil infiltration rate, f, (m/s) =		3.04E-06 normal test	
60	1.46				
90					
120		Input by:	CG	Date:	30/11/2020
180		Checked by:	RW	Date:	30/11/2020

Soakaway testing was undertaken within two of the trial pits and was generally carried out in accordance with BRE Digest 365: Soakaway Design. The result sheets are presented in Appendix D. The trial pits were excavated to a maximum depth of 3.00mbgl using an excavator with a 0.60m wide bucket. The strata were then logged and water was poured into the pit. Table 6 below gives a summary of the related infiltration rates.

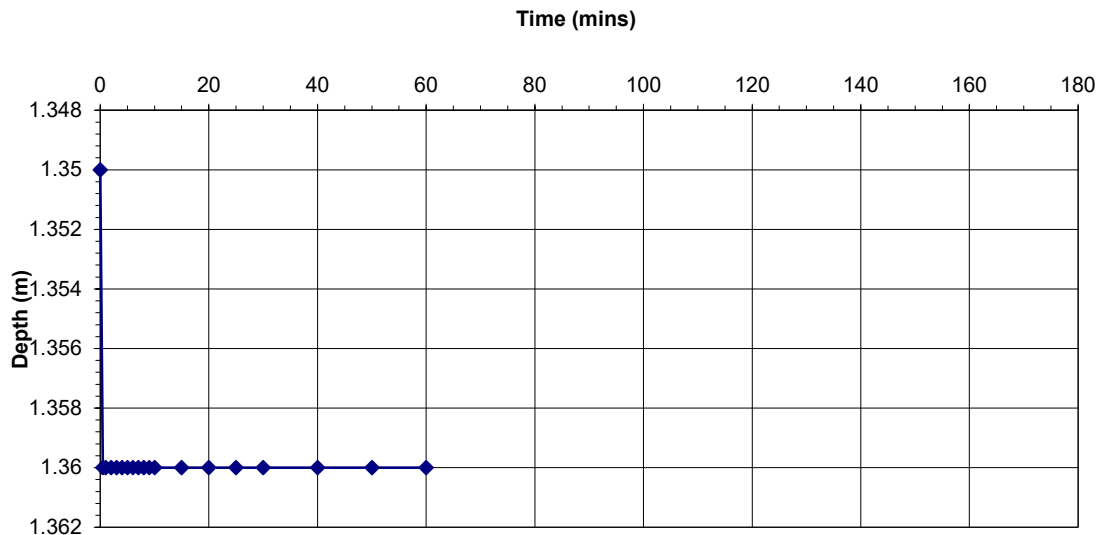
Client: Cassel Hotels (Cambridge) Ltd			
Site: Hotel Felix, Cambridge			
Job No:	S201112		
Pit No:	TP8	Test No:	1
CALCULATION OF SOIL INFILTRATION RATE			
Time (min)	Depth (m)	Pit Dimensions	Length (m) = 1.90
0	1.35		Width (m) = 0.60
0.5	1.36		Depth (m) = 3.00
1	1.36		
2	1.36	Depth at start of test (m) =	1.350
3	1.36	Depth at end of test (m) =	1.360
4	1.36	75% level (m) =	1.353
5	1.36	50% Effective Depth	1.645
6	1.36	25% level (m) =	1.358
7	1.36		
8	1.36	Base area of pit (m²) =	1.140
9	1.36	V_{p75-25} (m³) =	0.006
10	1.36	a_{0.50} (m²) =	9.365
15	1.36		
20	1.36	From the graph:	
25	1.36	tp 75 (min) =	0
30	1.36	tp 25 (min) =	60
40	1.36		
50	1.36	Soil infiltration rate, f, (m/s) =	1.69E-07 normal test
60	1.36		
90			
120		Input by: CG	Date: 30/11/2020
180		Checked by: RW	Date: 30/11/2020
