## Geoenvironmental Assessment - Factual Report, Northstowe Phase 1

Gallagher

February 2012

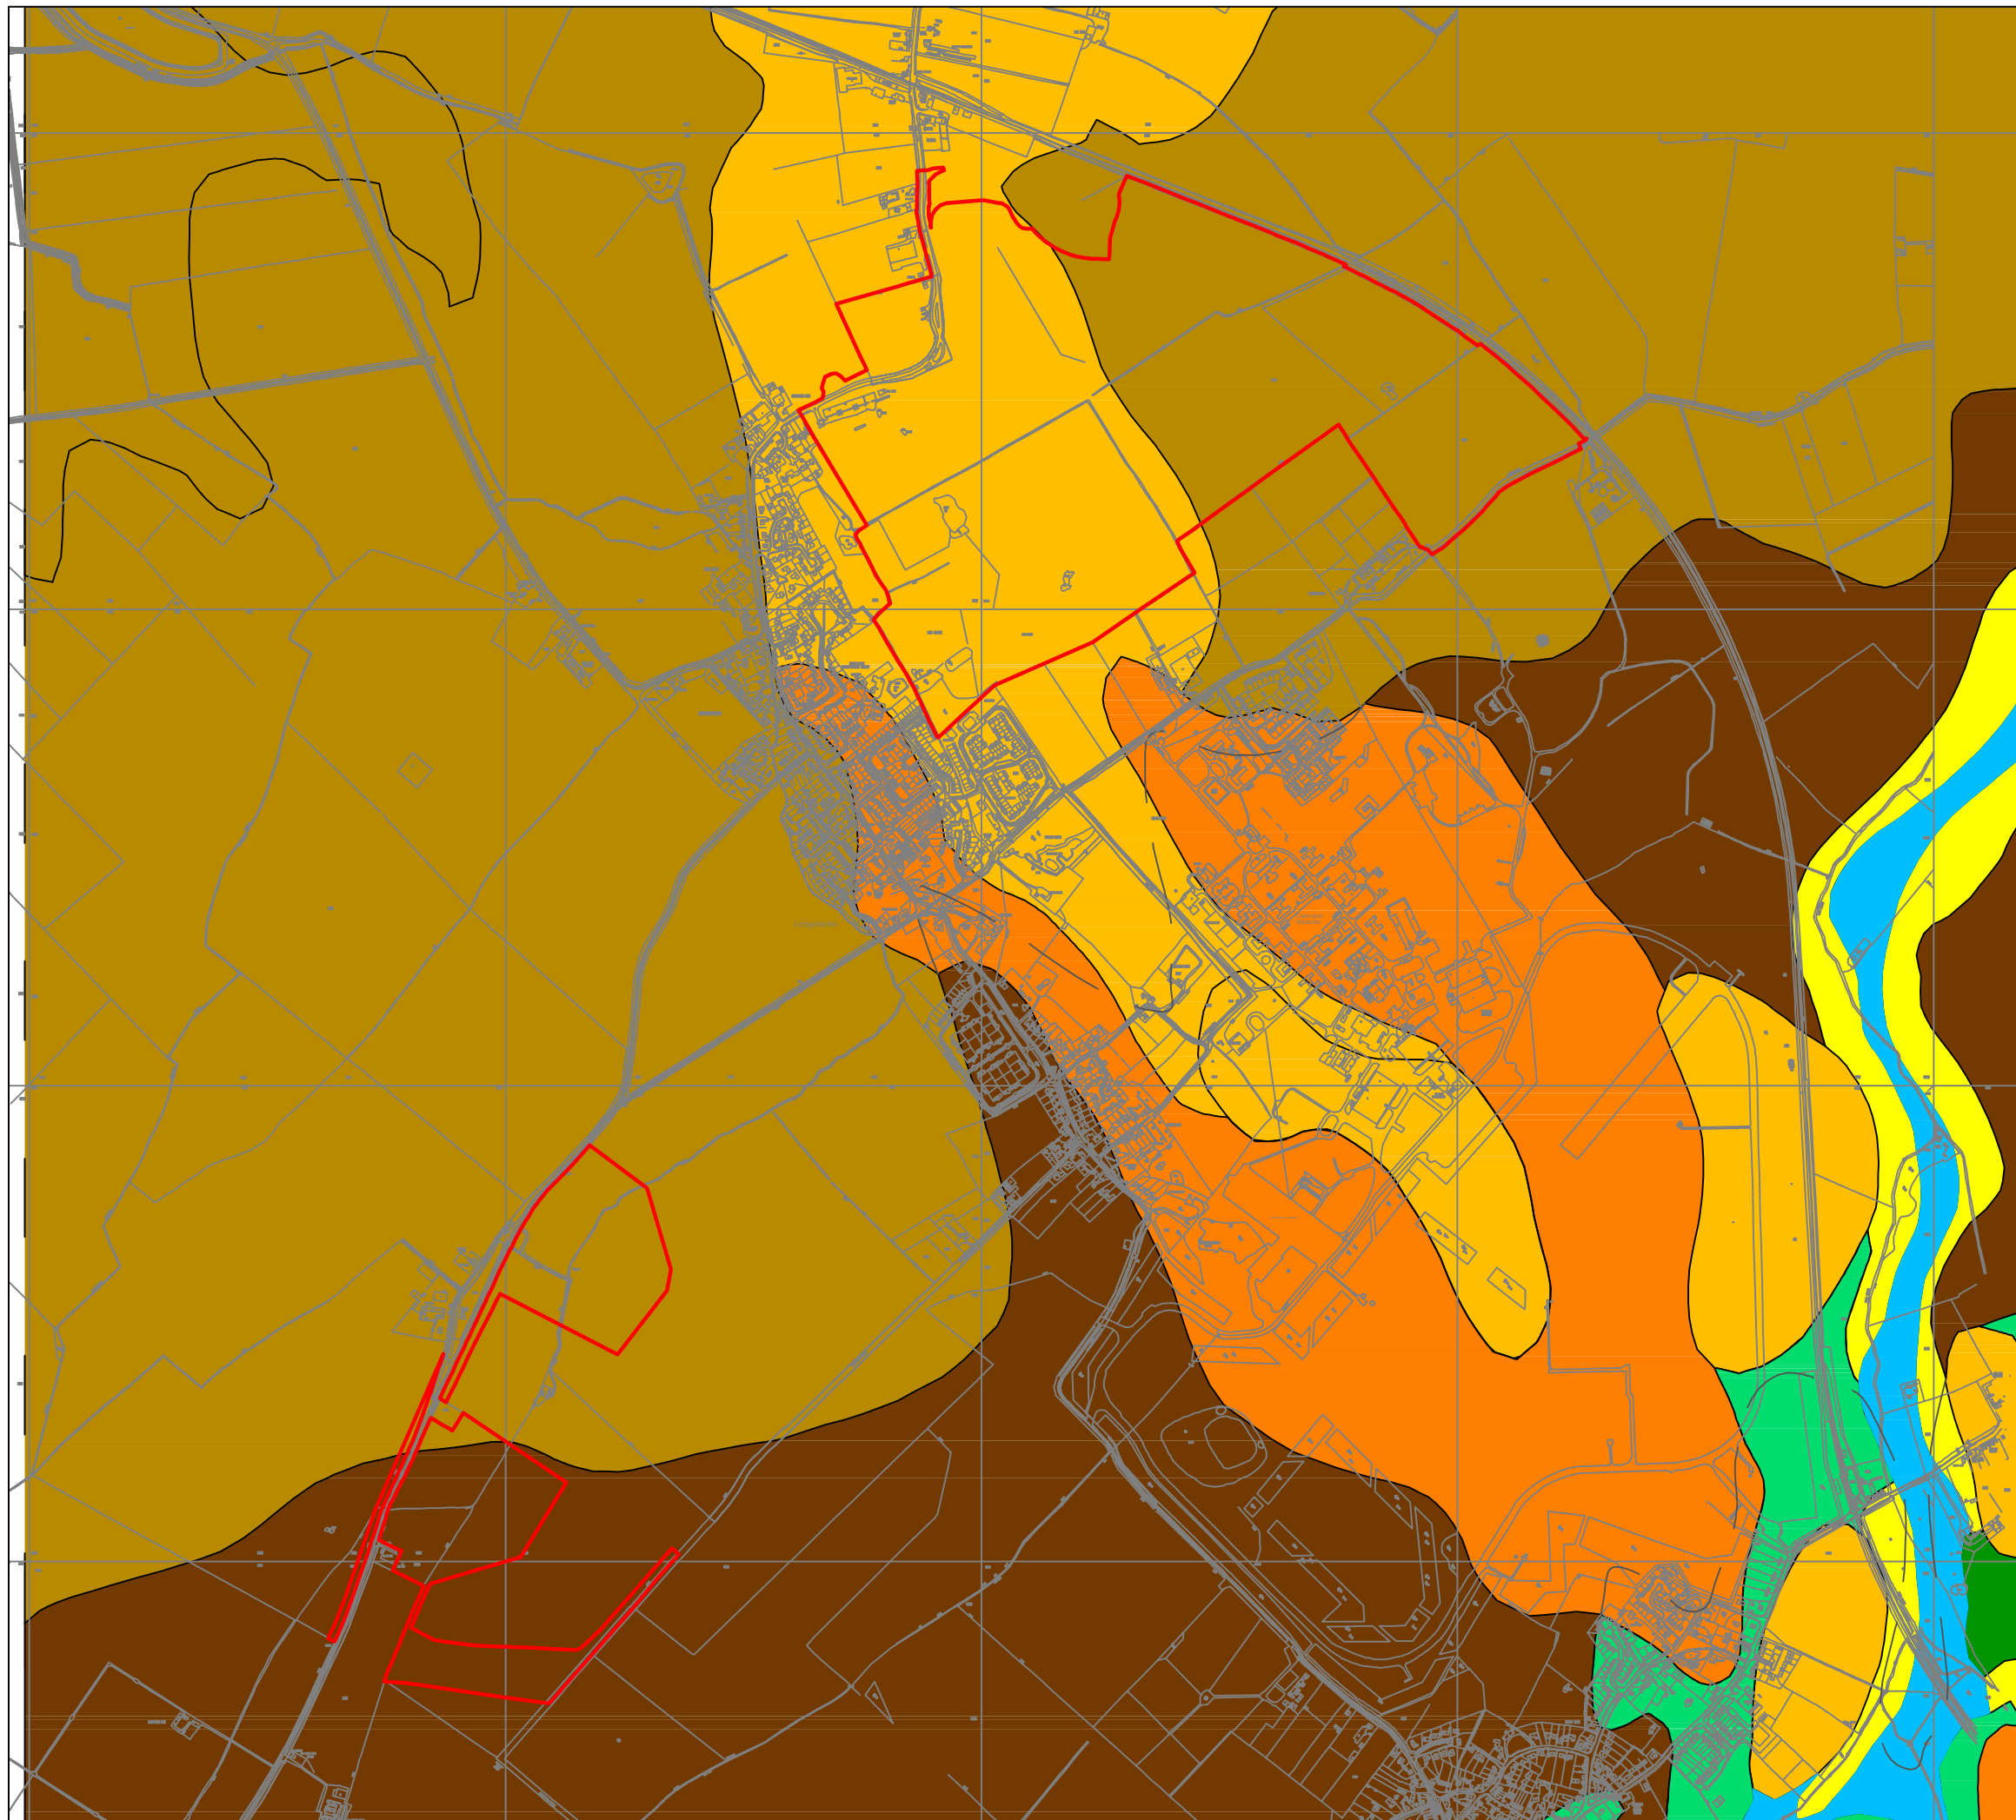
- Alluvium
- Alluvium on 2nd River Terrace Gravels
- 2nd River Terrace Gravels
- 3rd River Terrace Gravels
- 4th River Terrace Gravels
- Boulder Clay
- Gault
- Lower Greensand
- Kimmeridge Clay
- Ampthill Clay
- Inferred boundary of solid geology beneath drift
- Site Boundary
