# 3 PRELIMINARY RISK ASSESSMENT (PRA)

#### 3.1 Site walkover

#### 3.2 Ground conditions

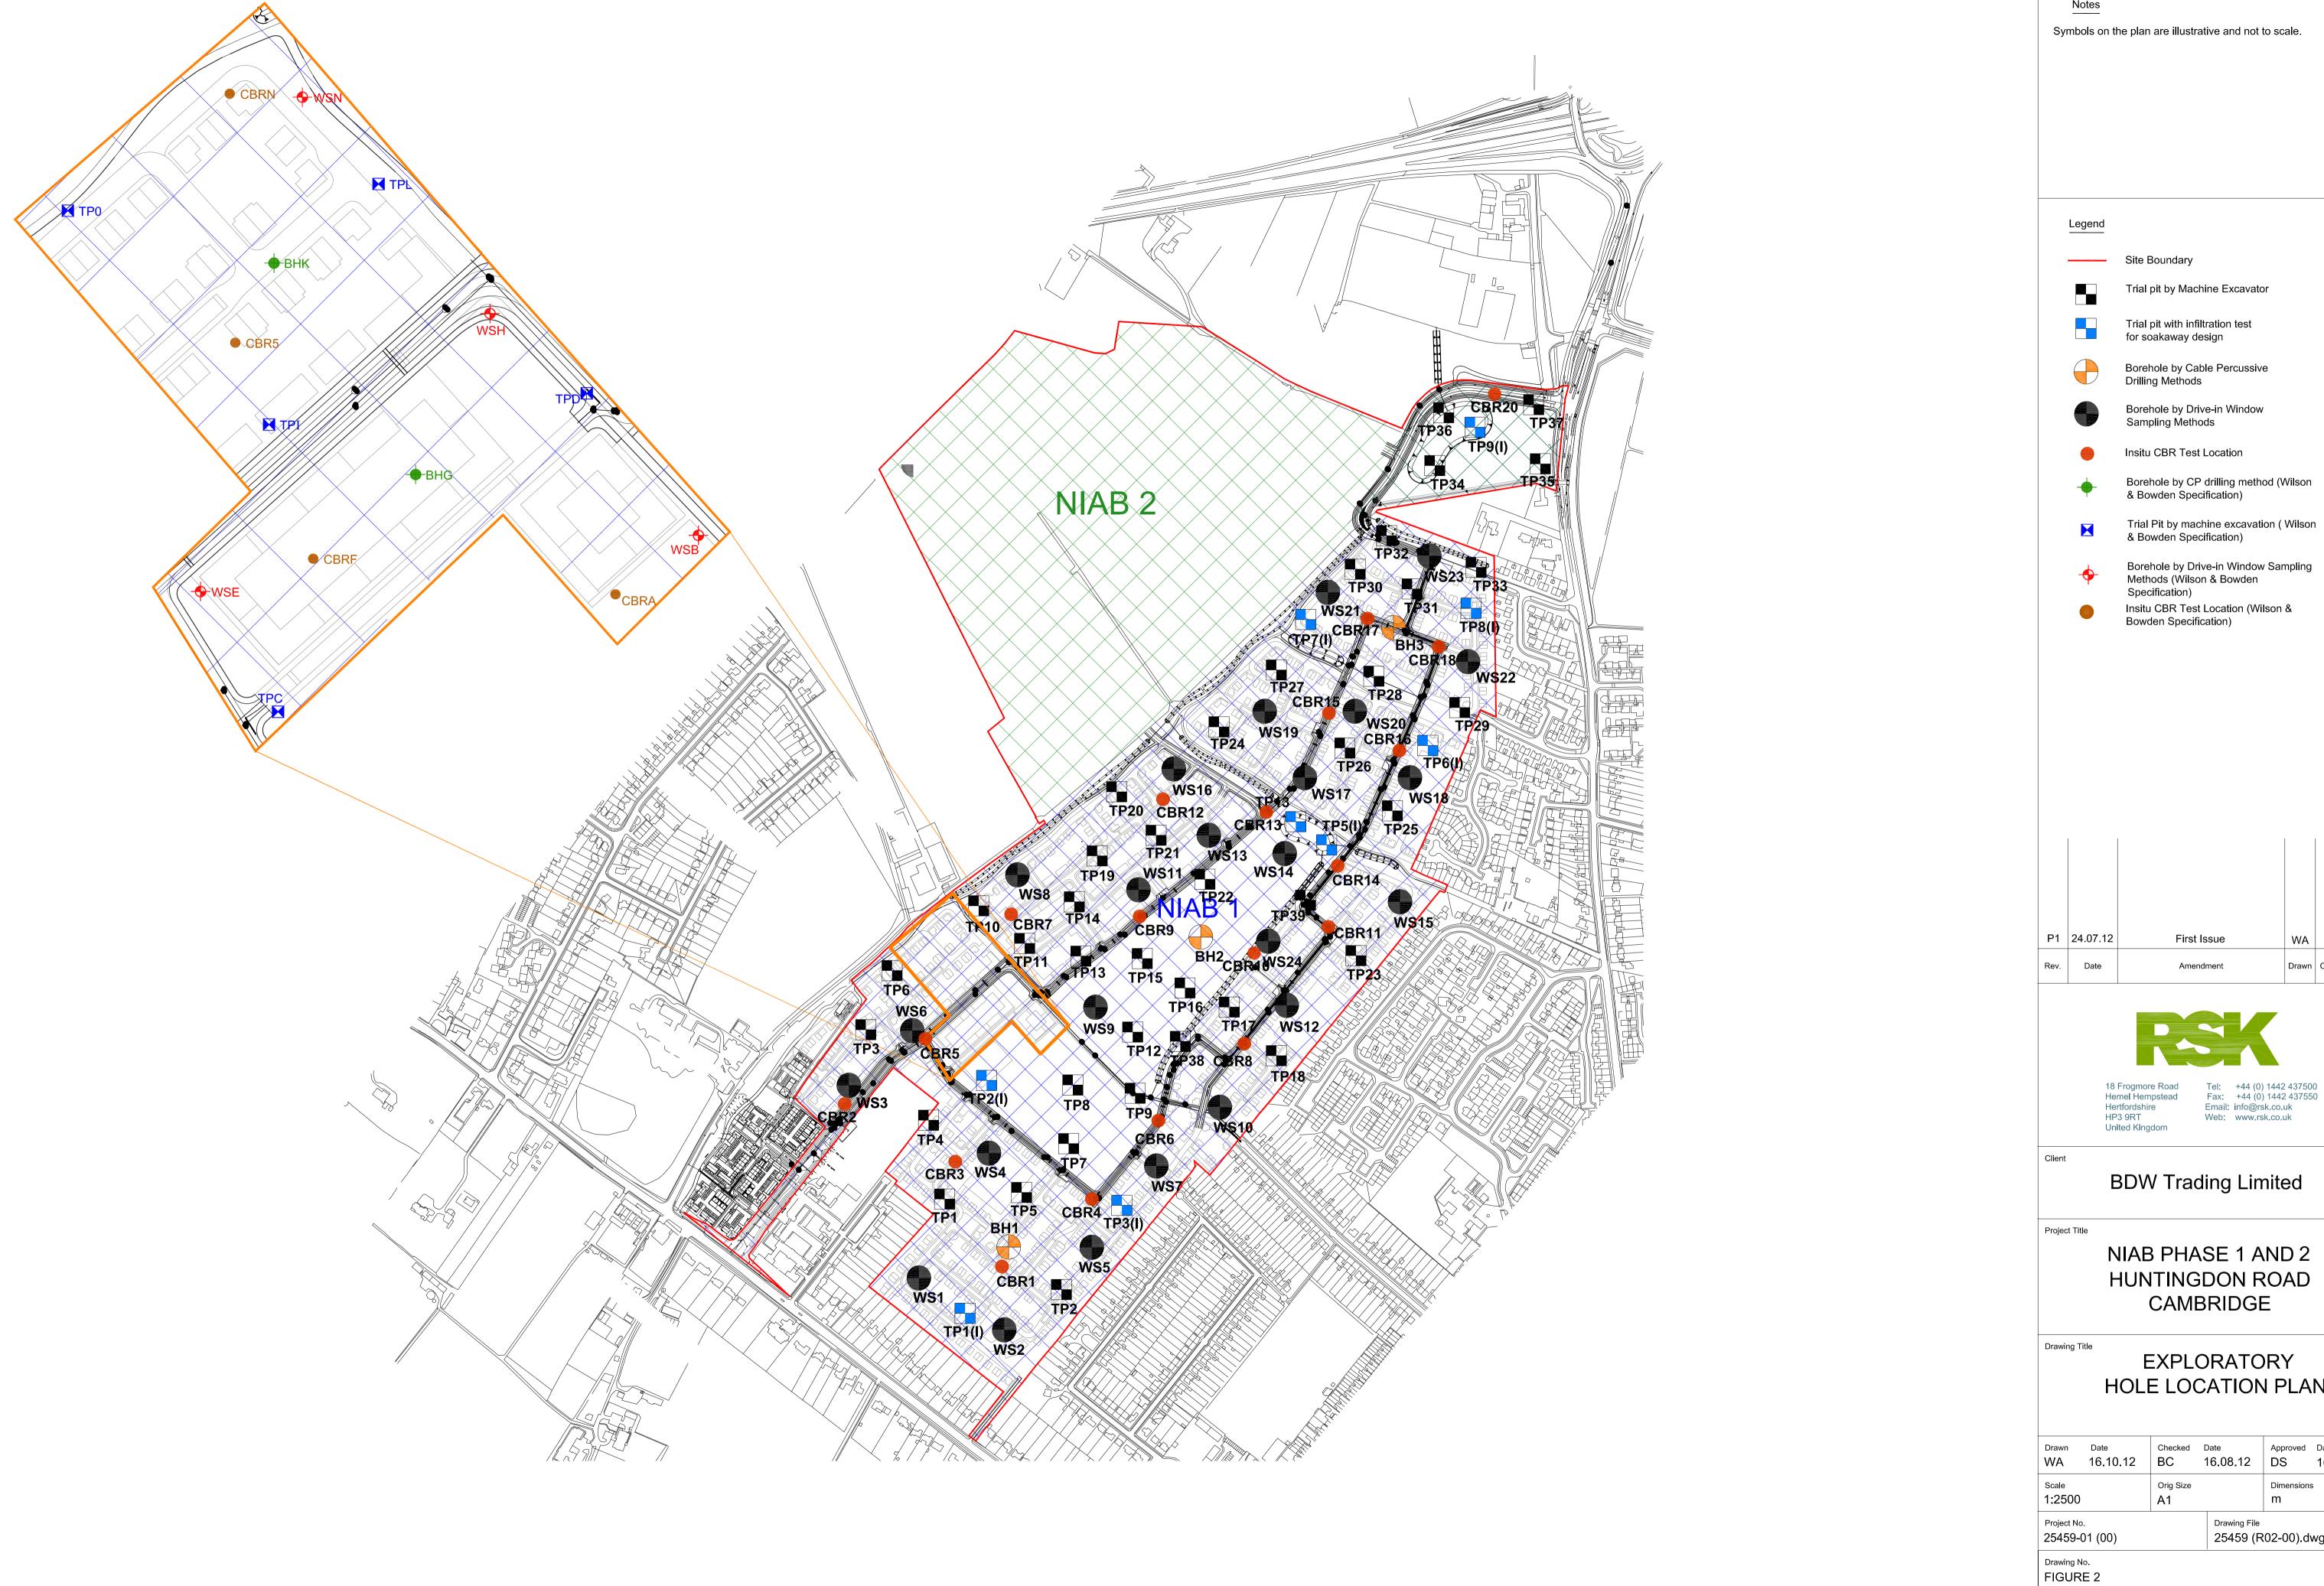
HOLE LOCATION PLAN

Borehole by CP drilling method (Wilson & Bowden Specification)

Trial Pit by machine excavation ( Wilson & Bowden Specification)

- 5 no. Cable percussive boreholes to a maximum 15m depth, with associated sampling and in-situ testing;
- 28 no. Drive-in window sampler boreholes to a maximum 5m depth, with associated sampling and in-situ testing;
- 53 no. Machine excavated trial pits to approximately 3m depth, with associated sampling and in-situ testing;
- 9 no. Infiltration test locations; and
- 24 no. in-situ CBR determinations using vehicle mounted plunger method.

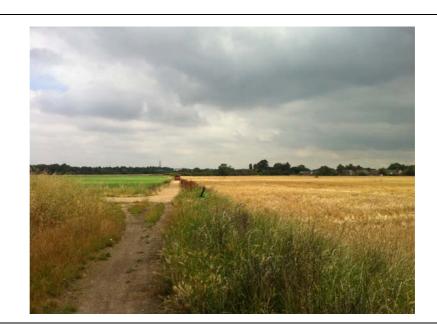
North-western site boundary and public rightof-way

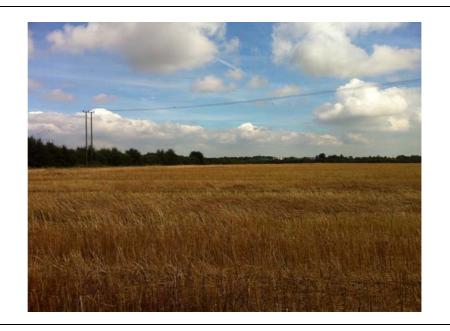
View north from concrete hardstanding in southwest portion of the site

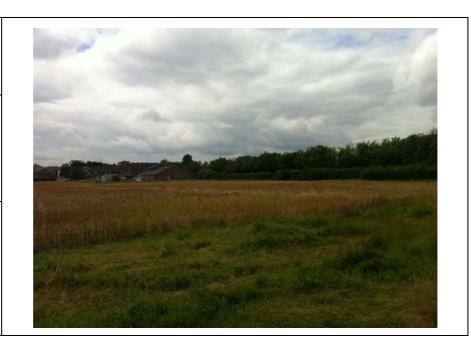
Northwest site boundary and existing off-site NIAB facilities

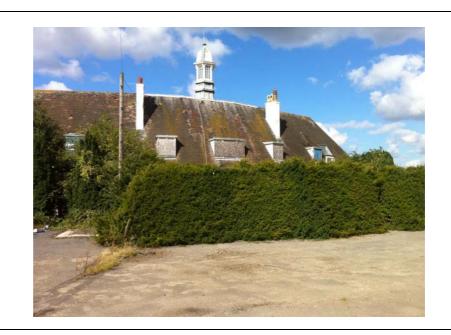
View to the rear of disused pavillion building
