BDW TRADING LIMITED

NIAB Phase 1, Huntingdon Rd, Cambridge

Report for Main Site Investigation

Title: Report for Main Site Investigation: NIAB Phase 1, Huntingdon Road, Cambridge

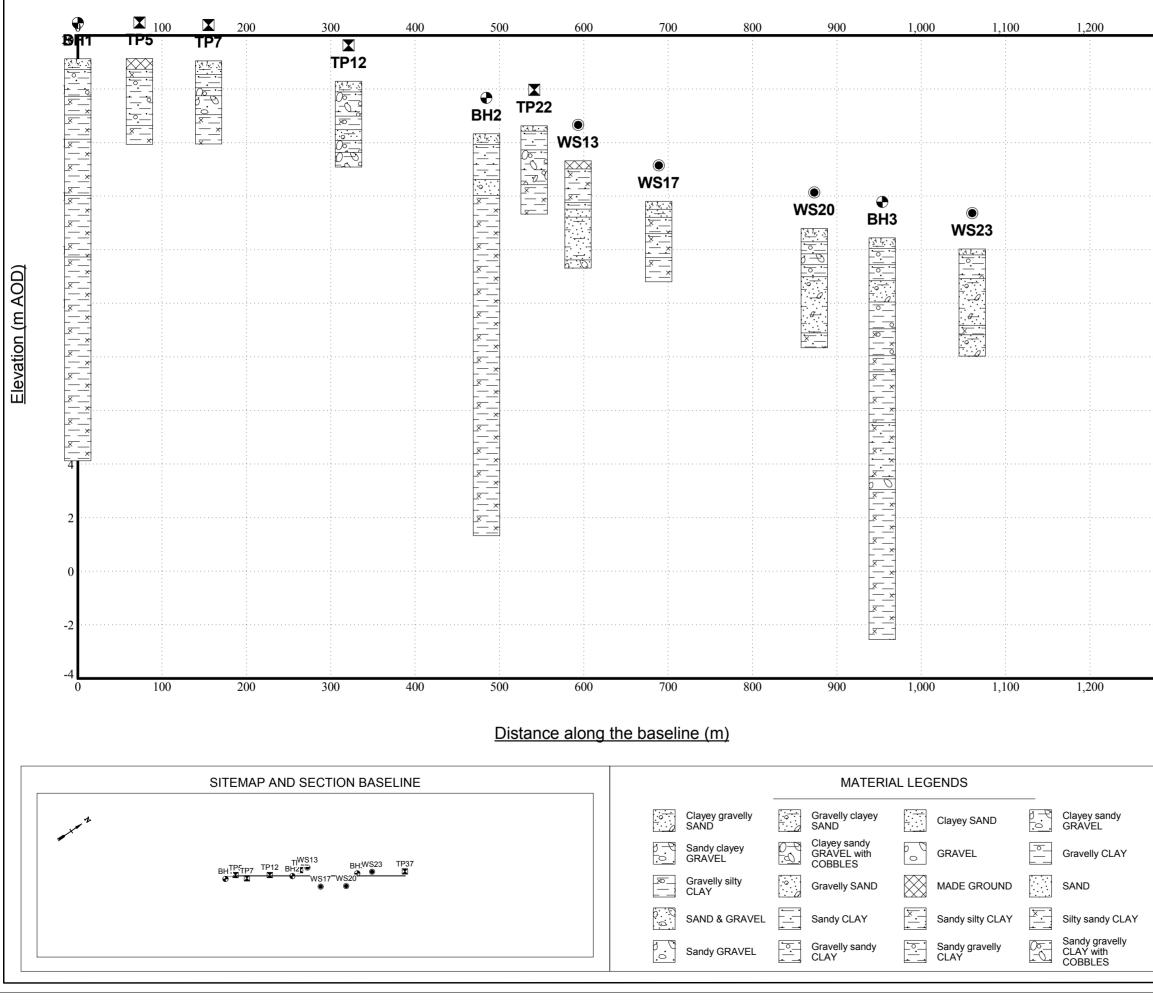
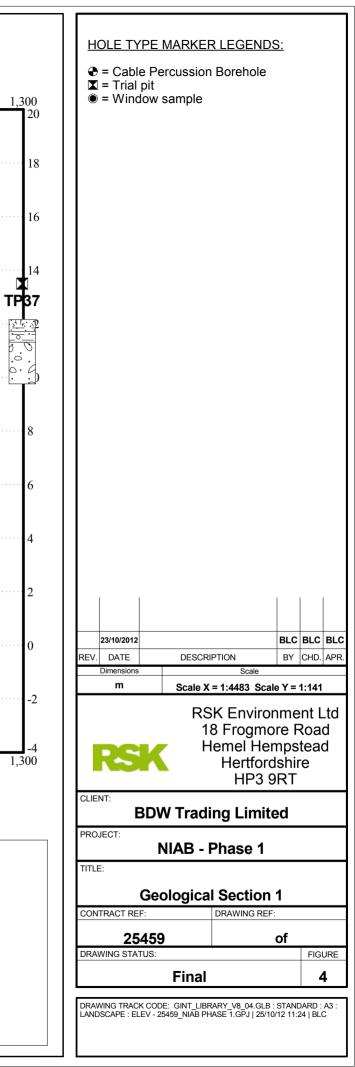
SUBSURFACE SECTION DIAGRAM

The exploratory holes revealed that the site is underlain by a variable thickness of topsoil and/or made ground generally overlying a succession of River Terrace Deposits and Gault Clay in the north/northeast and directly overlying Gault Clay in the south. Deposits of the Gault Clay Formation were encountered to the terminal depth of the investigation at 15m bgl. This confirms the stratigraphical succession described within the initial conceptual model. For the purpose of discussion, the ground conditions are summarised in Table 10 and the strata discussed in subsequent subsections.

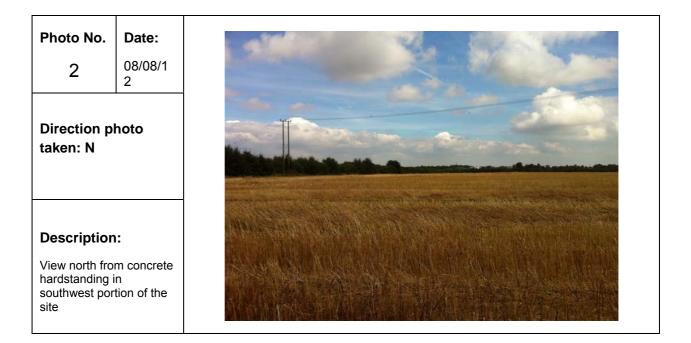
oto No. 3	Date: 08/08/12	and the second second	-	- Ster
irection aken: SW	Photo			
Description lorthwest site and existing of acilities	boundary

The site was visited on 17th August 2012 to undertake a site walkover. Photographs are provided in Appendix C. No significant contamination or geotechnical issues were identified, although it is recognised that the previous investigation by Millard Consulting Engineers identified the presence of TPH contamination in proximity to the disused sports pavilion. However, no surface staining was observed during the recent walkover survey in the location that is understood to have historically supported the tank.

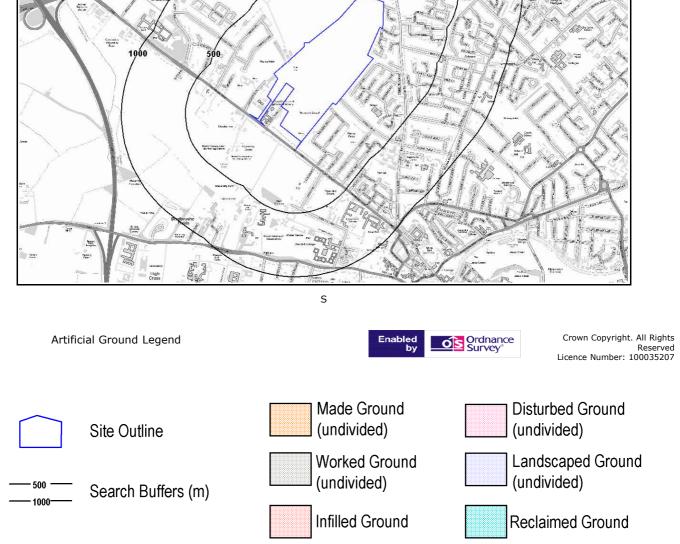
1.1 Artificial Ground Map

Geological information represented on the mapping is derived from the BGS Digital Geological map of Great Britain at 1:50,000 scale.

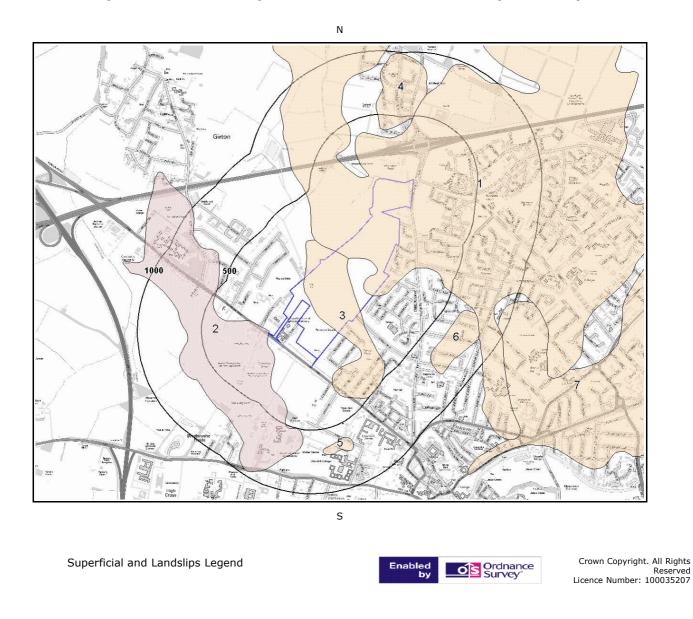
1.2 Superficial Deposits and Landslips Map

Geological information represented on the mapping is derived from the BGS Digital Geological map of Great Britain at 1:50,000 scale.
