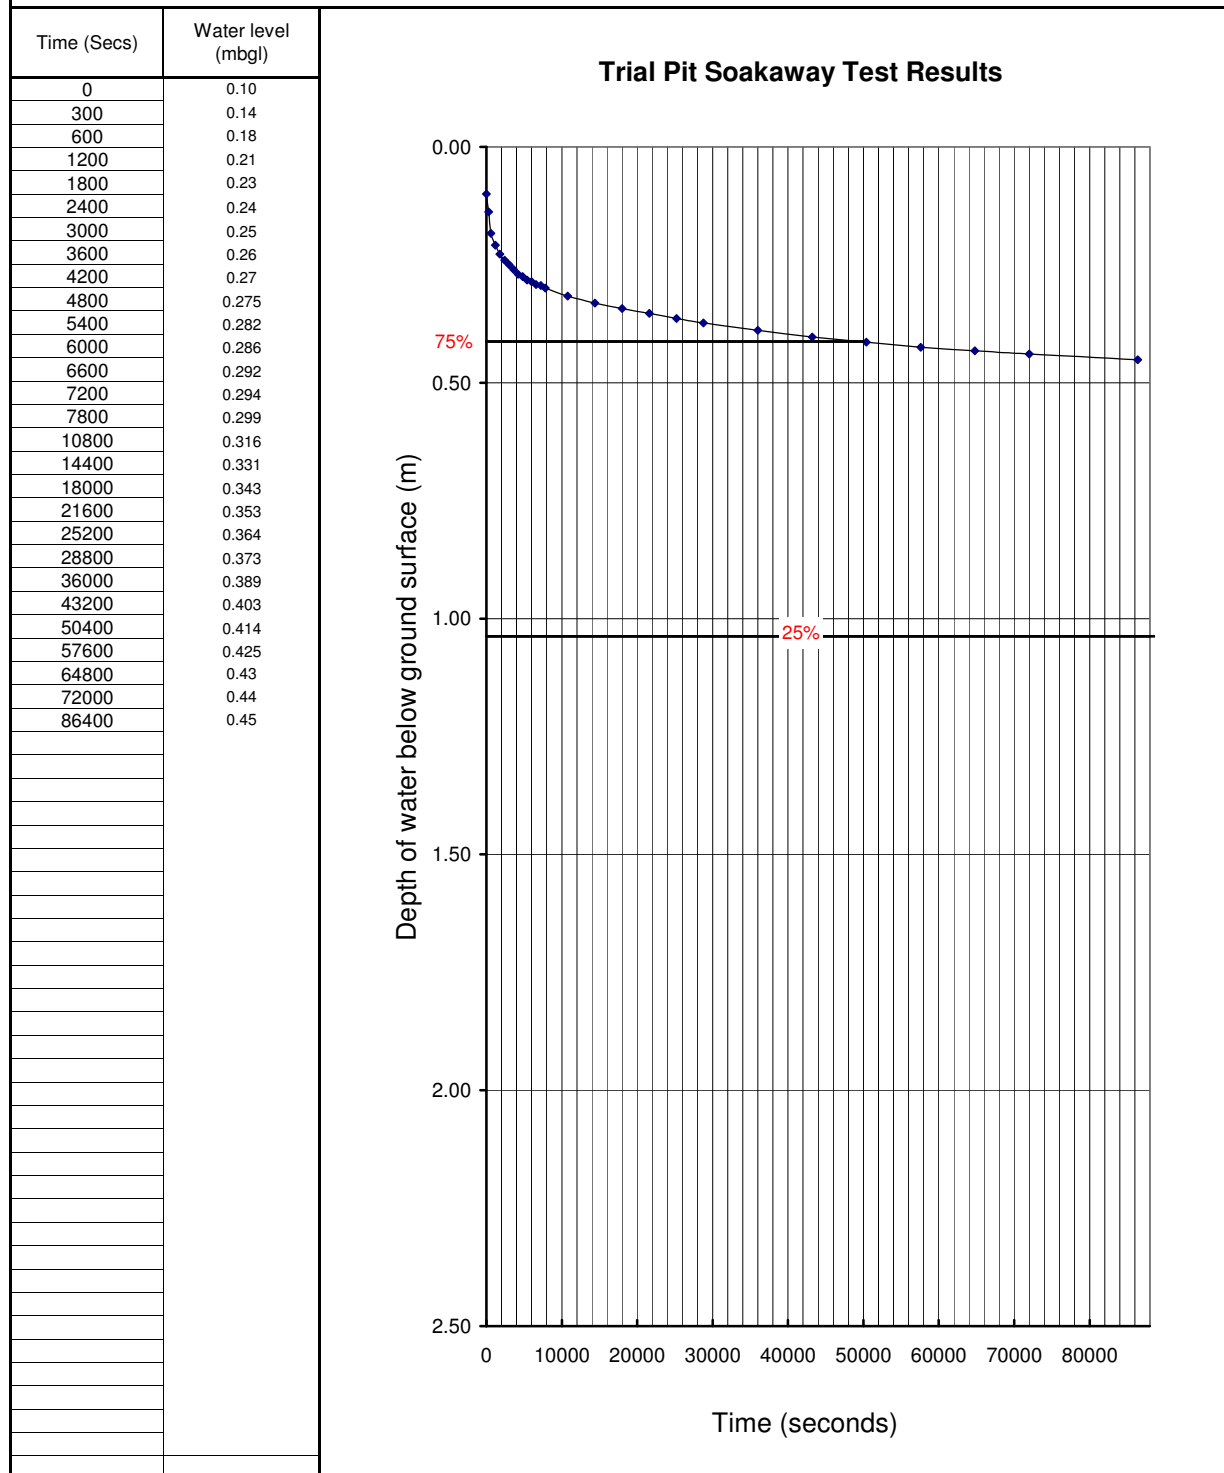
Location	TP1 (i)	Test No	Test 1
Client	BDW Trading Limited	Length of Trial Pit (m)	1.45
Job Number	25459	Width of Trial Pit (m)	0.45
Date	28.08.12	Water level at start (mbgl)	0.1
Operator	MOS / OP	Depth to Base of Trial Pit (m)	1.35

Trial Pit Soakaway Test to BRE Digest 365

$V_{p75-25} (m^3)$	-
$a_{p50} (m^2)$	-
$t_{p75} (s)$	-
$t_{p25} (s)$	-
$t_{p75-25} (s)$	-
Infiltration Rate (m/s)	INVALID

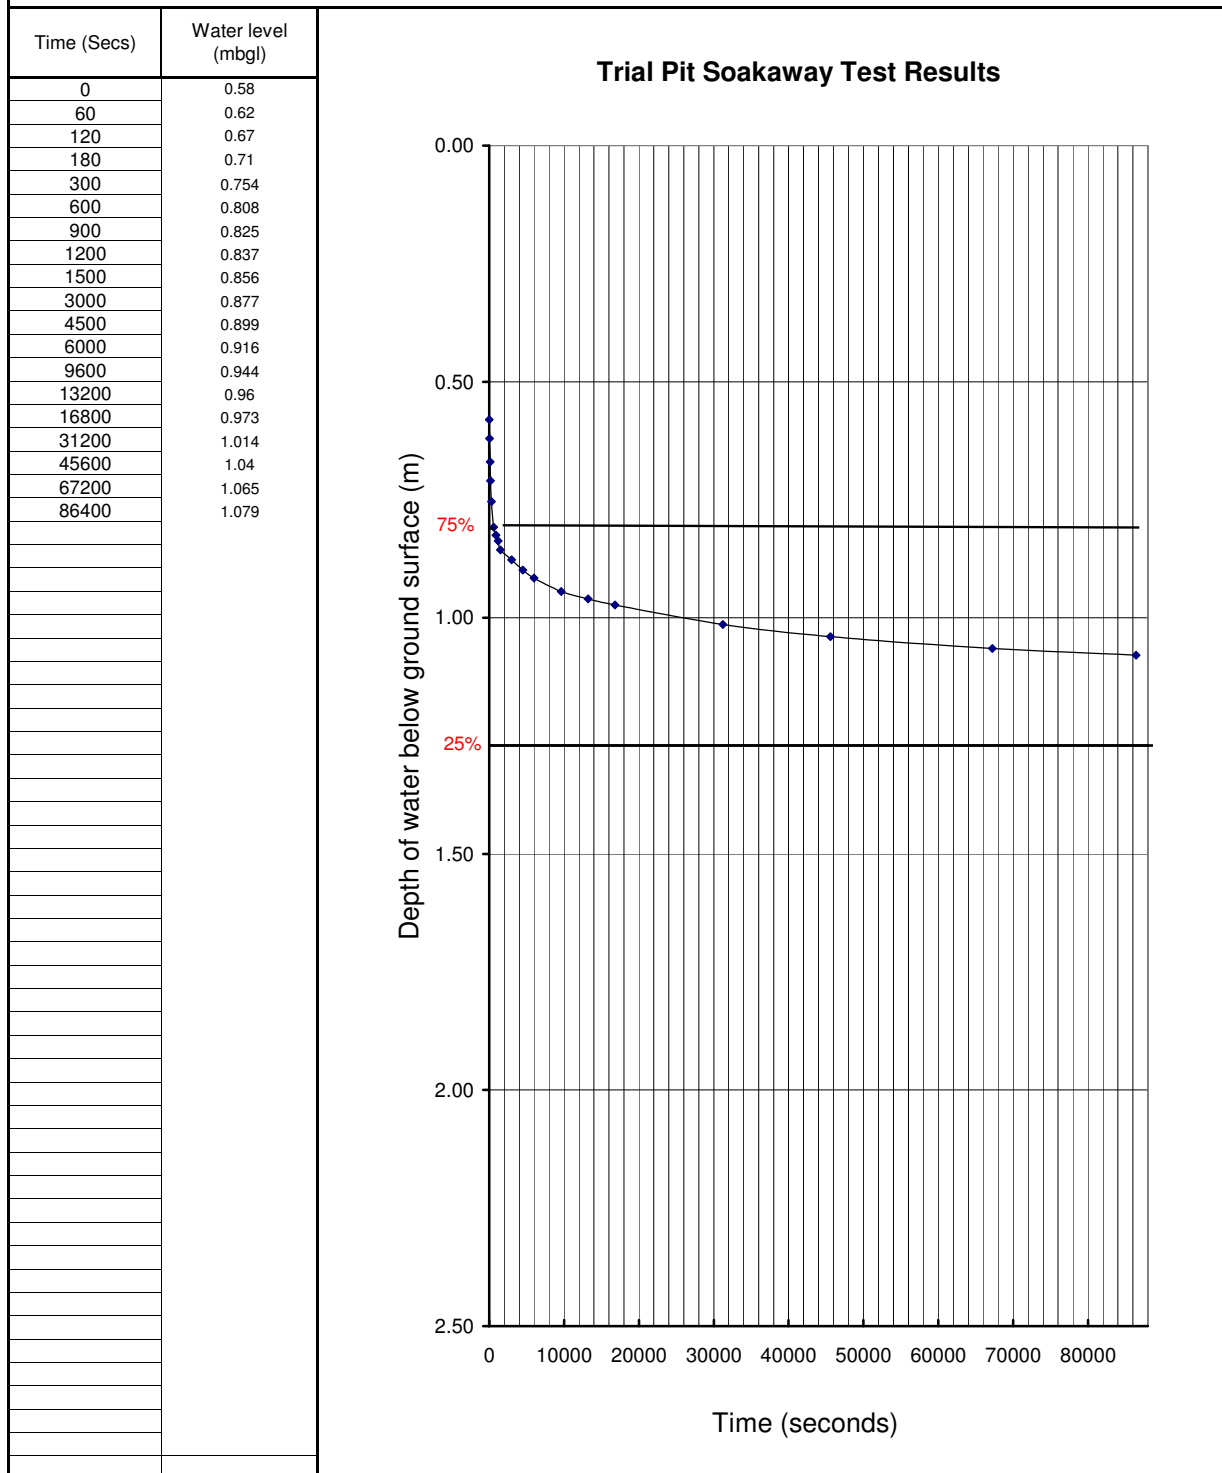
Location	TP2(i)	Test No	Test 1
Client	BDW Trading Limited	Length of Trial Pit (m)	1.1
Job Number	25459	Width of Trial Pit (m)	0.45
Date	28.08.12 - 29.08.12	Water level at start (mbgl)	0.58
Operator	MOS / OP	Depth to Base of Trial Pit (m)	1.50

Trial Pit Soakaway Test to BRE Digest 365

$V_{p75-25} (m^3)$	-
$a_{p50} (m^2)$	-
$t_{p75} (s)$	-
$t_{p25} (s)$	-
$t_{p75-25} (s)$	-
Infiltration Rate (m/s)	INVALID

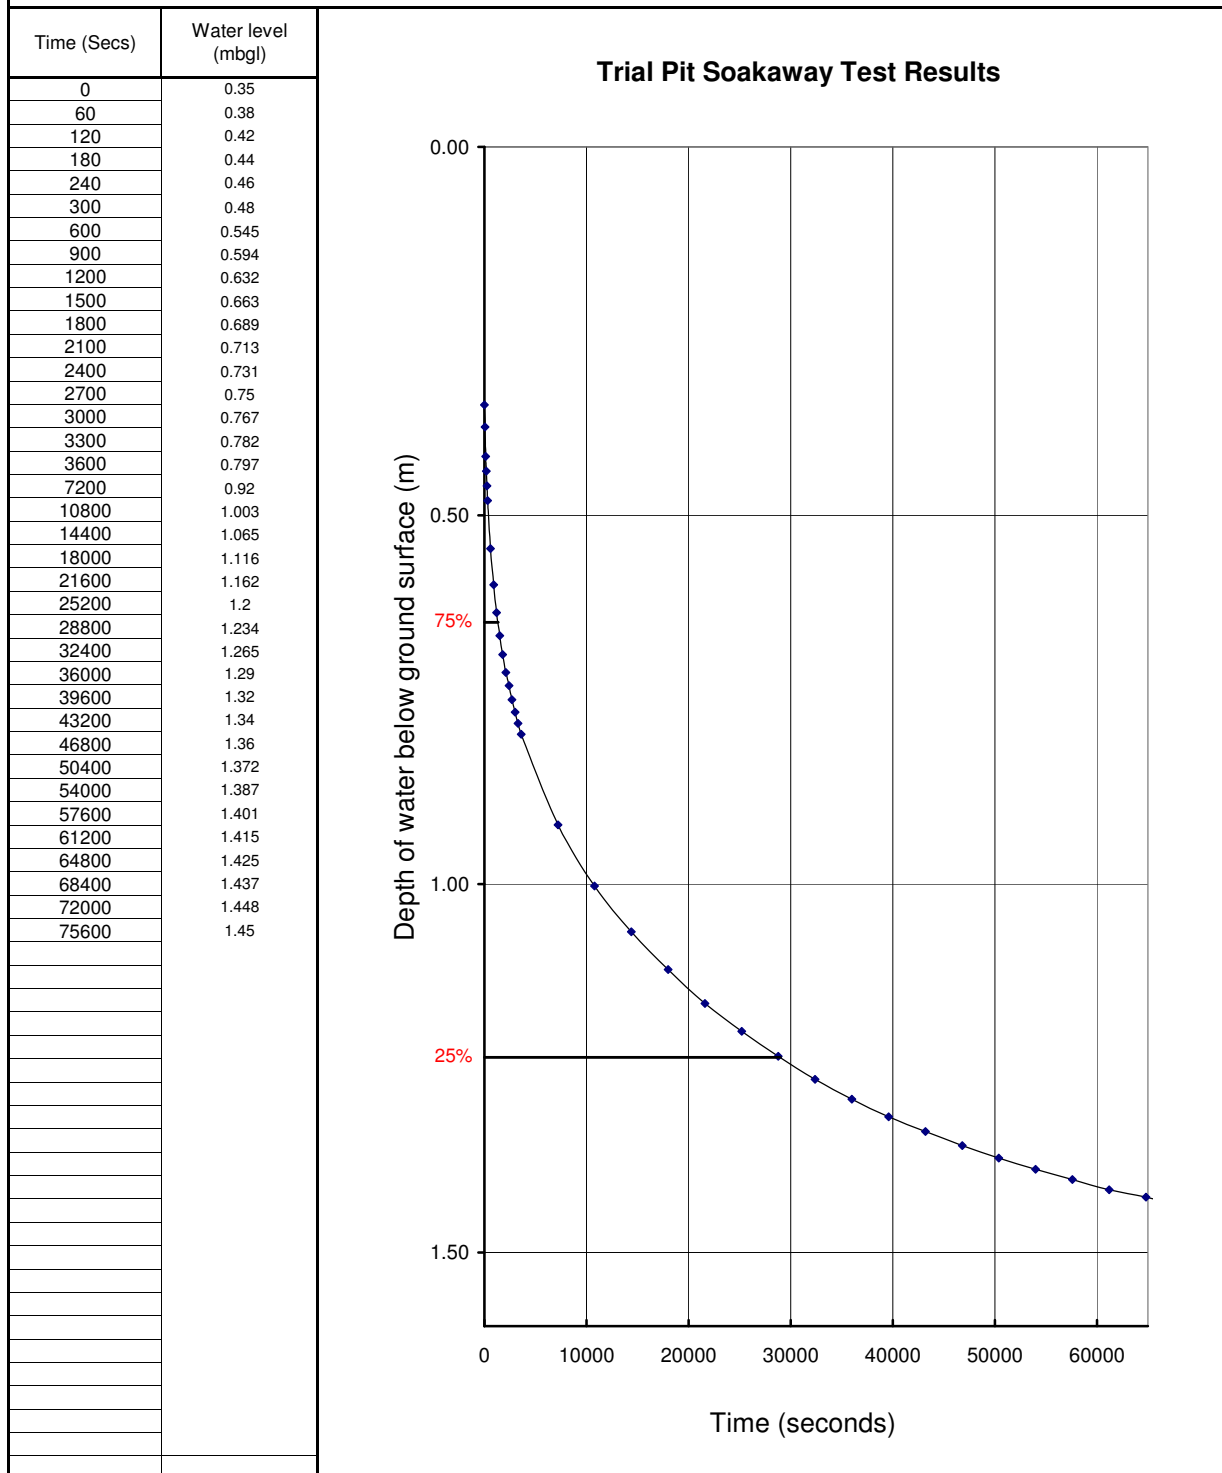
Location	TP4 (i)	Test No	Test 1
Client	BDW Trading Limited	Length of Trial Pit (m)	1.29
Job Number	25459	Width of Trial Pit (m)	0.45
Date	30.08.12 - 31.08.12	Water level at start (mbgl)	0.35
Operator	MOS / OP / BC	Depth to Base of Trial Pit (m)	1.53

Trial Pit Soakaway Test to BRE Digest 365

$V_{p75-25} (m^3)$	0.10
$a_{p50} (m^2)$	2.63
$t_{p75} (s)$	1350.00
$t_{p25} (s)$	29000.00
$t_{p75-25} (s)$	27650.00
Infiltration Rate (m/s)	1.41E-06

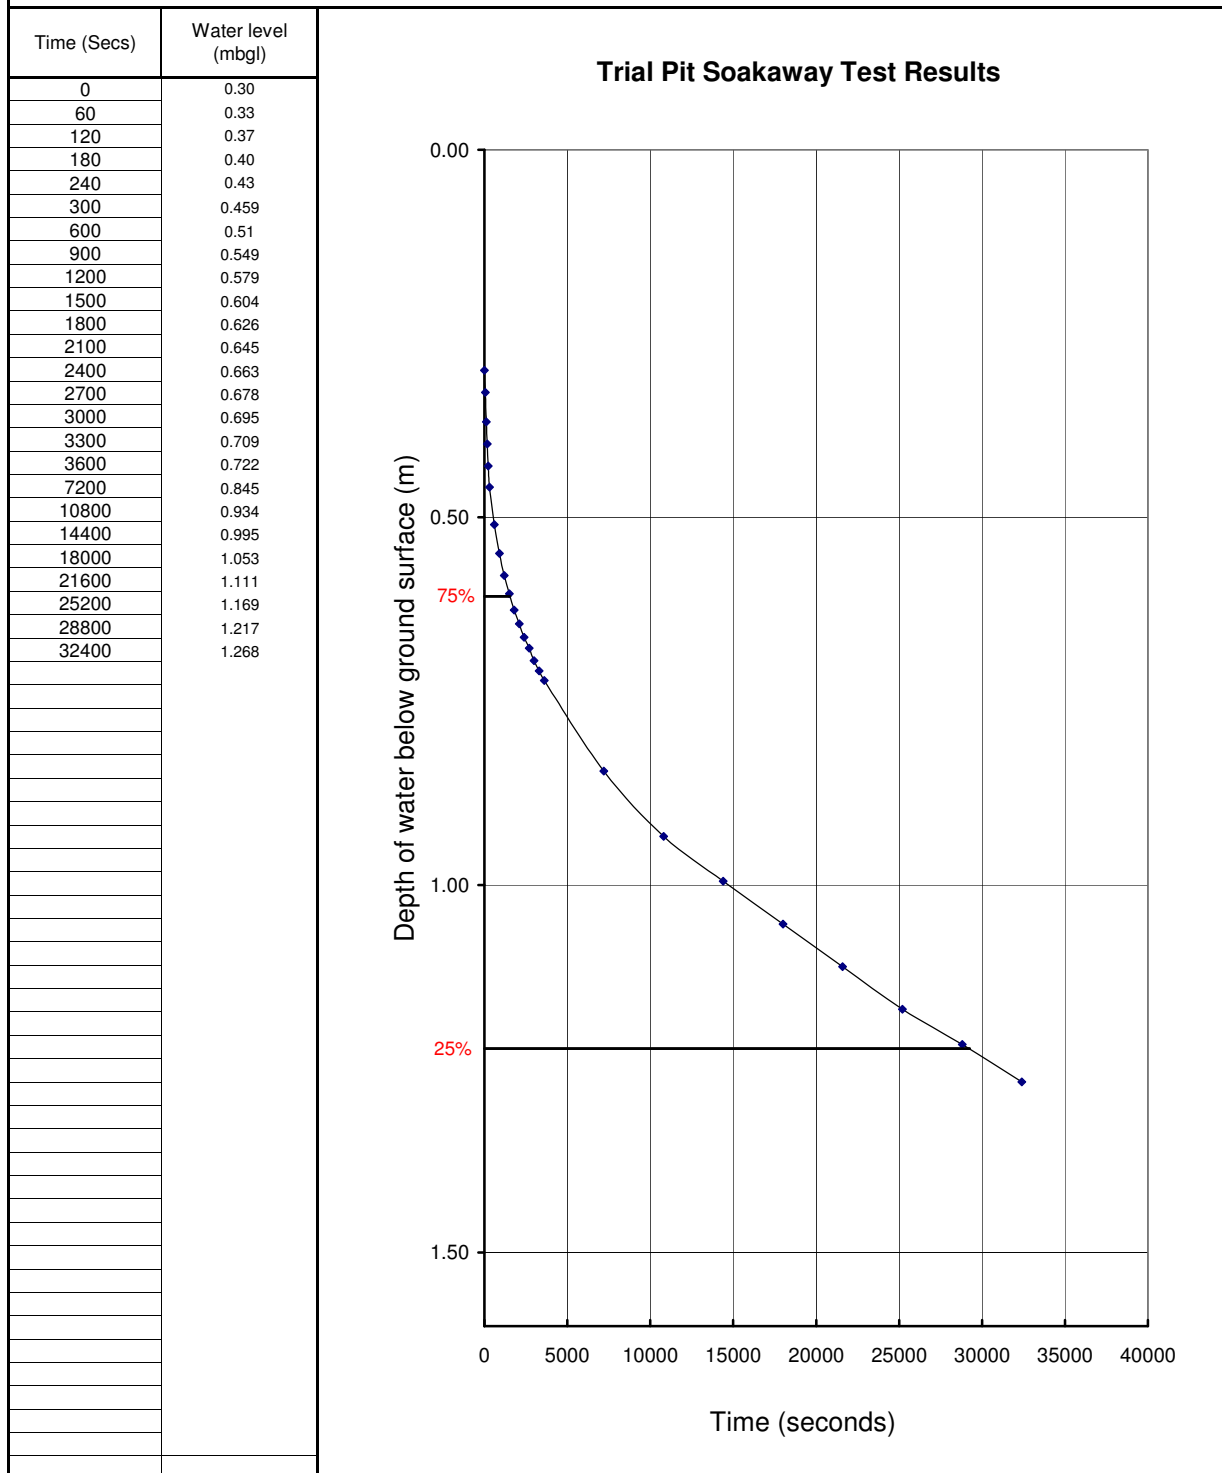
Location	TP4 (i)	Test No	Test 2
Client	BDW Trading Limited	Length of Trial Pit (m)	1.29
Job Number	25459	Width of Trial Pit (m)	0.45
Date	31.08.12	Water level at start (mbgl)	0.3
Operator	MOS	Depth to Base of Trial Pit (m)	1.53

Trial Pit Soakaway Test to BRE Digest 365

$V_{p75-25} (m^3)$	0.11
$a_{p50} (m^2)$	2.72
$t_{p75} (s)$	1550.00
$t_{p25} (s)$	29250.00
$t_{p75-25} (s)$	27700.00
Infiltration Rate (m/s)	1.42E-06

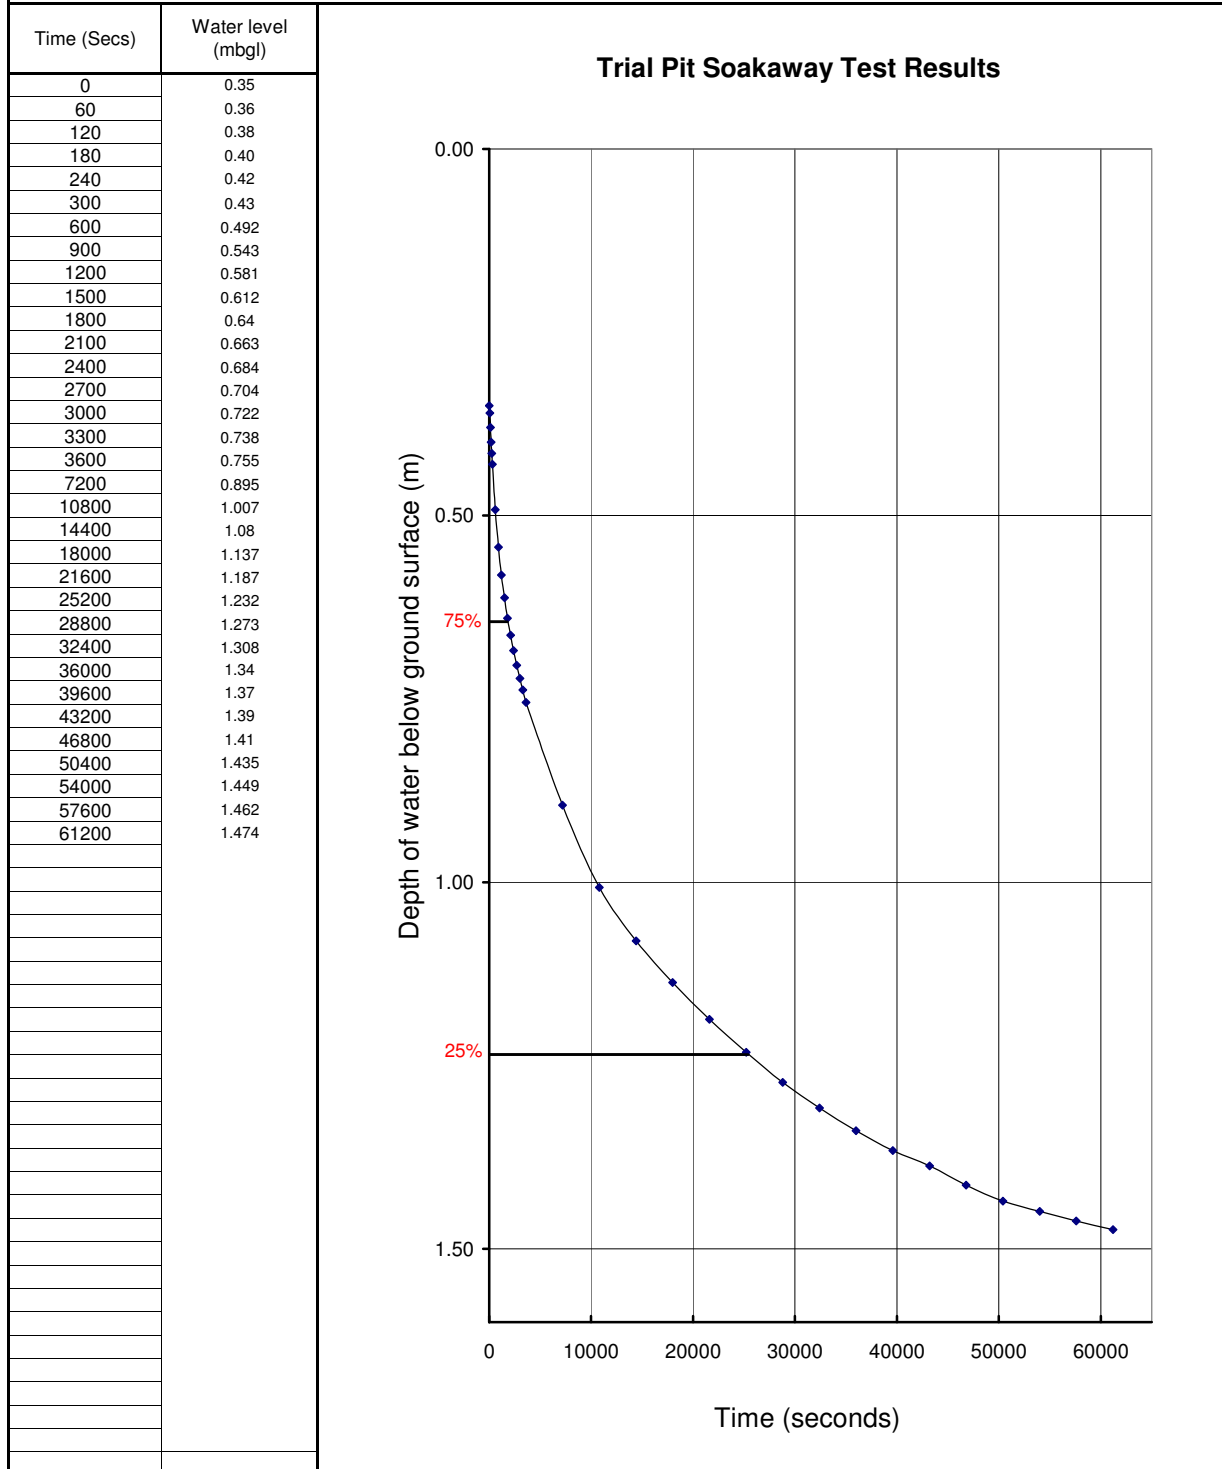
Location	TP4 (i)	Test No	Test 3
Client	BDW Trading Limited	Length of Trial Pit (m)	1.29
Job Number	25459	Width of Trial Pit (m)	0.45
Date	03.09.12	Water level at start (mbgl)	0.35
Operator	MOS / BC	Depth to Base of Trial Pit (m)	1.53

Trial Pit Soakaway Test to BRE Digest 365

$V_{p75-25} (m^3)$	0.10
$a_{p50} (m^2)$	2.63
$t_{p75} (s)$	1800.00
$t_{p25} (s)$	25400.00
$t_{p75-25} (s)$	23600.00
Infiltration Rate (m/s)	1.65E-06
