# UNCONSOLIDATED QUICK UNDRAINED (SINGLE STAGE) TRIAXIAL COMPRESSION TEST

| HP3 9RT | | NIAB Phase 1 | | 582260 | |

**APPENDIX B**  
**PHOTOGRAPHIC**  
**RECORD**

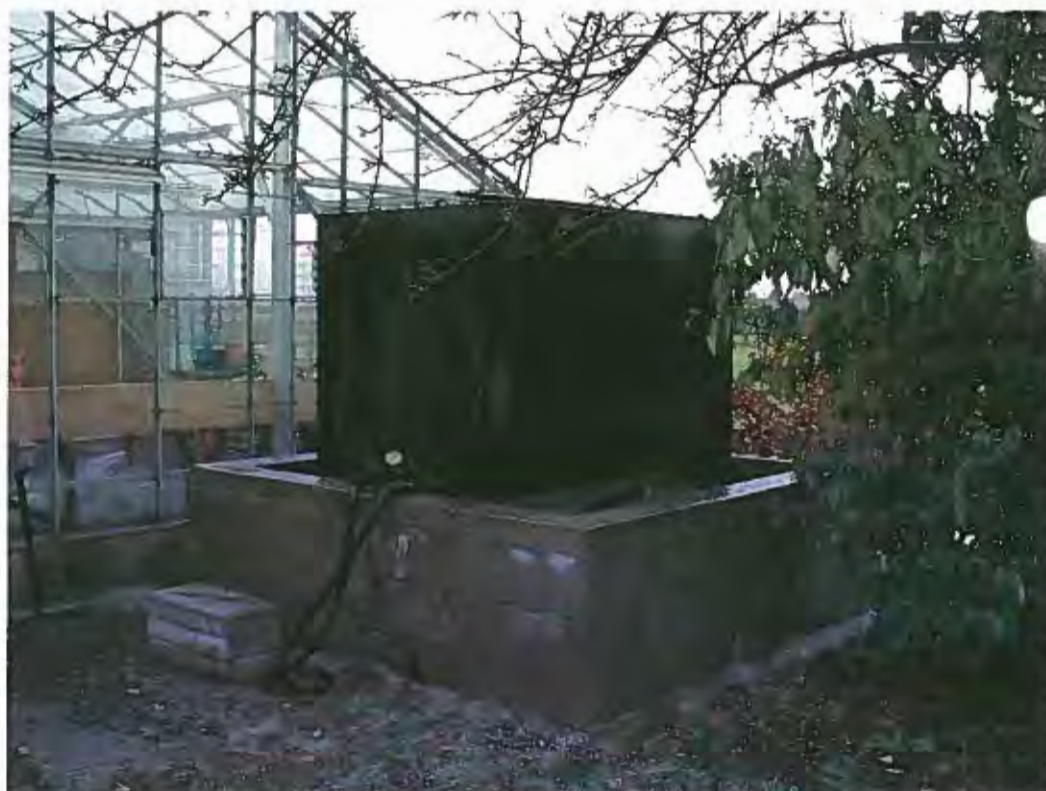
AST located beside Spore Proof Building/ glasshouse used to store diesel

- 2.5.2 A bulk storage tank use to store diesel is also situated next to the Spore Proof Block and adjacent glasshouse. The tank was noted as being in good condition with the fill point over an area of partial hardstanding. The bund was solid and in good condition, with standing water noted inside the bund (reducing the bunding capacity). It is understood that the diesel is used to fill a generator that powers a steaming unit used in some of the glasshouses.

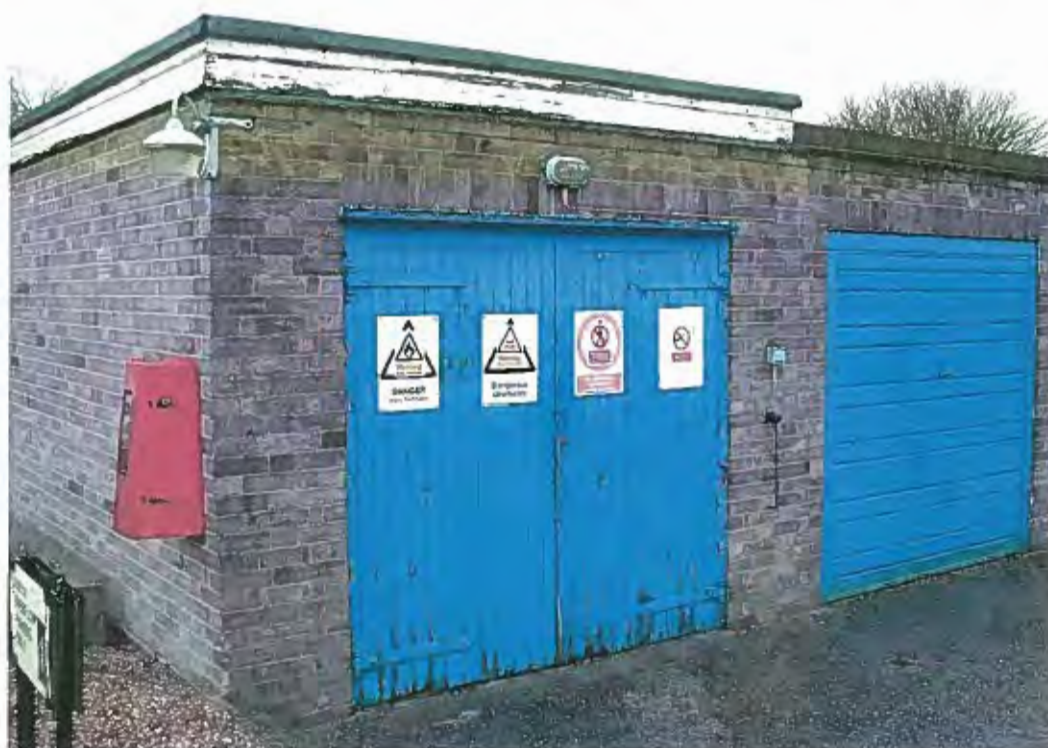
Agricultural chemical storage unit in the main site opposite the NIAB offices

- 2.5.4 Gas cylinders were observed to be stored outside and on the edge of the field situated in the main site area. The cylinders were stored in a cage, the cylinders appeared to be in good condition. Also ad-hoc drum storage was noted and other lockable storage unit also noted in the cage supported with some hazardous chemical signs.

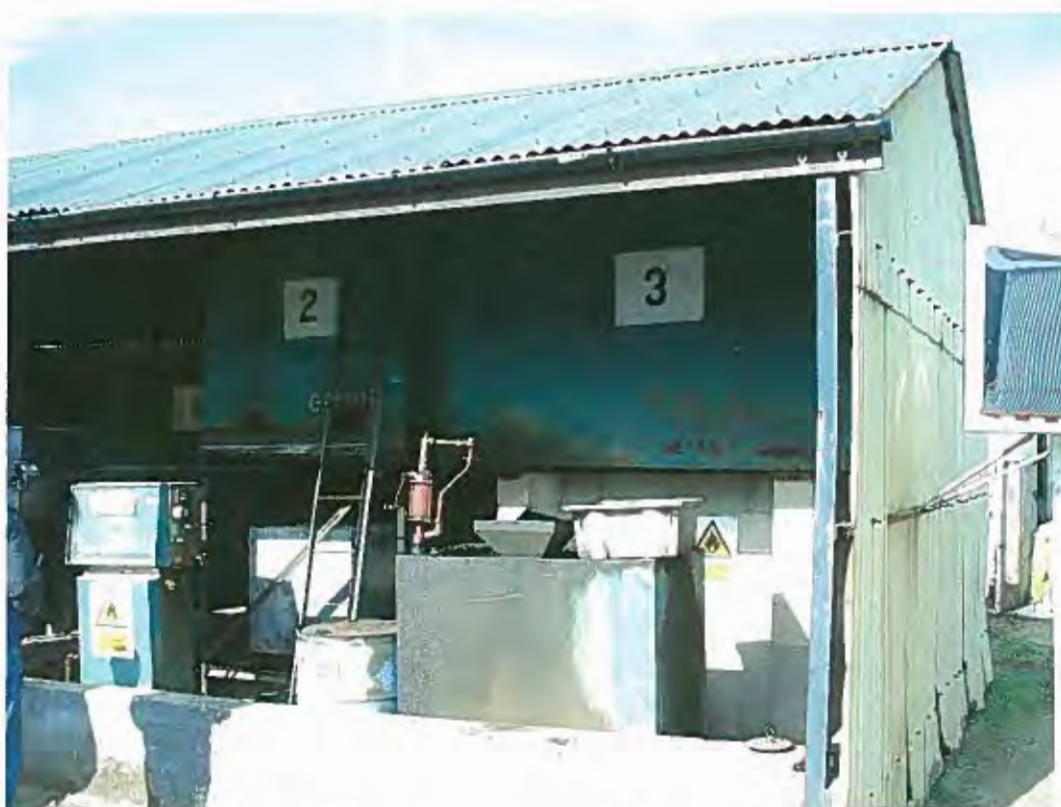
Tanks 2 and 3 used to store red diesel, pump and waste oil tank in off-site farm yard.

- 2.5.3 A total of three above ground storage tanks (Nos. 1, 2 and 3) were noted in the off-site farm yard. The three tanks have a total capacity of approximately 15000 litres, however no more than 6000 litres is stored. Tank No.1 was used to store white diesel (DERV) and is now redundant. Tanks 2 and 3 are used to store red diesel. The tanks and bund were noted to be in good condition with some oil staining noted in the base of the bund. The pump used to supply the red diesel is situated within the bund area and the fill point for agricultural machinery is on concrete hardstanding. The disused white diesel pump was observed outside the bund. A waste oil storage tank is also situated within the bund. It was confirmed during the inspection that the bund has a volume equal to 110% of the total capacity of the tanks and that the bund had been inspected and approved by the Environment Agency.

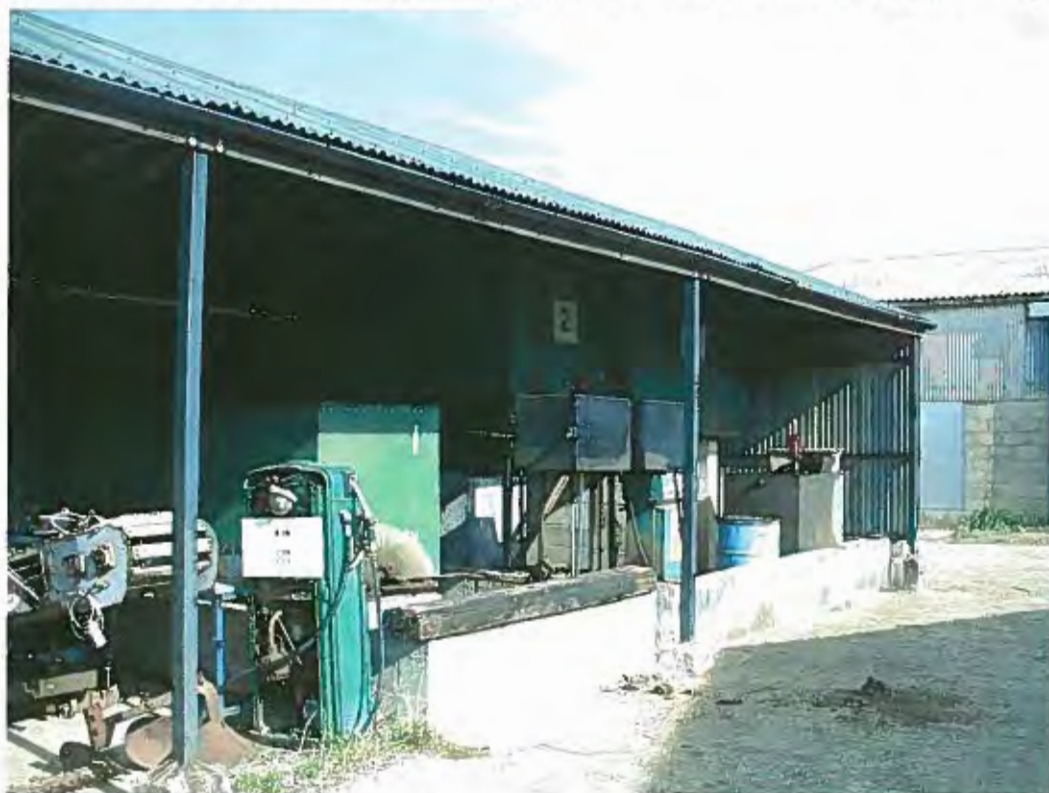
Redundant Tank 1 formally used to store white diesel and associated pump

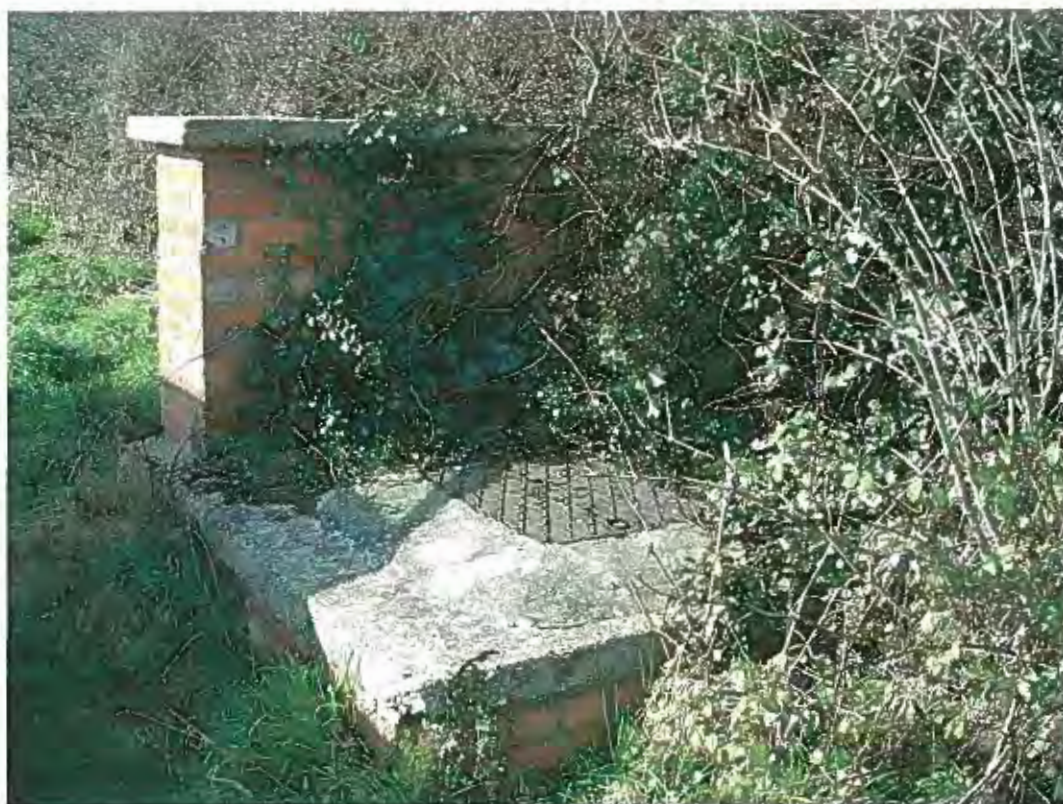
**View on Borehole (NIAB Field).**

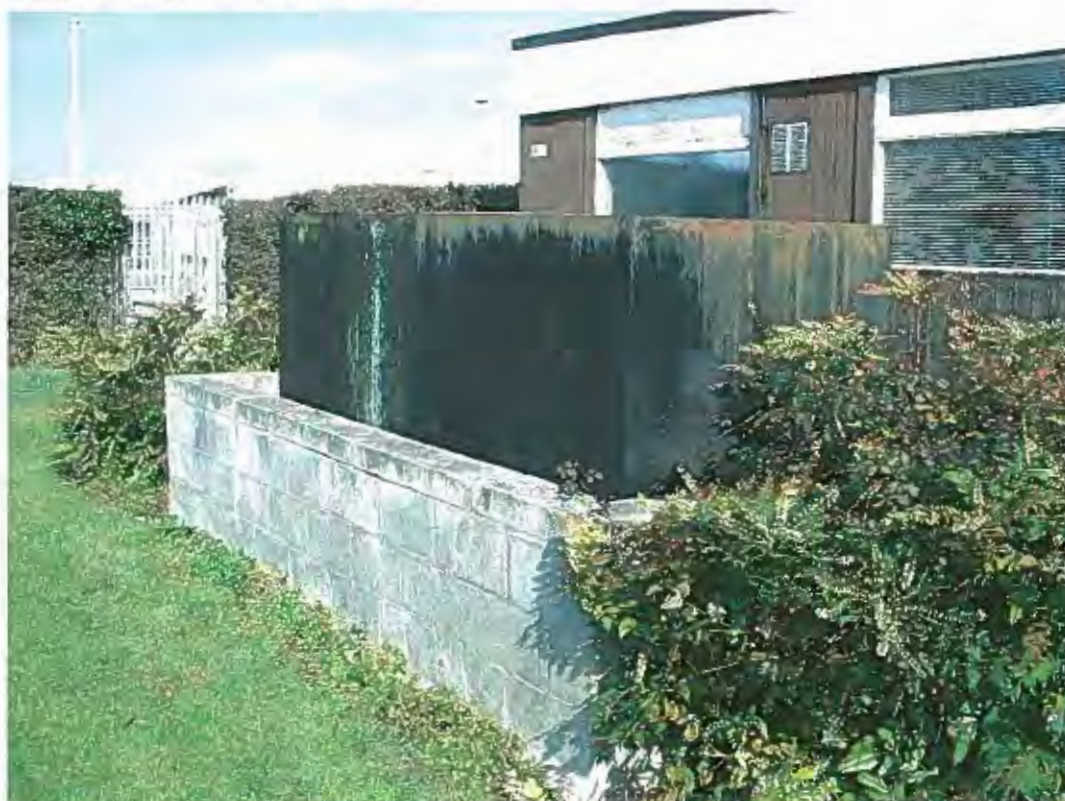
**4000 litre bunded AST located beside Farmer's Office**

- 2.5.1 A single 4000 litre above ground storage tank (No.4) is located next to the farmer's office and is used to store heating oil. The bunding and tank is in good condition with only slight staining around the fill point. There was no indication of any major spillages or contamination. Site personnel confirmed that the bunding has been

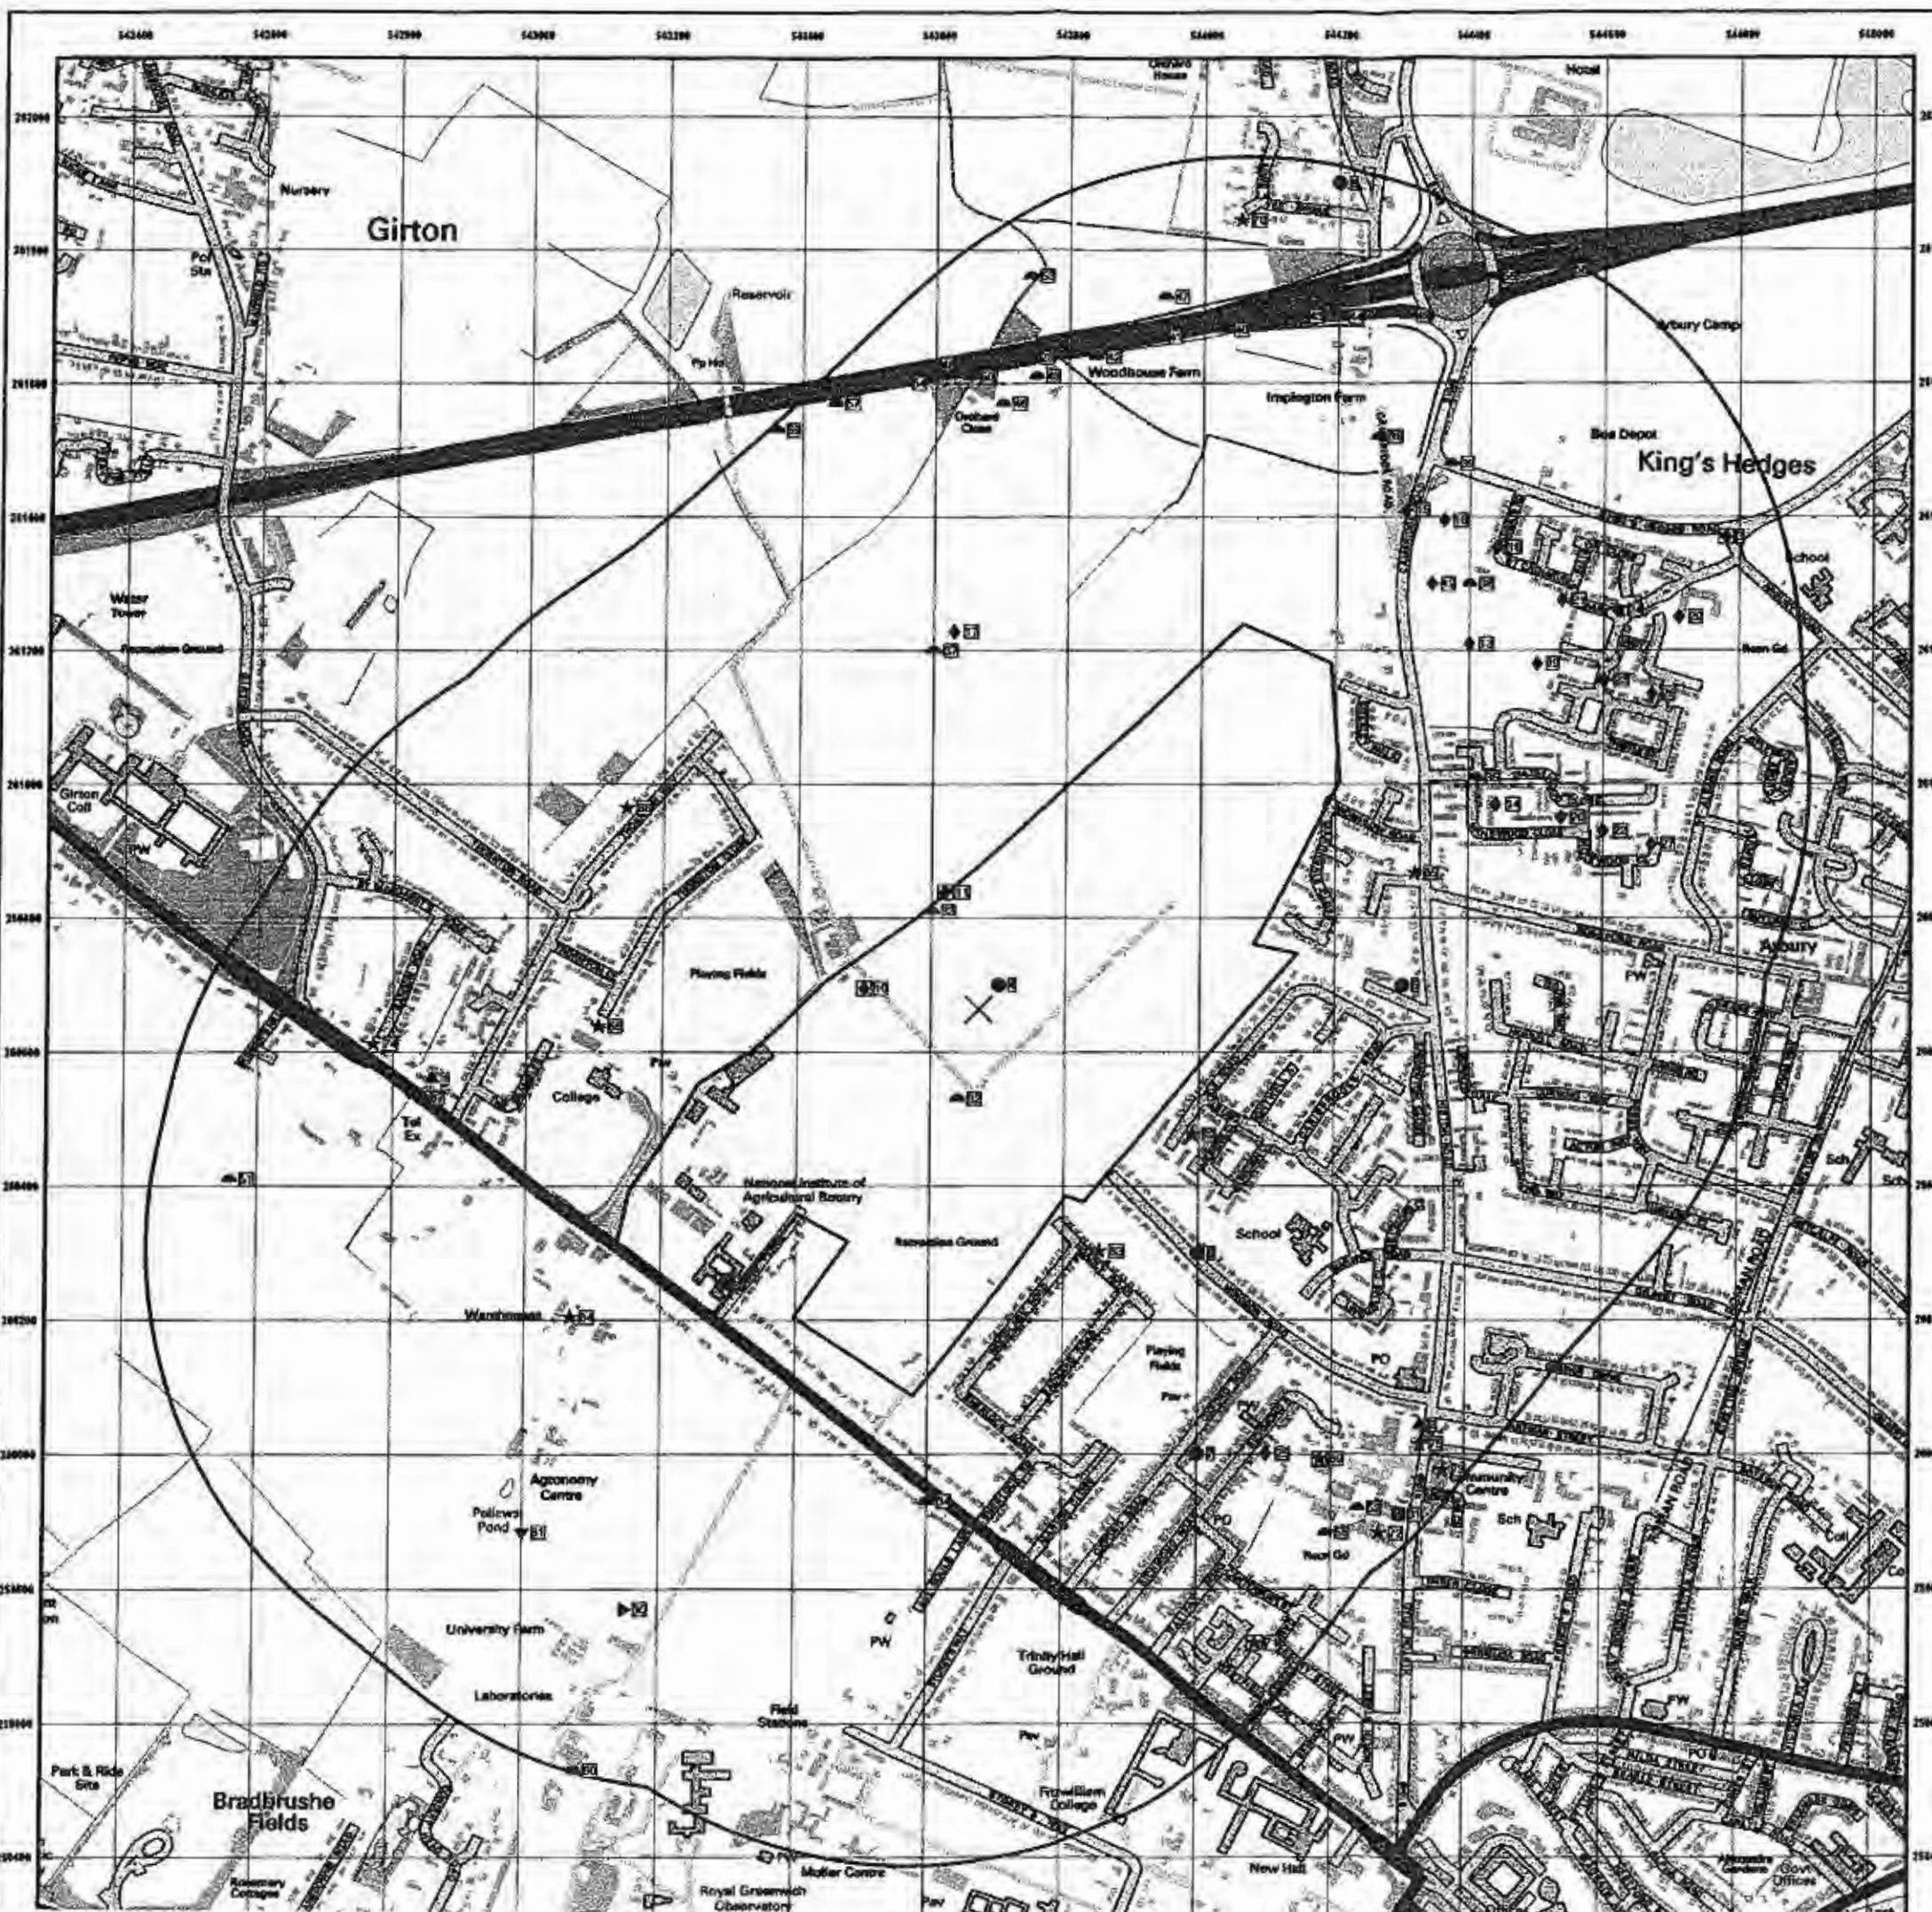
**FIGURE 2B**

**SITE LAYOUT PLAN  
(SPORTS FIELD)**

2.4 The site areas are described in detail below, together with any significant off-site uses. A site layout plan for each site area is shown on Figure 2 (A, B, C and D).
