Environmental Monitoring Report

Reporting Period
15/03/2010-30/04/2010

Former Bayer Crop Science Site
Hauxton
Cambridgeshire

May 2010

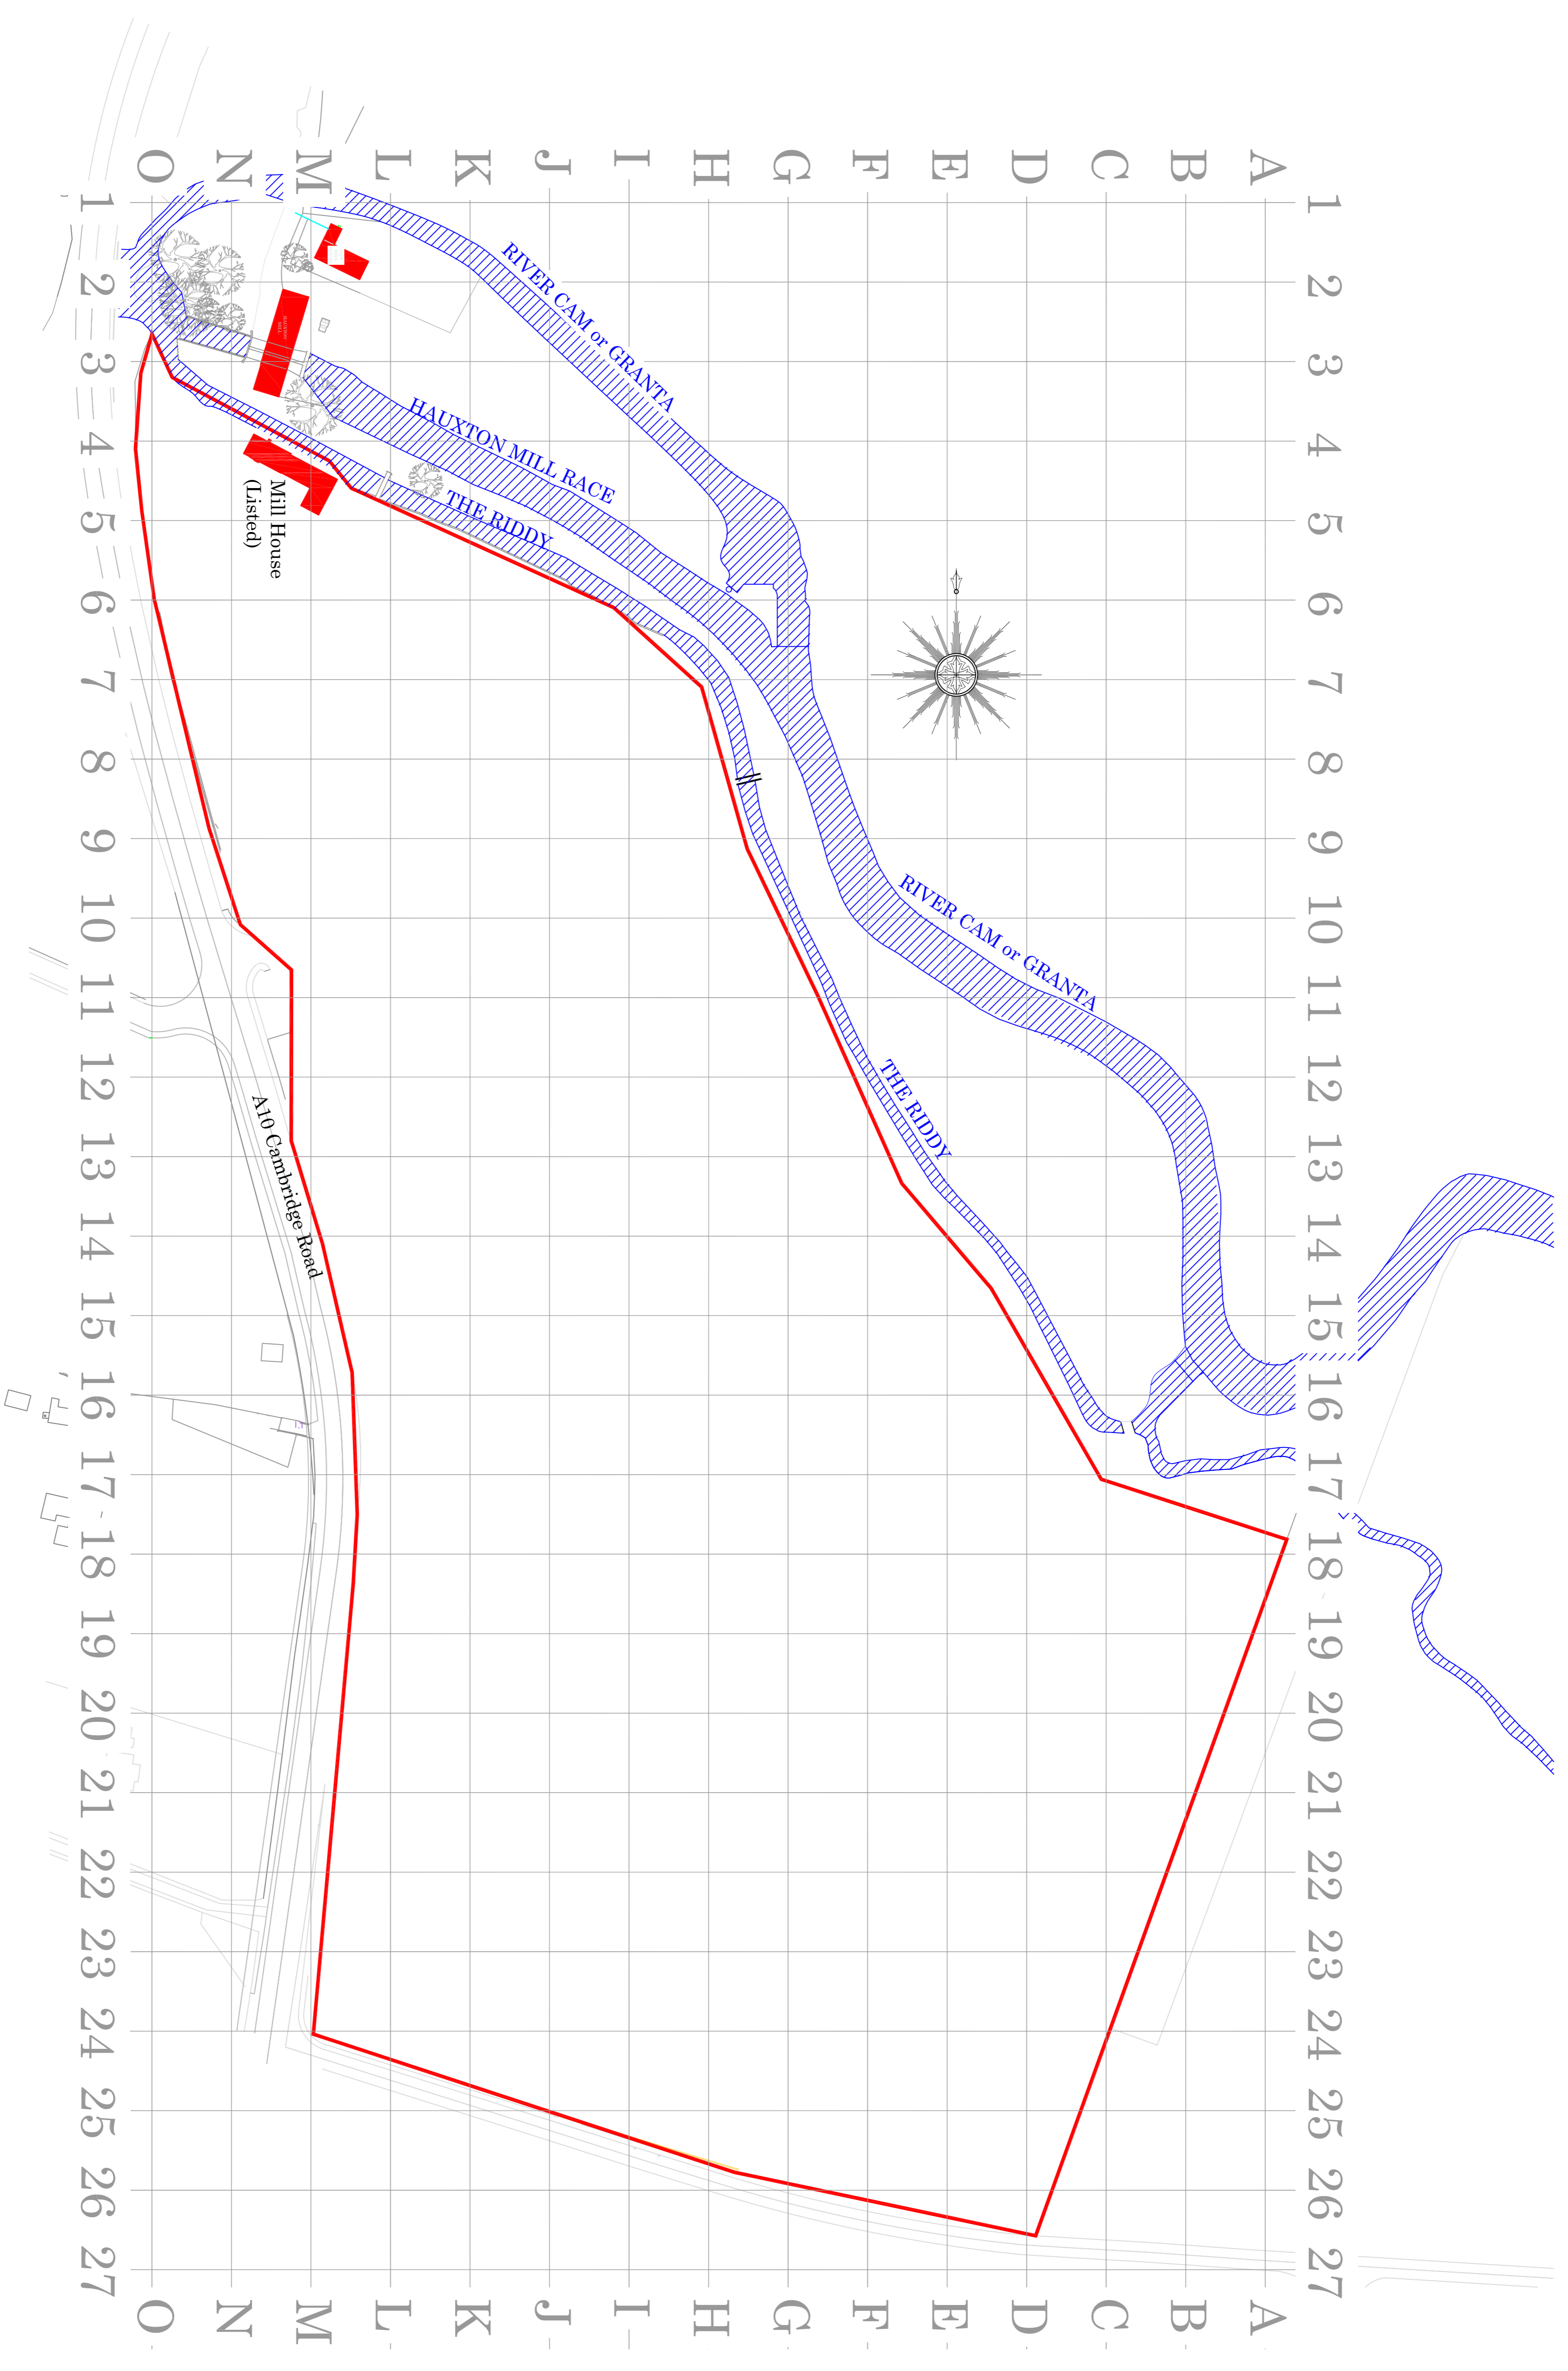
Dwg: 0907_07 Contact: 907BR4 Scale: 1:1000

Concrete was broken out across the first phase of excavation. The excavation was commenced for the installation of the lagoon area. (site grid references K14, K15 J15, see drawing D907_07, Appendix A) and also in the area for the main excavation (J8, J9, K8 and K9, see drawing D907_07, Appendix A). An odour control system was established around the area of the excavation with mobile units located within the processing area. Cemented (white) asbestos contaminated soils generated by the demolition of an out building (occurred in 2008) located in the garden areas of the former houses on Church Road, were quarantined for disposal later.

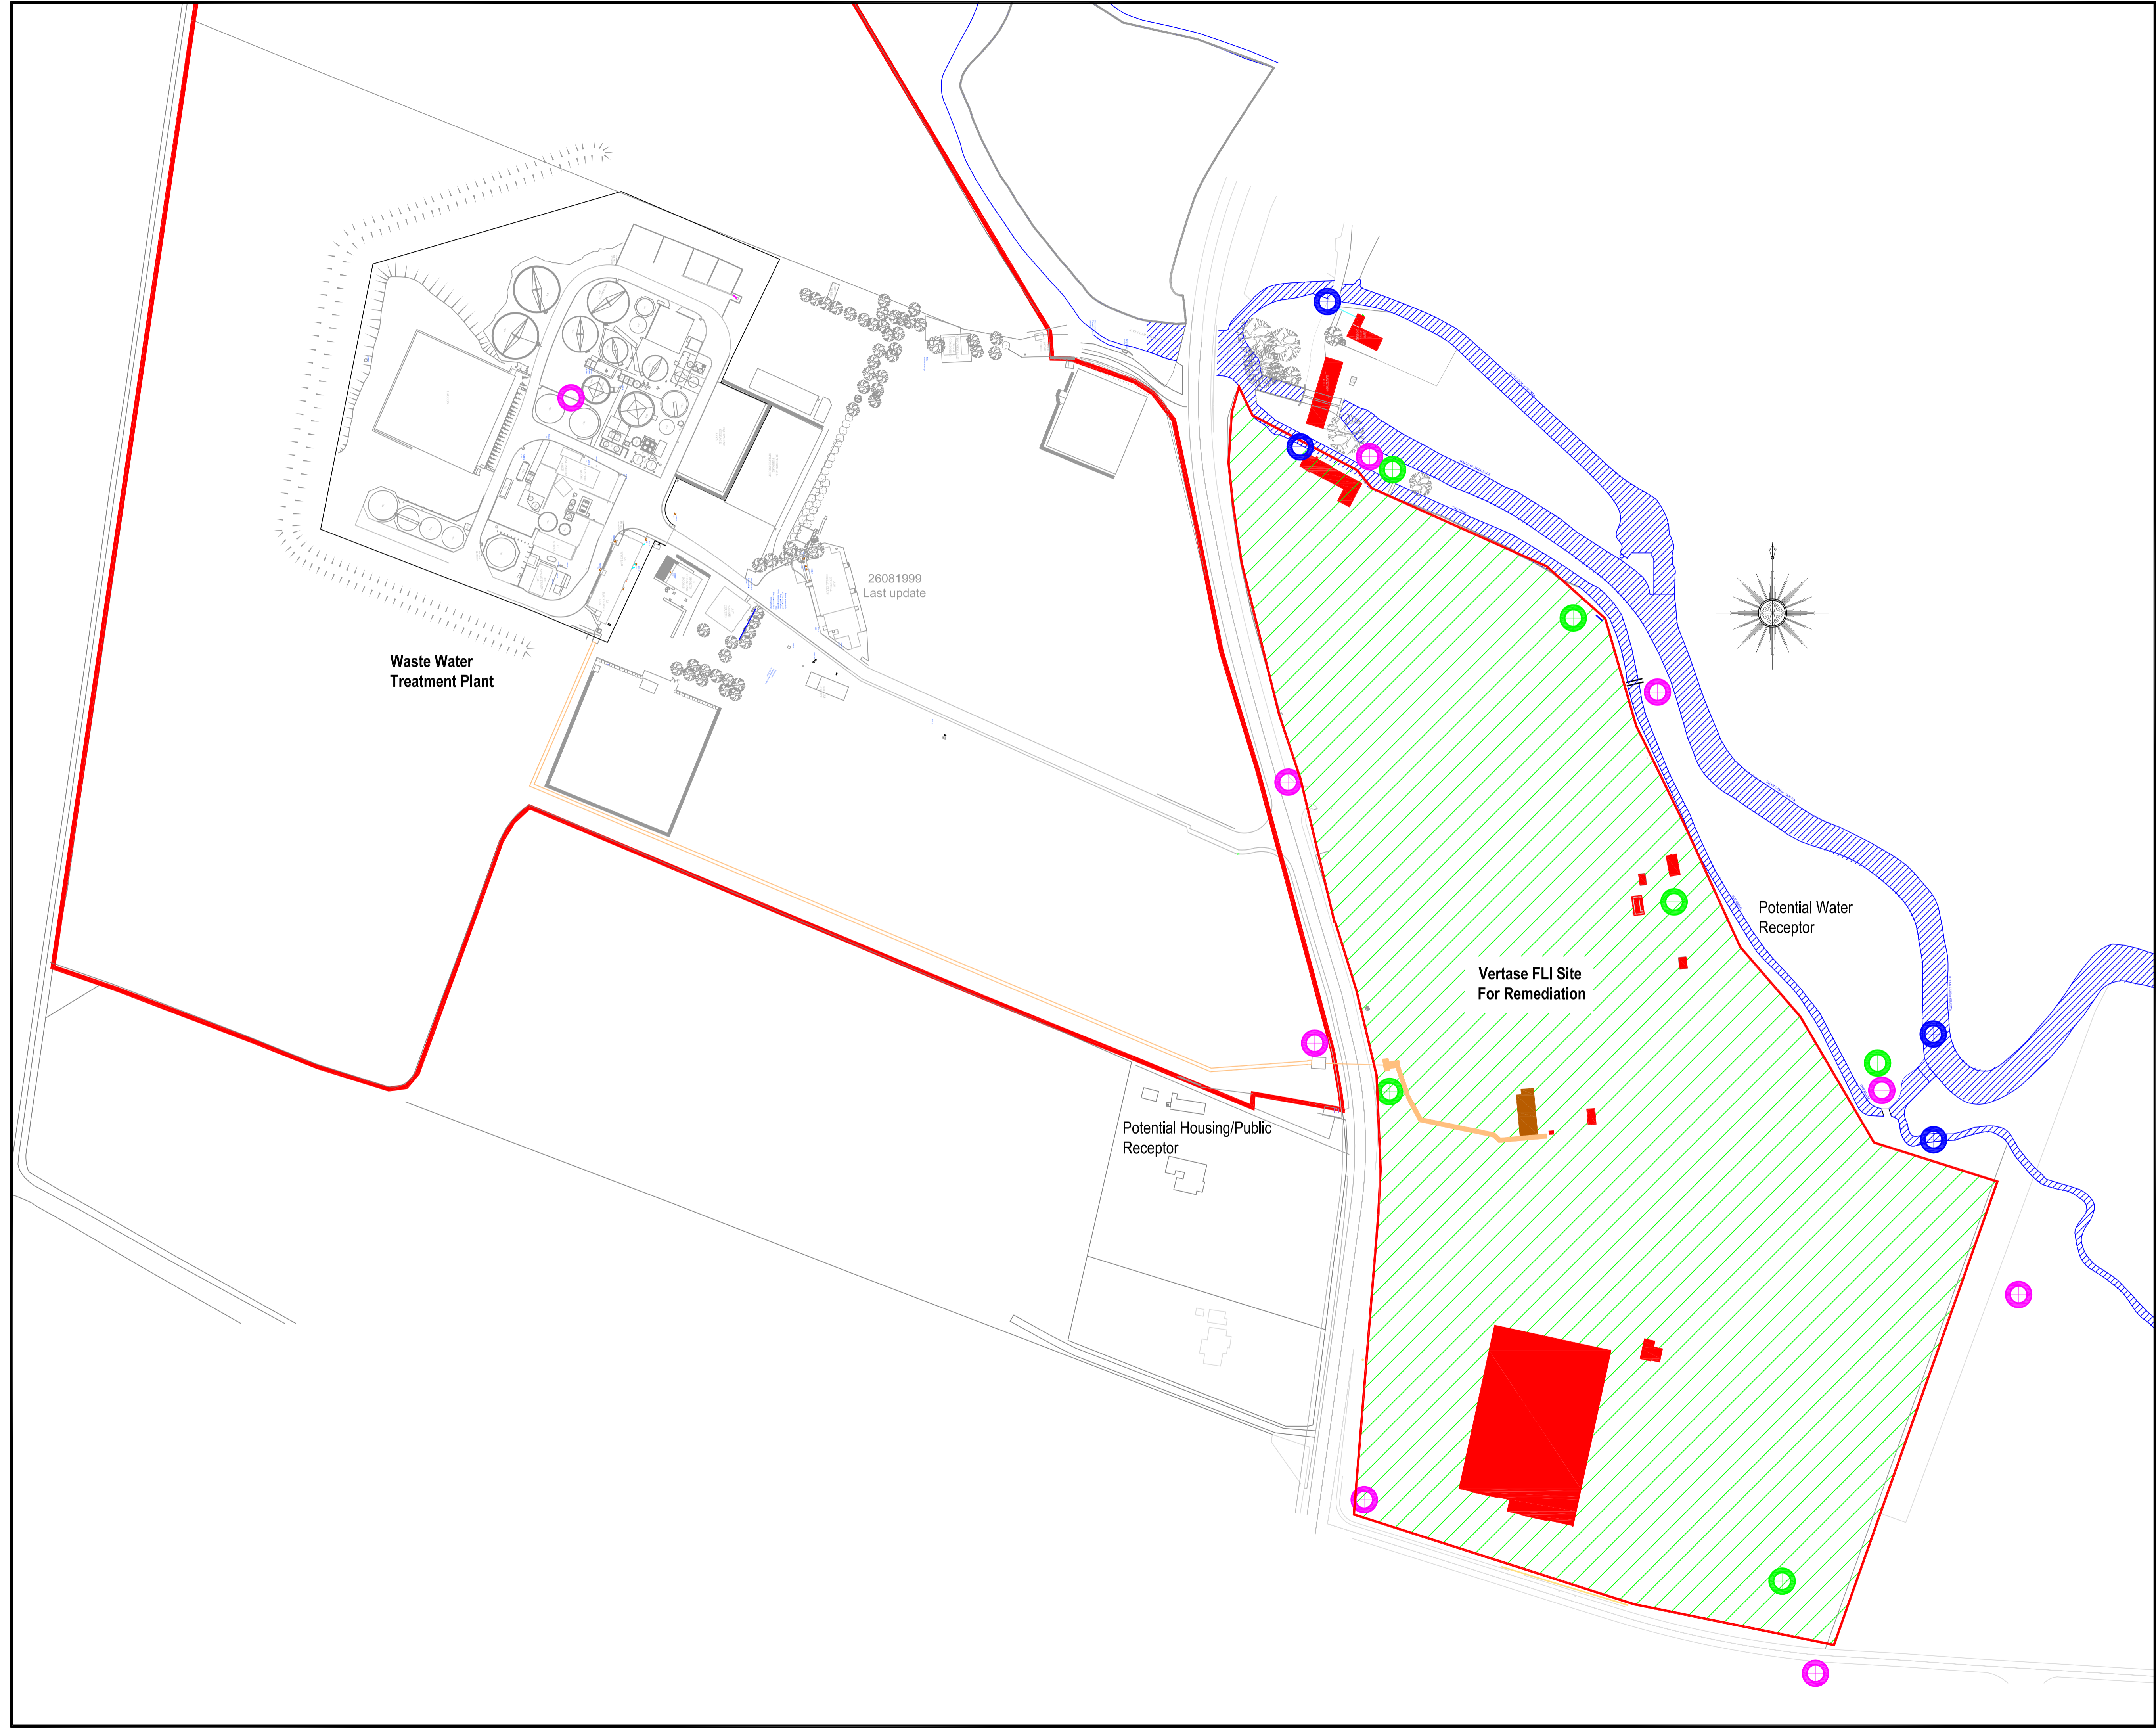
The environmental monitoring locations detailed in the Environmental Permit deployment form for the site are highlighted in drawing D907_33C in Appendix A.

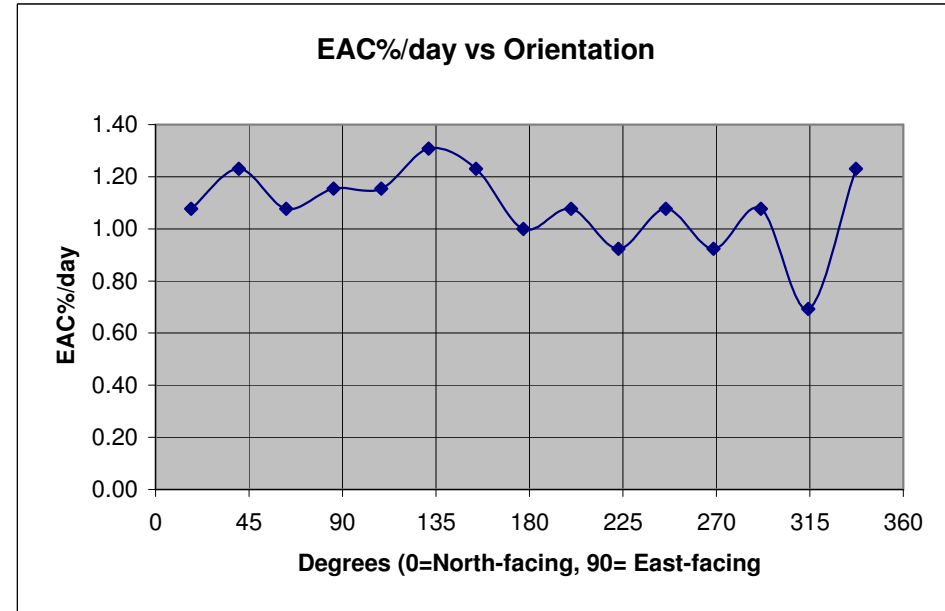
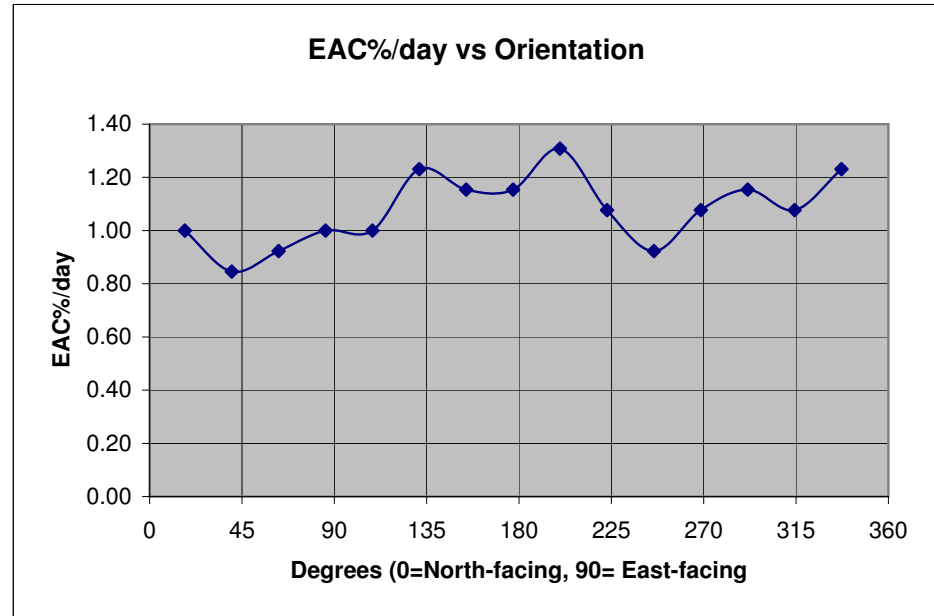
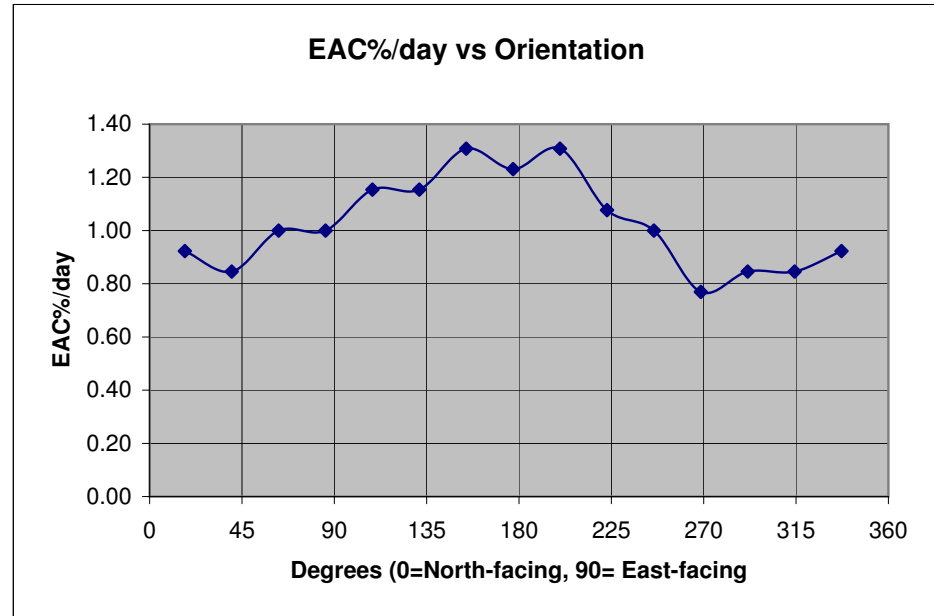
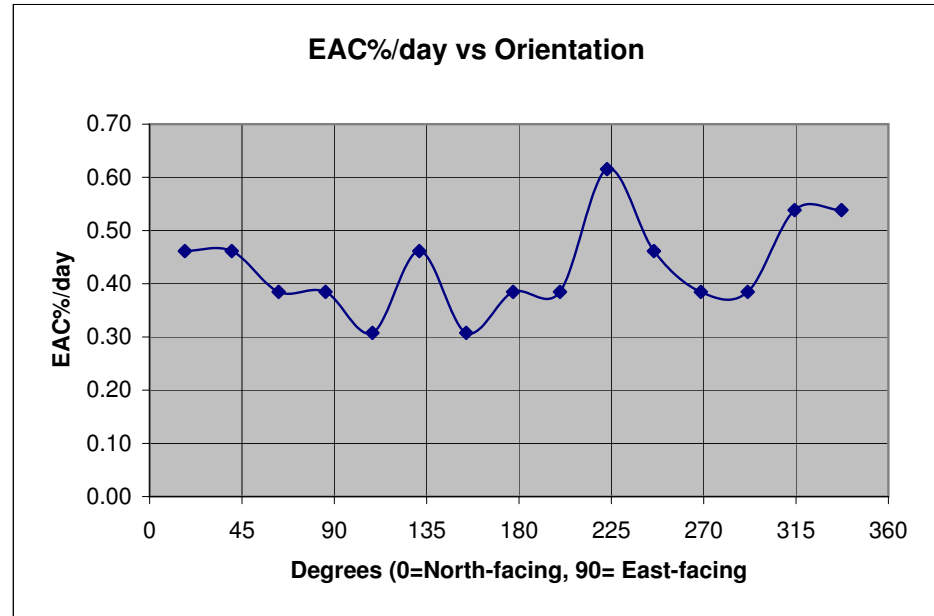
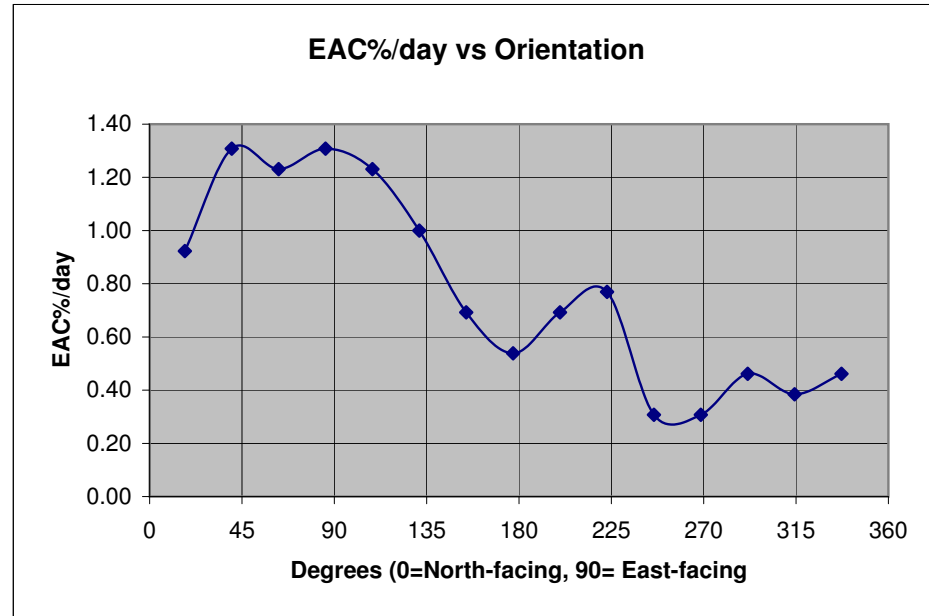
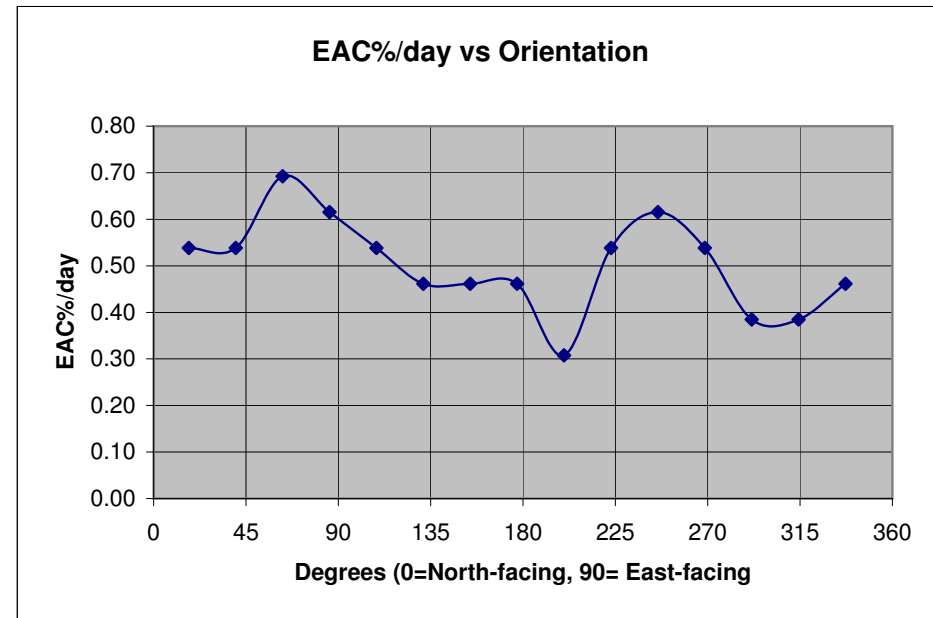
Directional dust deposition gauges at the six monitoring locations are analysed every fortnight for Effective Area Coverage (EAC) (percentage of dust deposition relating to the potential to cause nuisance), results generated by an external laboratory are presented in Appendix D.

Note: Cells coloured yellow are inputs.
 The rest are either constants or calculated values.
 The calculation is based on taking readings at 40mm intervals along the sticky pad.
