Environmental Monitoring Report

Reporting Period
15/03/2010-30/04/2010

Former Bayer Crop Science Site
Hauxton
Cambridgeshire

May 2010

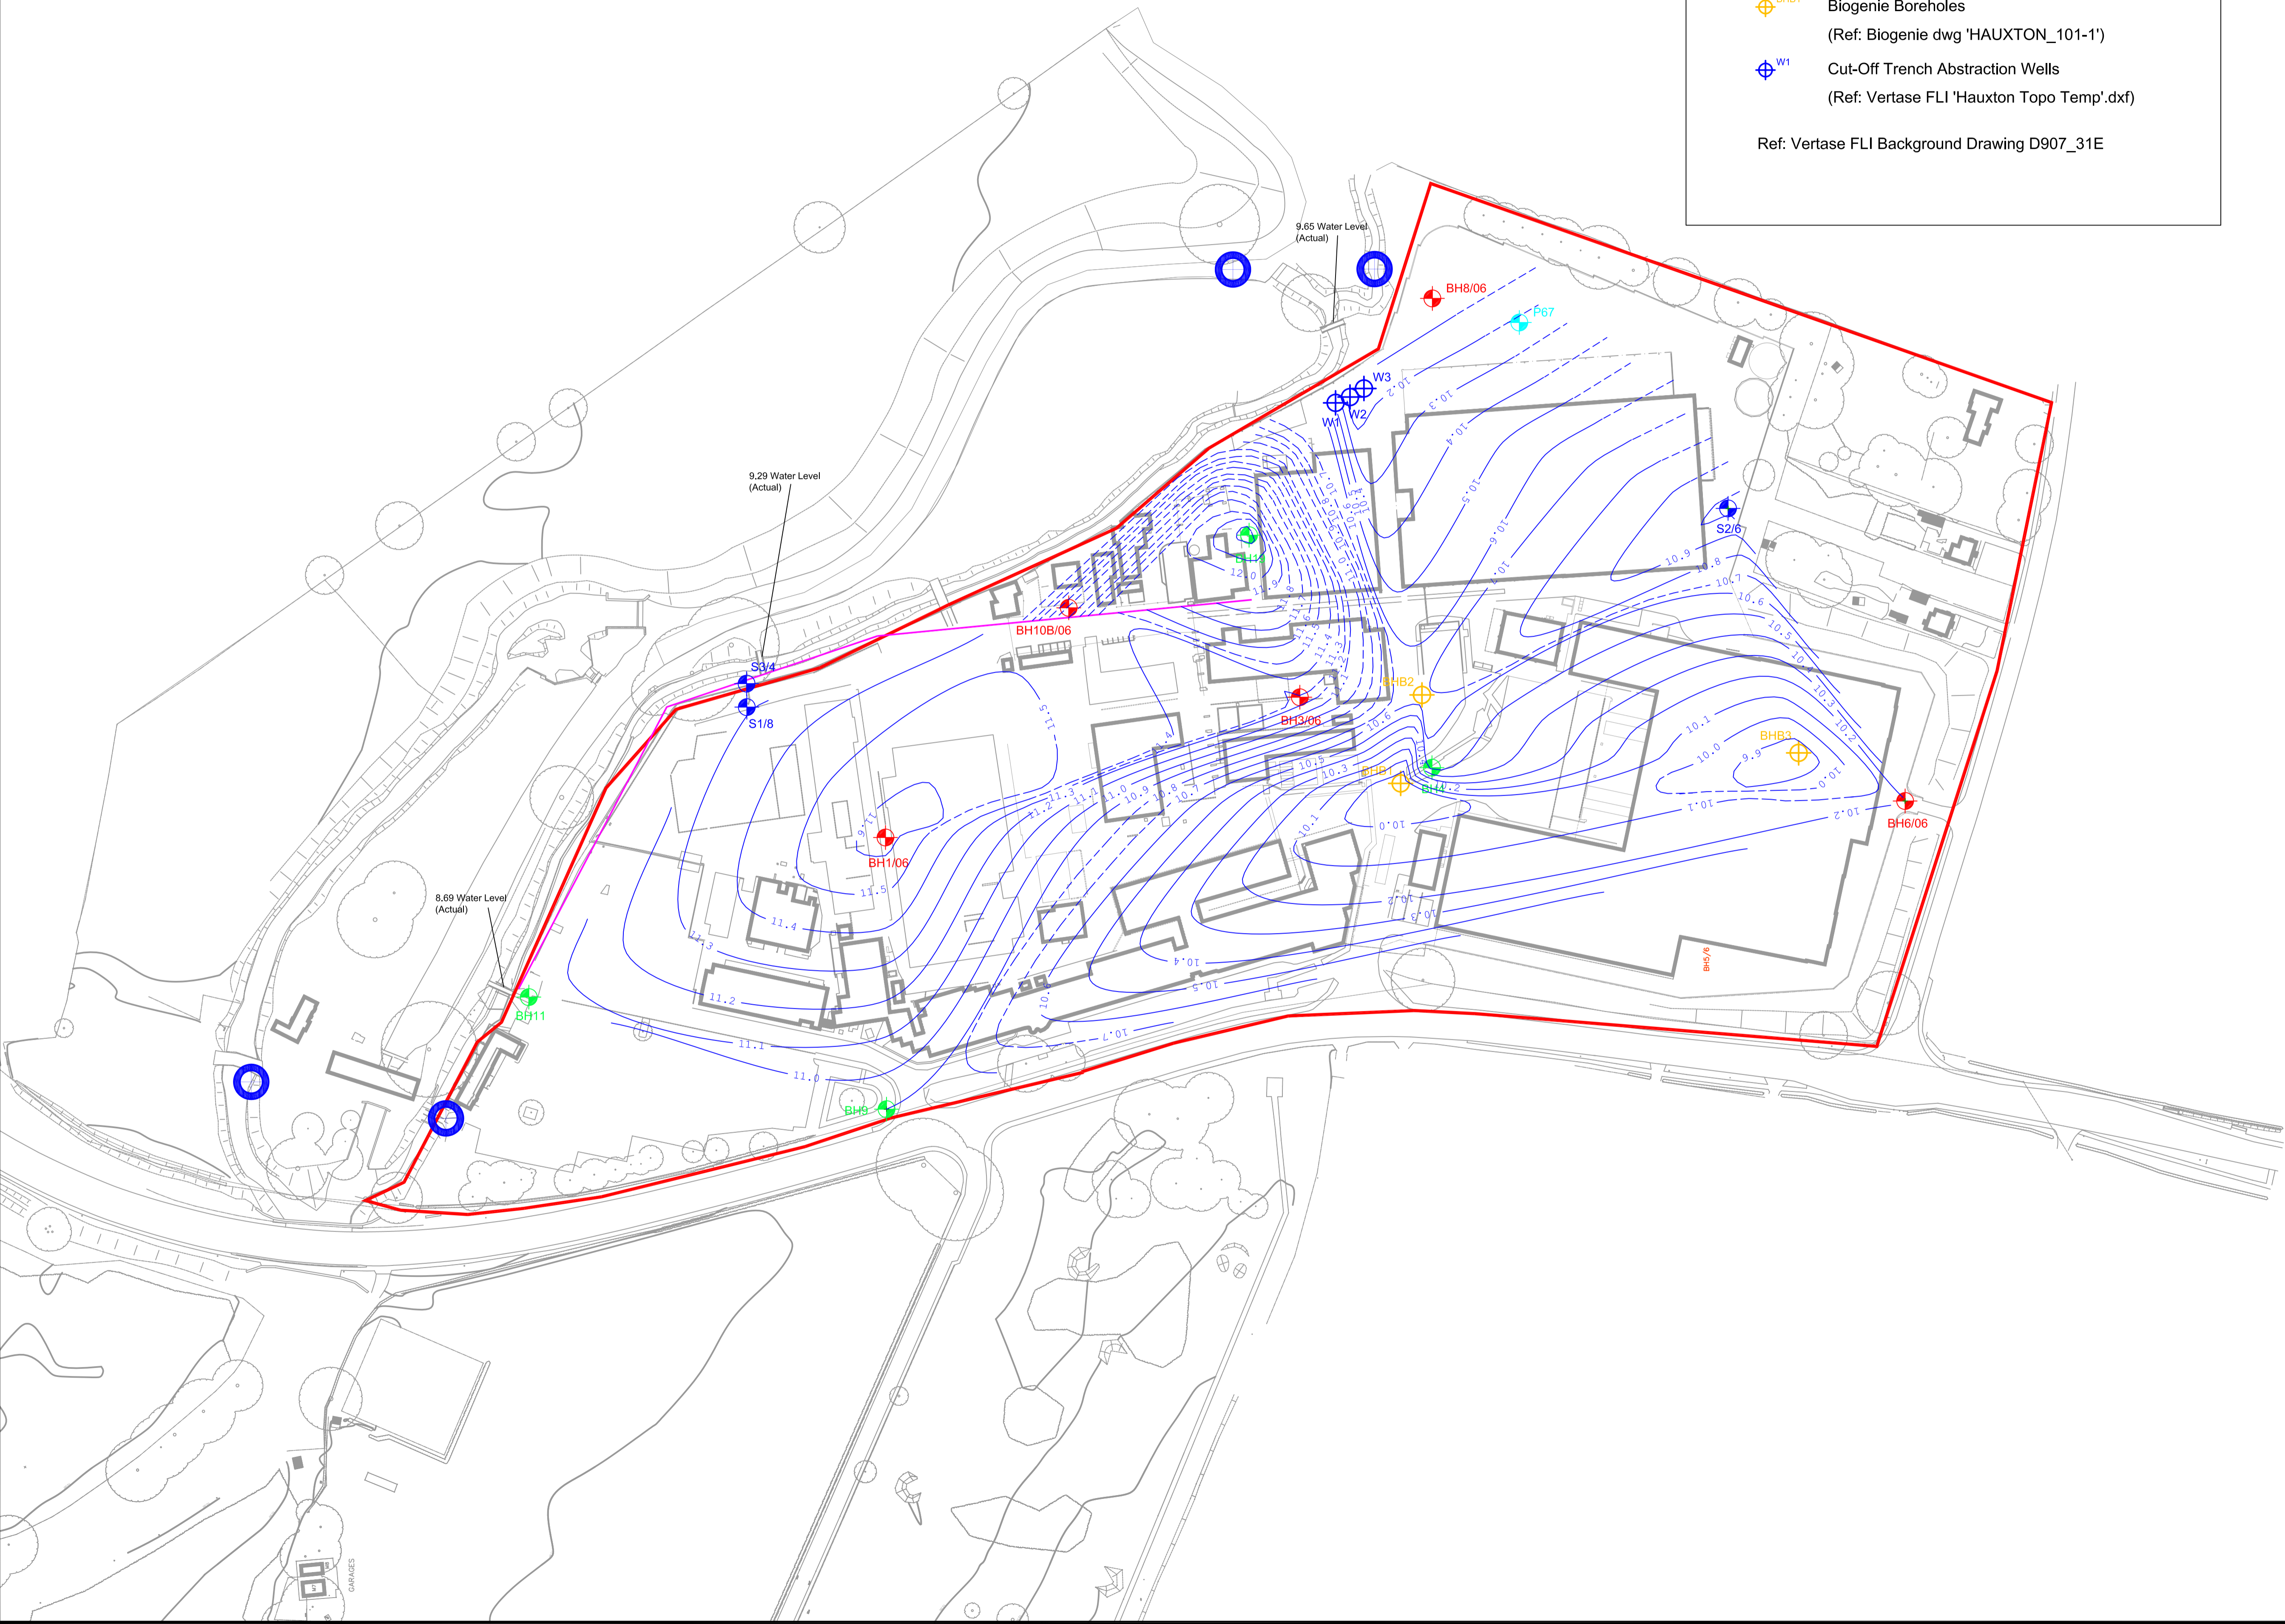
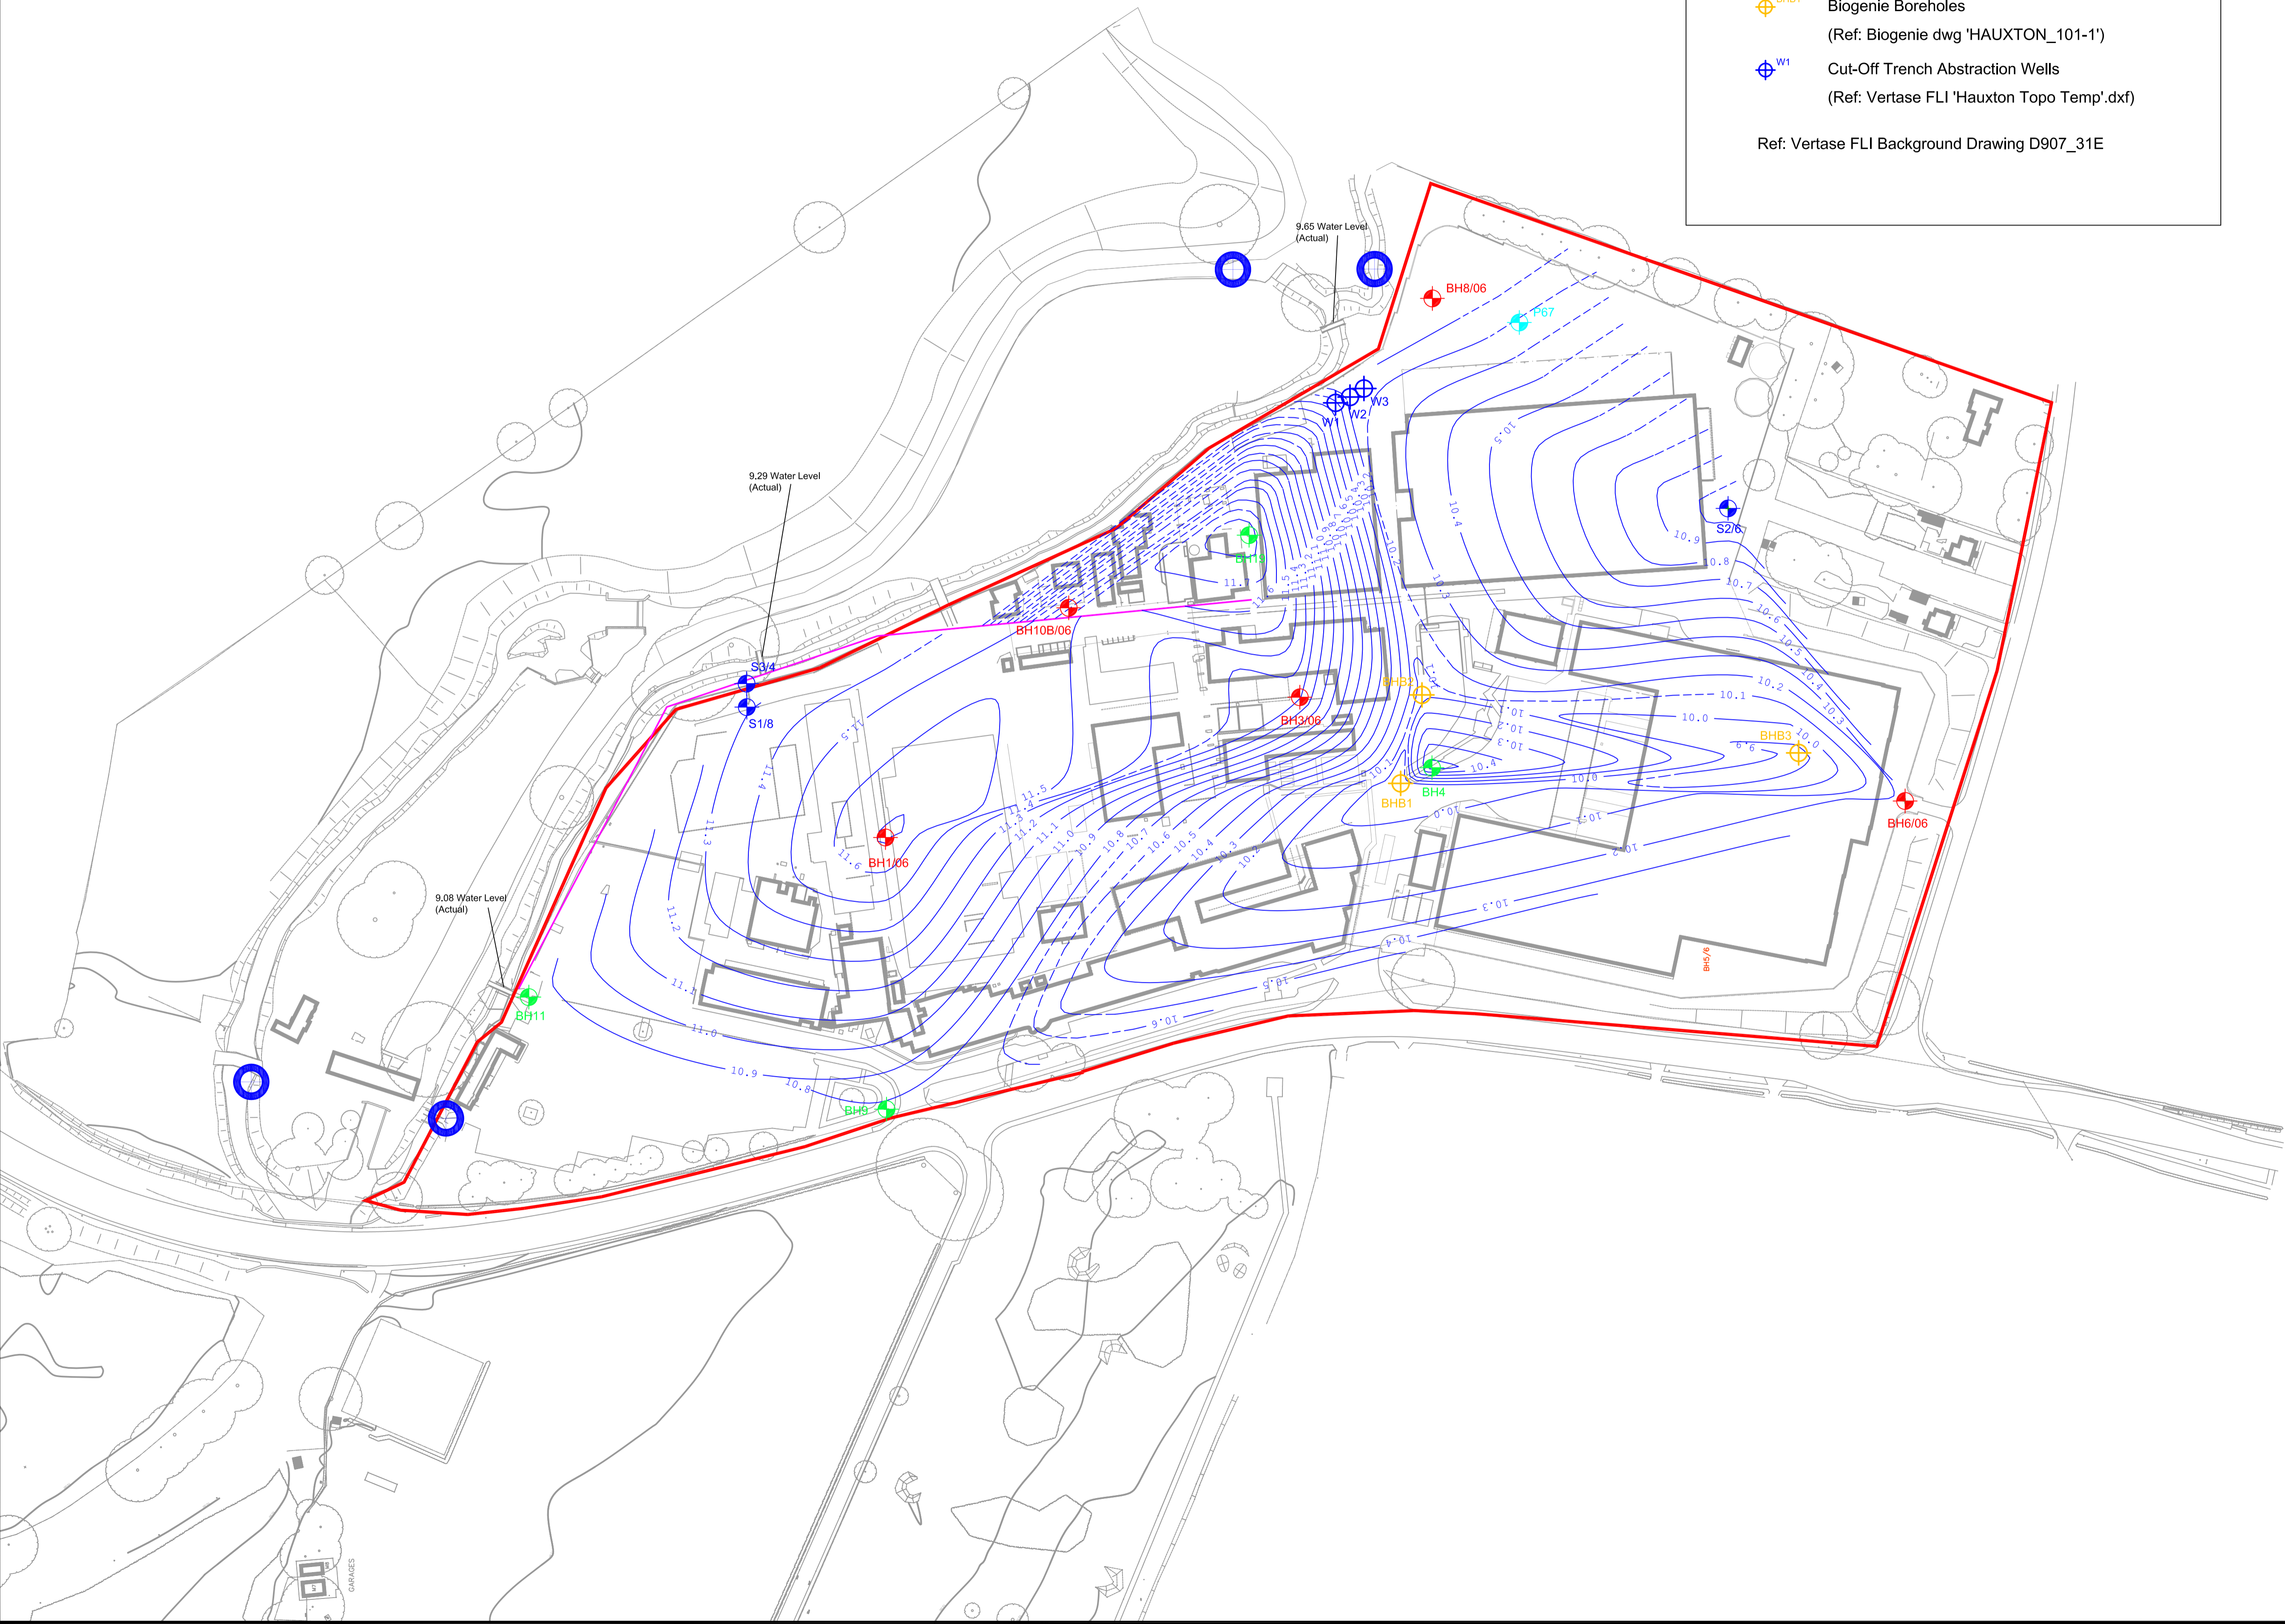
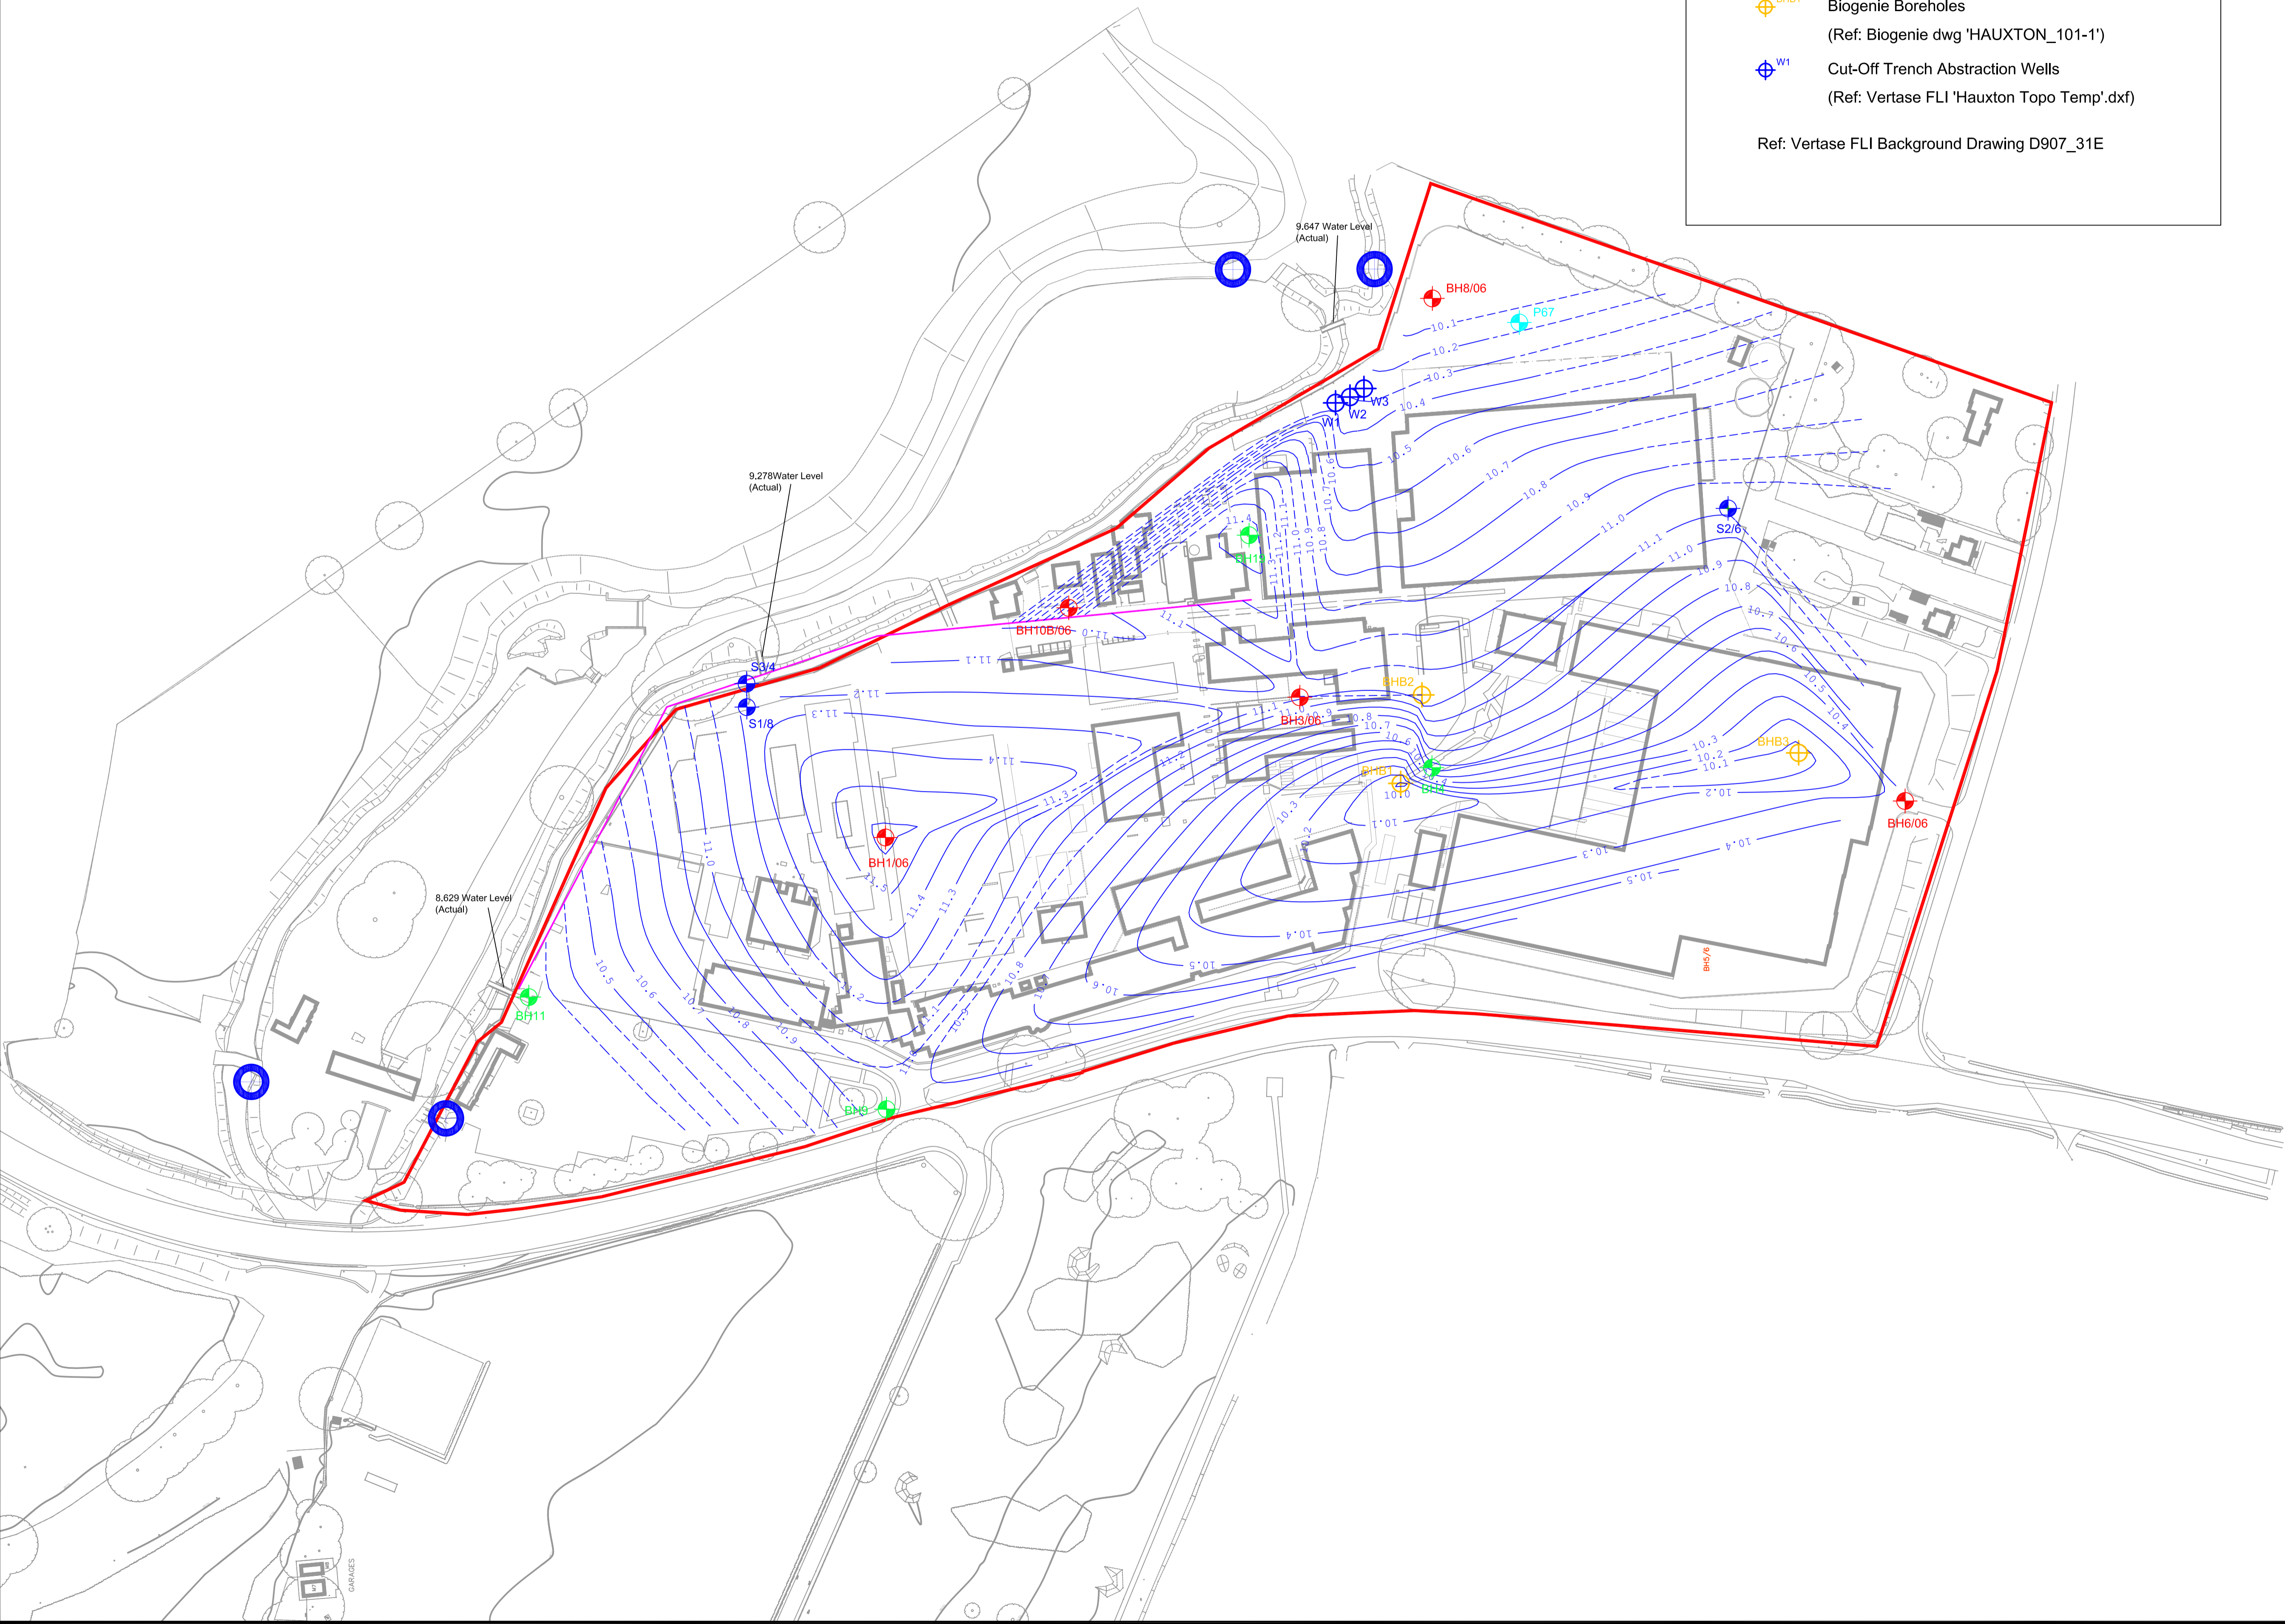
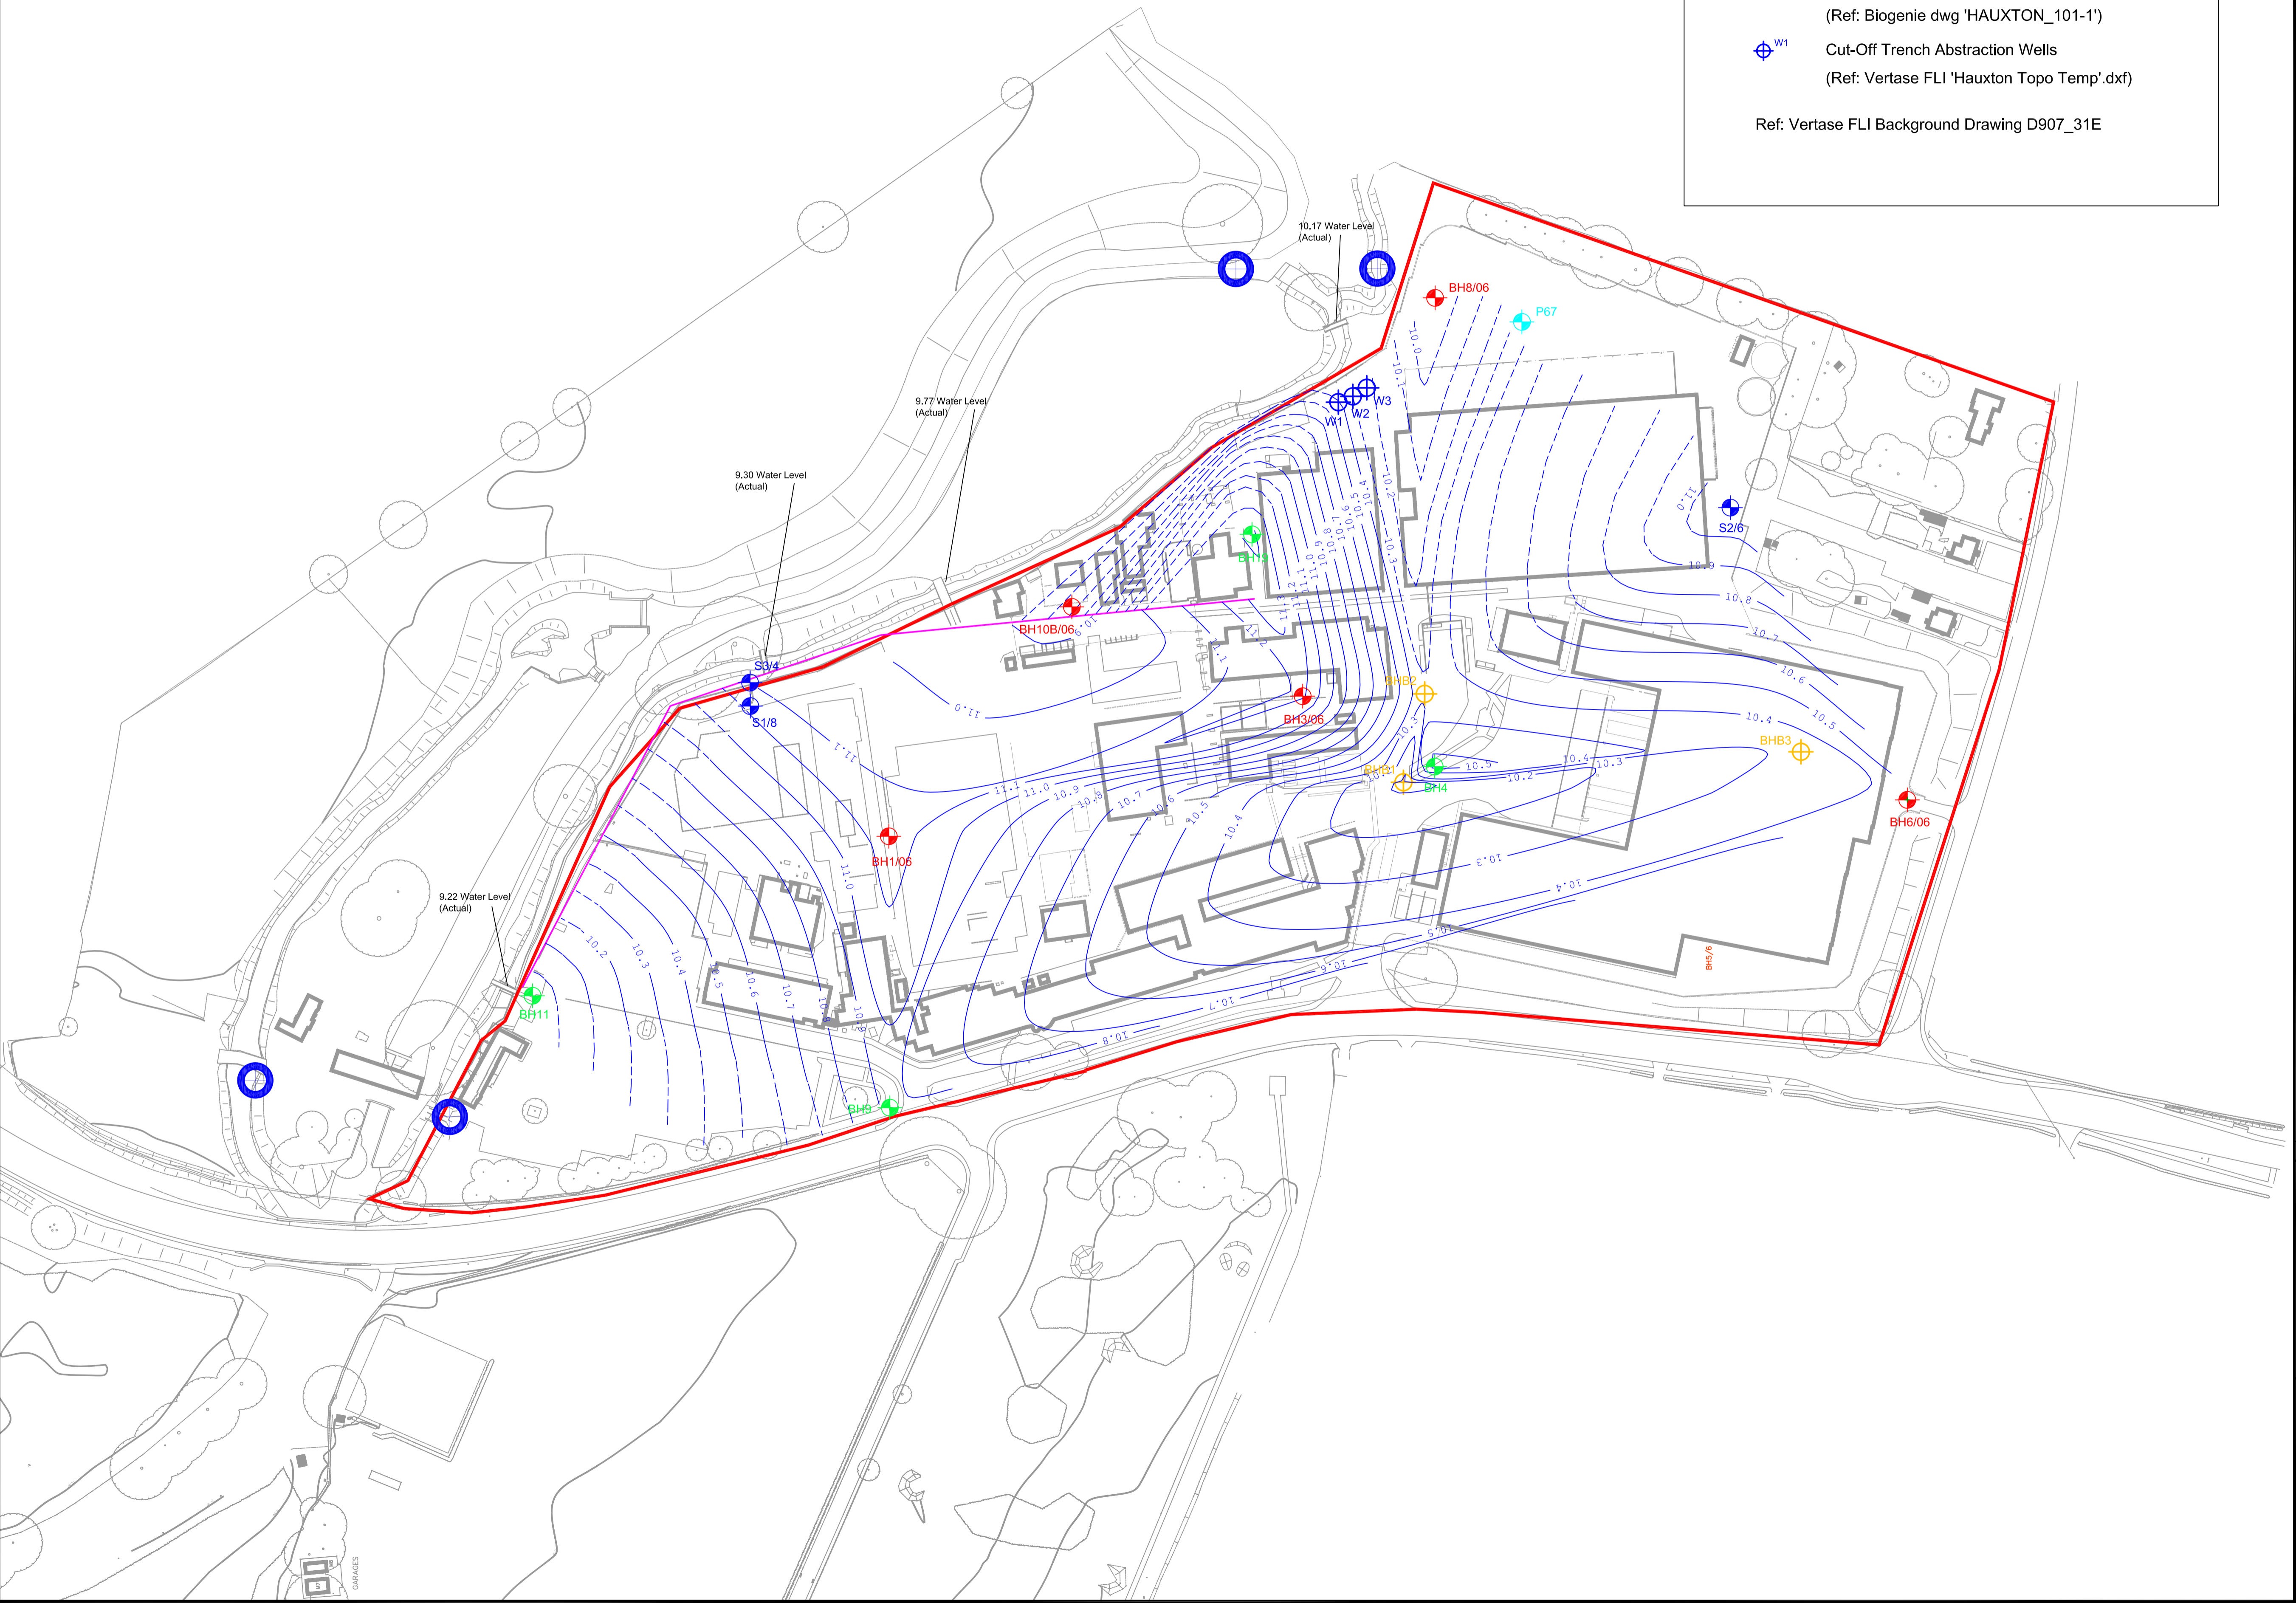
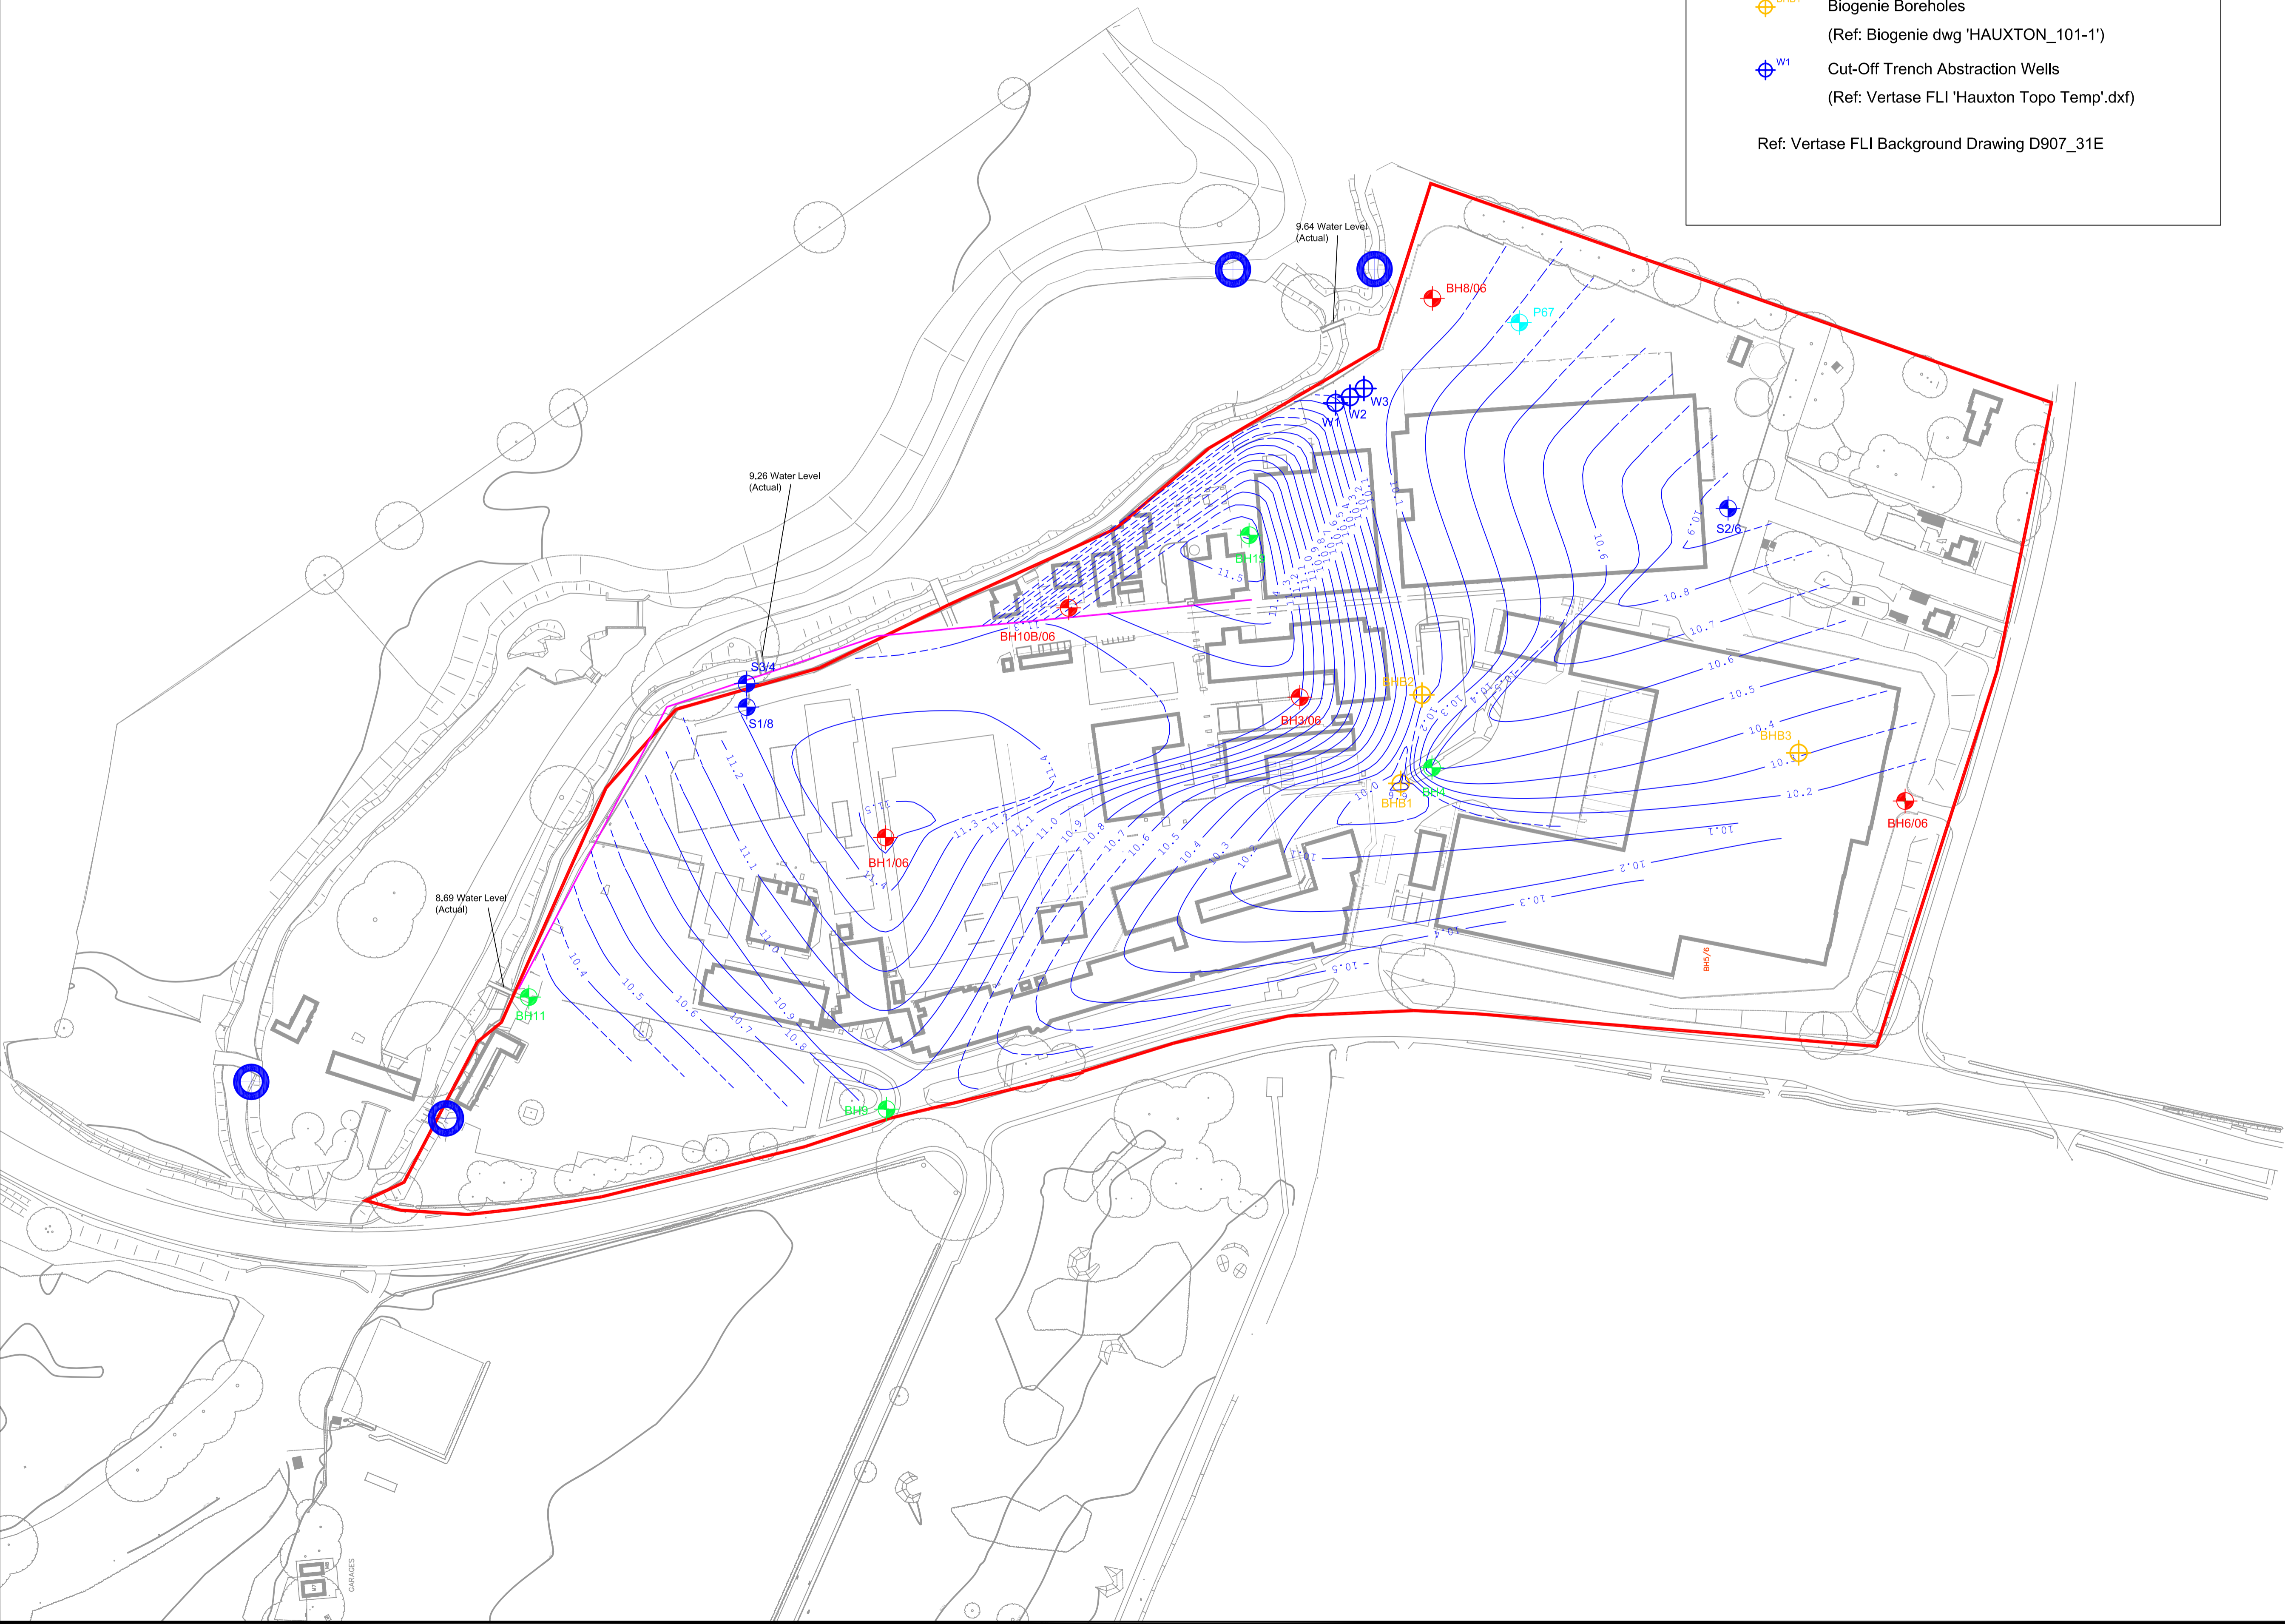
Appendix G
Groundwater Contour Plots

The five contour plots constructed (Appendix G) illustrate that there has been very little change in groundwater levels during the initial phase of works, the contour plots are very similar in pattern and actual measured values to the baseline data established throughout 2008 and 2009. The remediation works are not having a significant impact on the groundwater levels across the site, and therefore the groundwater has remained in a relatively static condition during the initial phase of excavations on site.
