# Environmental Monitoring Report

31/05/2010-04/07/2010

Former Bayer Crop Science Site  
Hauxton  
Cambridgeshire

Harrow Estates Plc

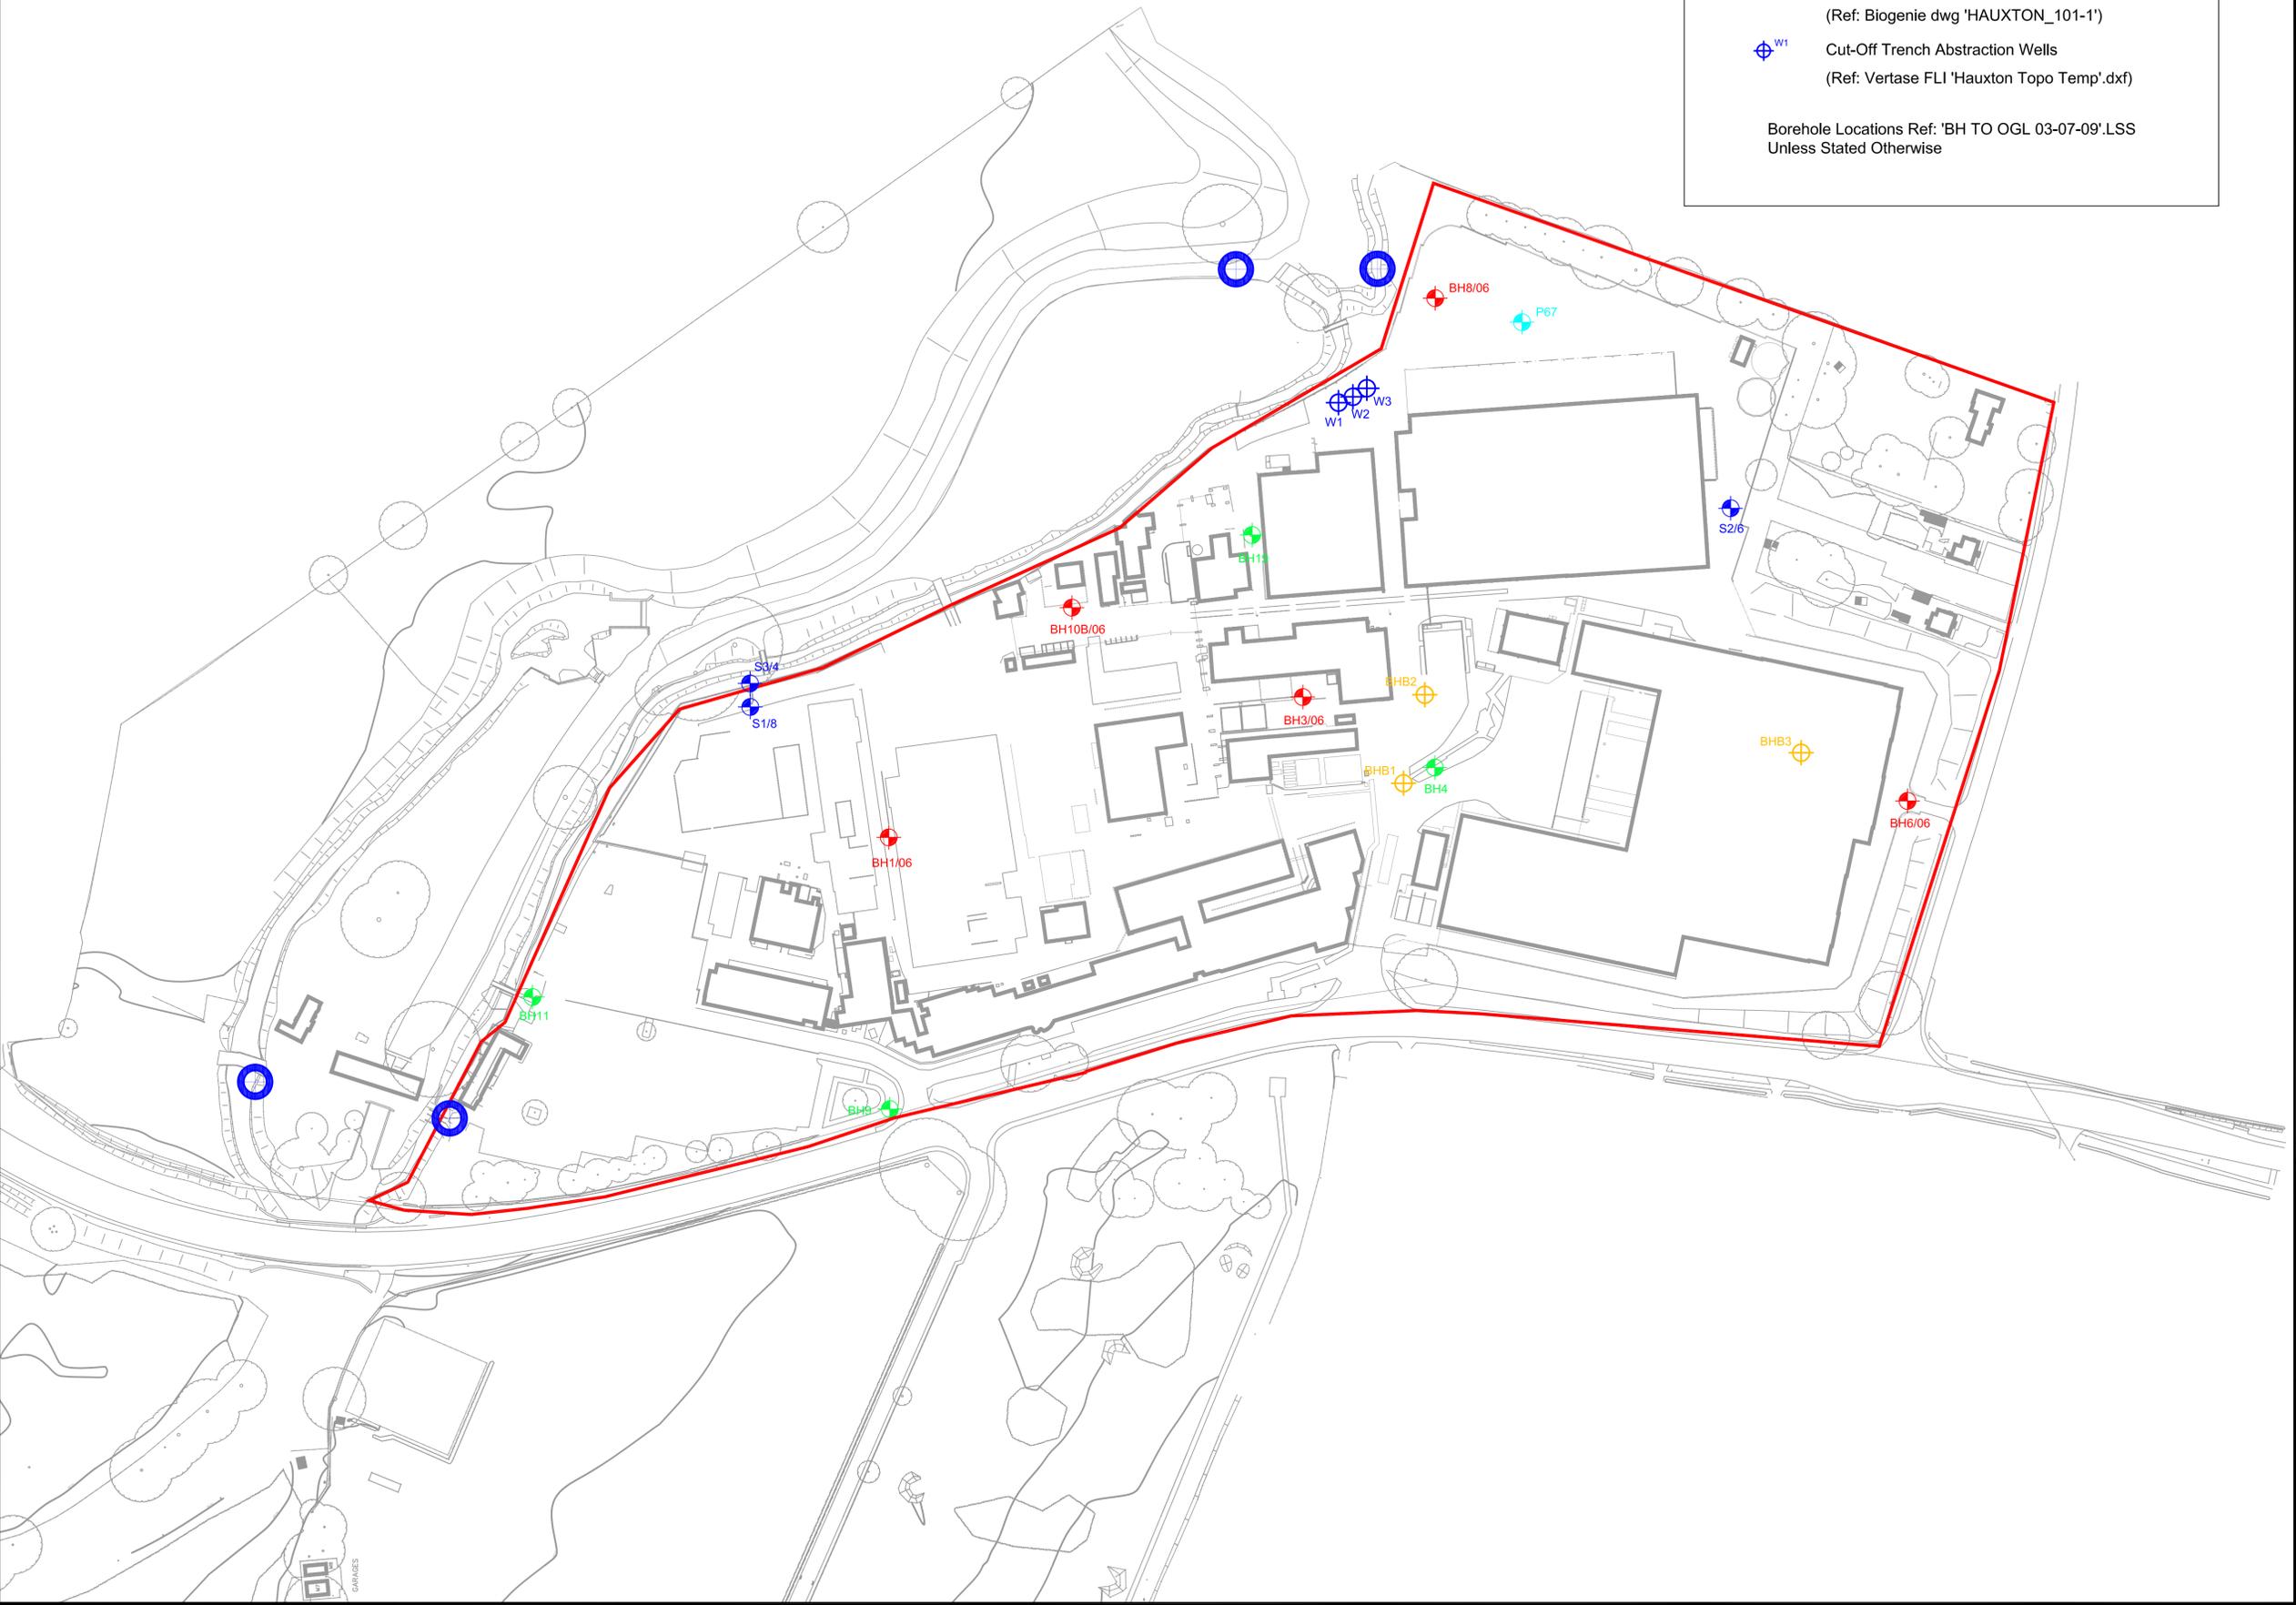
Dwg: D907_31	Contract: 907BRI	Scale: 1:1000
--------------	------------------	---------------

Borehole Locations Ref: 'BH TO OGL 03-07-09'.LSS  
Unless Stated Otherwise

E	BHB1,BHB2,BHB3, W1,W2,W3,BH3-06 & BH08-06 Added (BH3-06 & BH08-06 Ref:D907_31 Iss 0)	MRG	17-08-09
D	BH1 Removed & BH19 Added	MRG	07-07-08
C	BH1 Added	JWH	11 June 2008
B	BH5/06 Erased S2/6 Added	JWH	09 June 2008
A	Boreholes Erased	JWH	14 May 2008
	FIRST ISSUE		23 April 2008

Groundwater levels are recorded within at least 11 borehole locations onsite on a daily basis, to ensure the groundwater beneath the site remains in a static condition during the remediation works and does not pose a risk to surface and groundwater bodies beyond the site boundary.

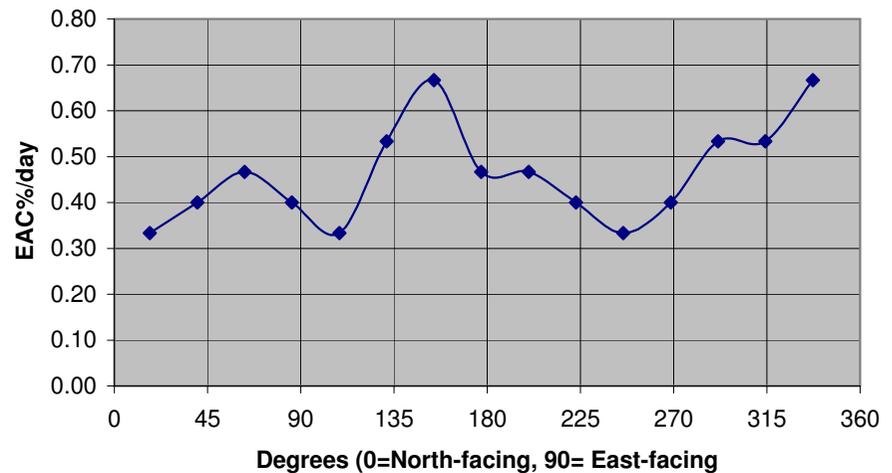
EAC%/day vs Orientation

Note: Cells coloured yellow are inputs.  
 The rest are either constants or calculated values.  
 The calculation is based on taking readings at 40mm intervals along the sticky pad.

### Gauge Number - NE1 location 907BRI

X Axis mm	Meter	Angle deg	EAC%/day
20	84	337	0.40
40	83	314	0.47
60	83	291	0.47
80	82	269	0.53
100	80	246	0.67
120	81	223	0.60
140	80	200	0.67
160	80	177	0.67
180	81	154	0.60
200	82	131	0.53
220	83	109	0.47
240	84	86	0.40
260	83	63	0.47
280	82	40	0.53
300	82	17	0.53

Directional dust deposition gauges at the six monitoring locations are analysed every fortnight for Effective Area Coverage (EAC) (percentage of dust deposition relating to the potential to cause nuisance), results generated by an external laboratory are presented in Appendix D.

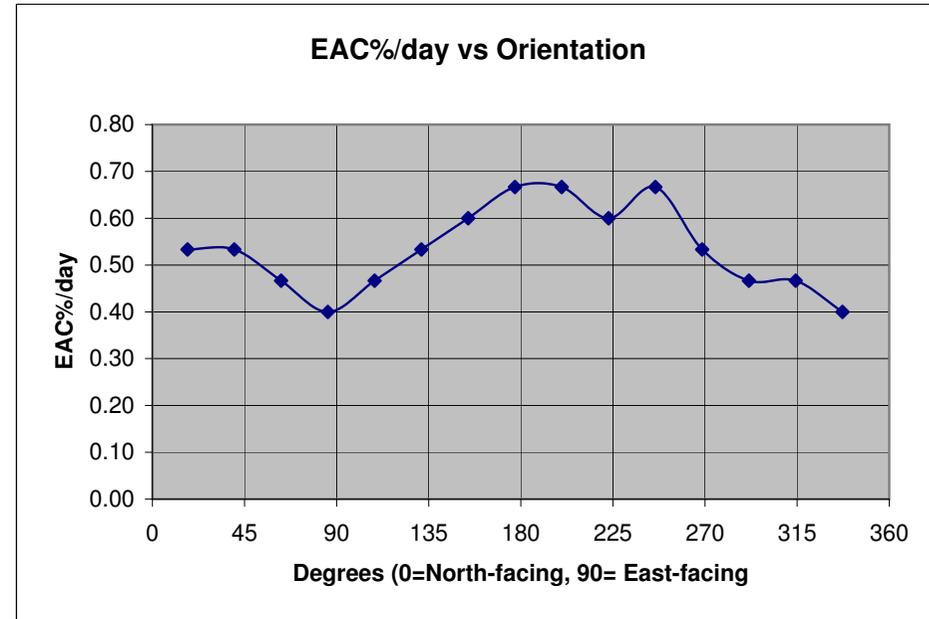
Note: Cells coloured yellow are inputs.  
 The rest are either constants or calculated values.  
 The calculation is based on taking readings at 40mm intervals along the sticky pad.

### Gauge Number - NE2 location 907BRI

X Axis mm	Meter	Angle deg	EAC%/day
20	83	337	0.47
40	85	314	0.33
60	84	291	0.40
80	82	269	0.53
100	81	246	0.60
120	81	223	0.60
140	83	200	0.47
160	84	177	0.40
180	86	154	0.27
200	87	131	0.20
220	85	109	0.33
240	87	86	0.20
260	85	63	0.33
280	85	40	0.33
300	84	17	0.40

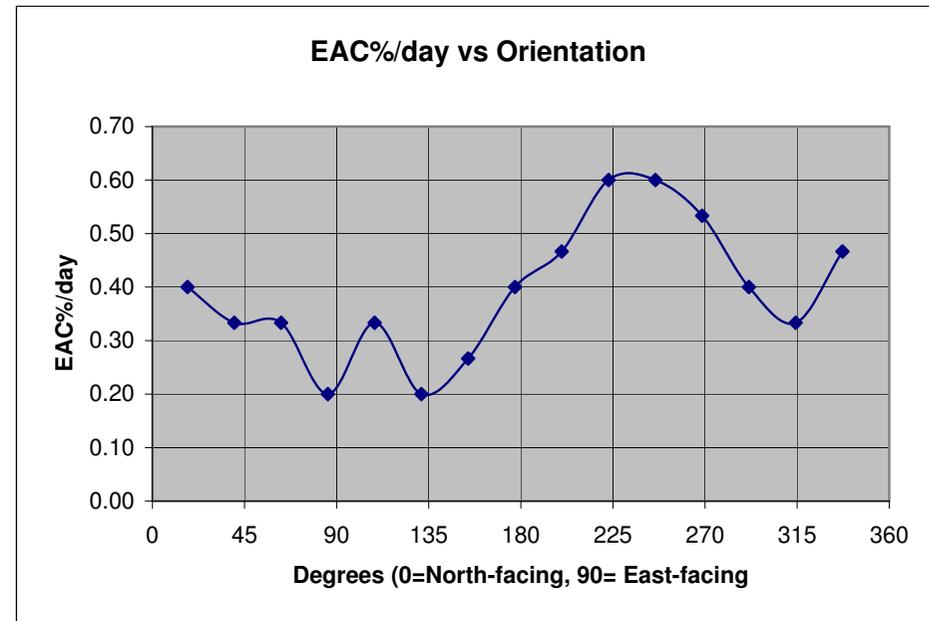
Note: Cells coloured yellow are inputs.  
 The rest are either constants or calculated values.  
 The calculation is based on taking readings at 40mm intervals along the sticky pad.

### Gauge Number - South location 907BRI

X Axis mm	Meter	Angle deg	EAC%/day
20	81	337	0.60
40	81	314	0.60
60	80	291	0.67
80	81	269	0.60
100	80	246	0.67
120	79	223	0.73
140	78	200	0.80
160	77	177	0.87
180	80	154	0.67
200	78	131	0.80
220	78	109	0.80
240	77	86	0.87
260	79	63	0.73
280	80	40	0.67
300	80	17	0.67

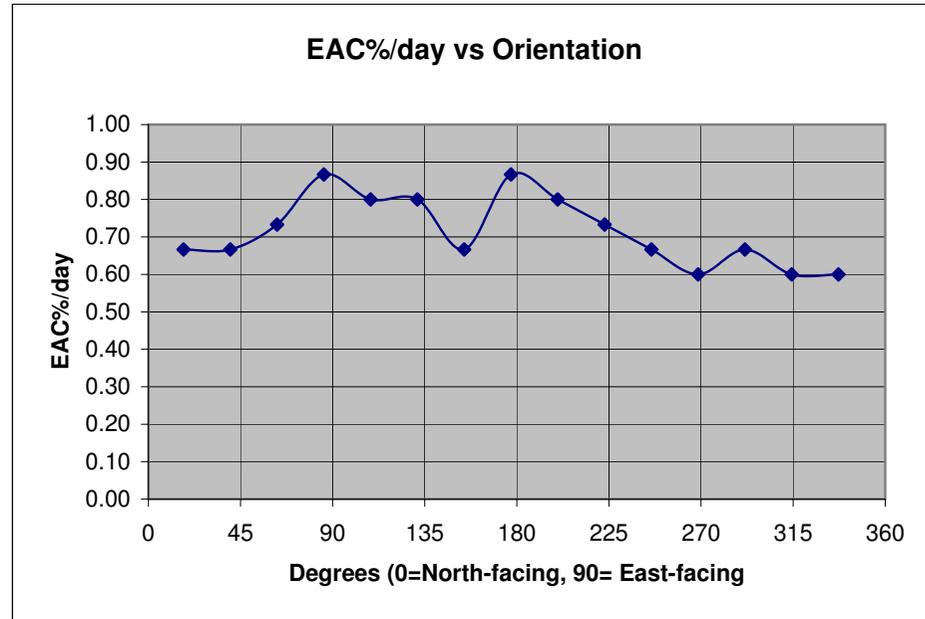
Note: Cells coloured yellow are inputs.  
 The rest are either constants or calculated values.  
 The calculation is based on taking readings at 40mm intervals along the sticky pad.

### Gauge Number - West location 907BRI

X Axis mm	Meter	Angle deg	EAC%/day
20	<b>83</b>	337	0.47
40	<b>80</b>	314	0.67
60	<b>78</b>	291	0.80
80	<b>79</b>	269	0.73
100	<b>77</b>	246	0.87
120	<b>74</b>	223	1.07
140	<b>73</b>	200	1.13
160	<b>72</b>	177	1.20
180	<b>73</b>	154	1.13
200	<b>72</b>	131	1.20
220	<b>74</b>	109	1.07
240	<b>77</b>	86	0.87
260	<b>78</b>	63	0.80
280	<b>81</b>	40	0.60
300	<b>81</b>	17	0.60

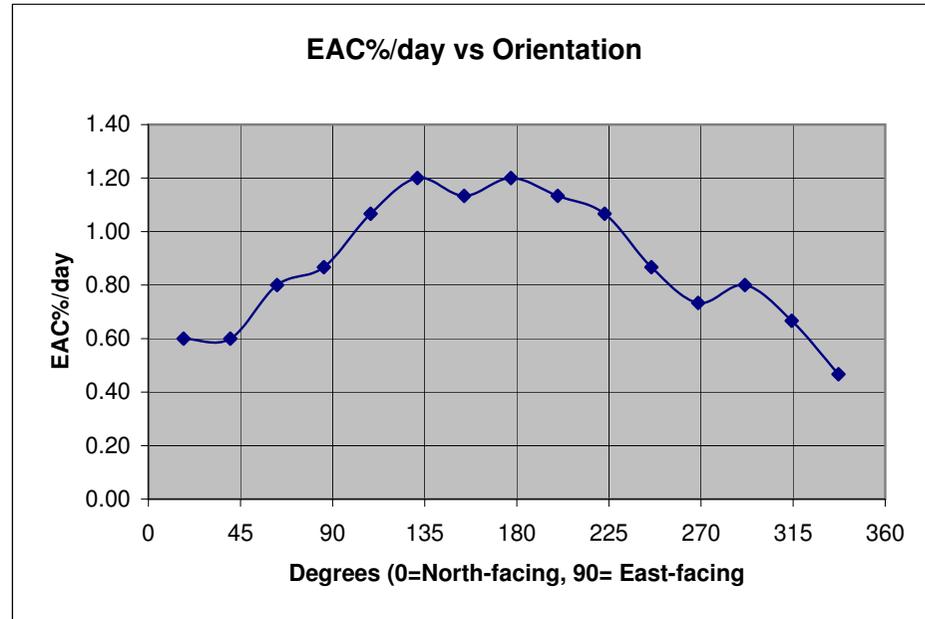
Note: Cells coloured yellow are inputs.  
 The rest are either constants or calculated values.  
 The calculation is based on taking readings at 40mm intervals along the sticky pad.

### Gauge Number - East location 907BRI

X Axis mm	Meter	Angle deg	EAC%/day
20	85	337	0.33
40	83	314	0.47
60	84	291	0.40
80	86	269	0.27
100	85	246	0.33
120	84	223	0.40
140	83	200	0.47
160	83	177	0.47
180	85	154	0.33
200	87	131	0.20
220	88	109	0.13
240	88	86	0.13
260	87	63	0.20
280	85	40	0.33
300	84	17	0.40

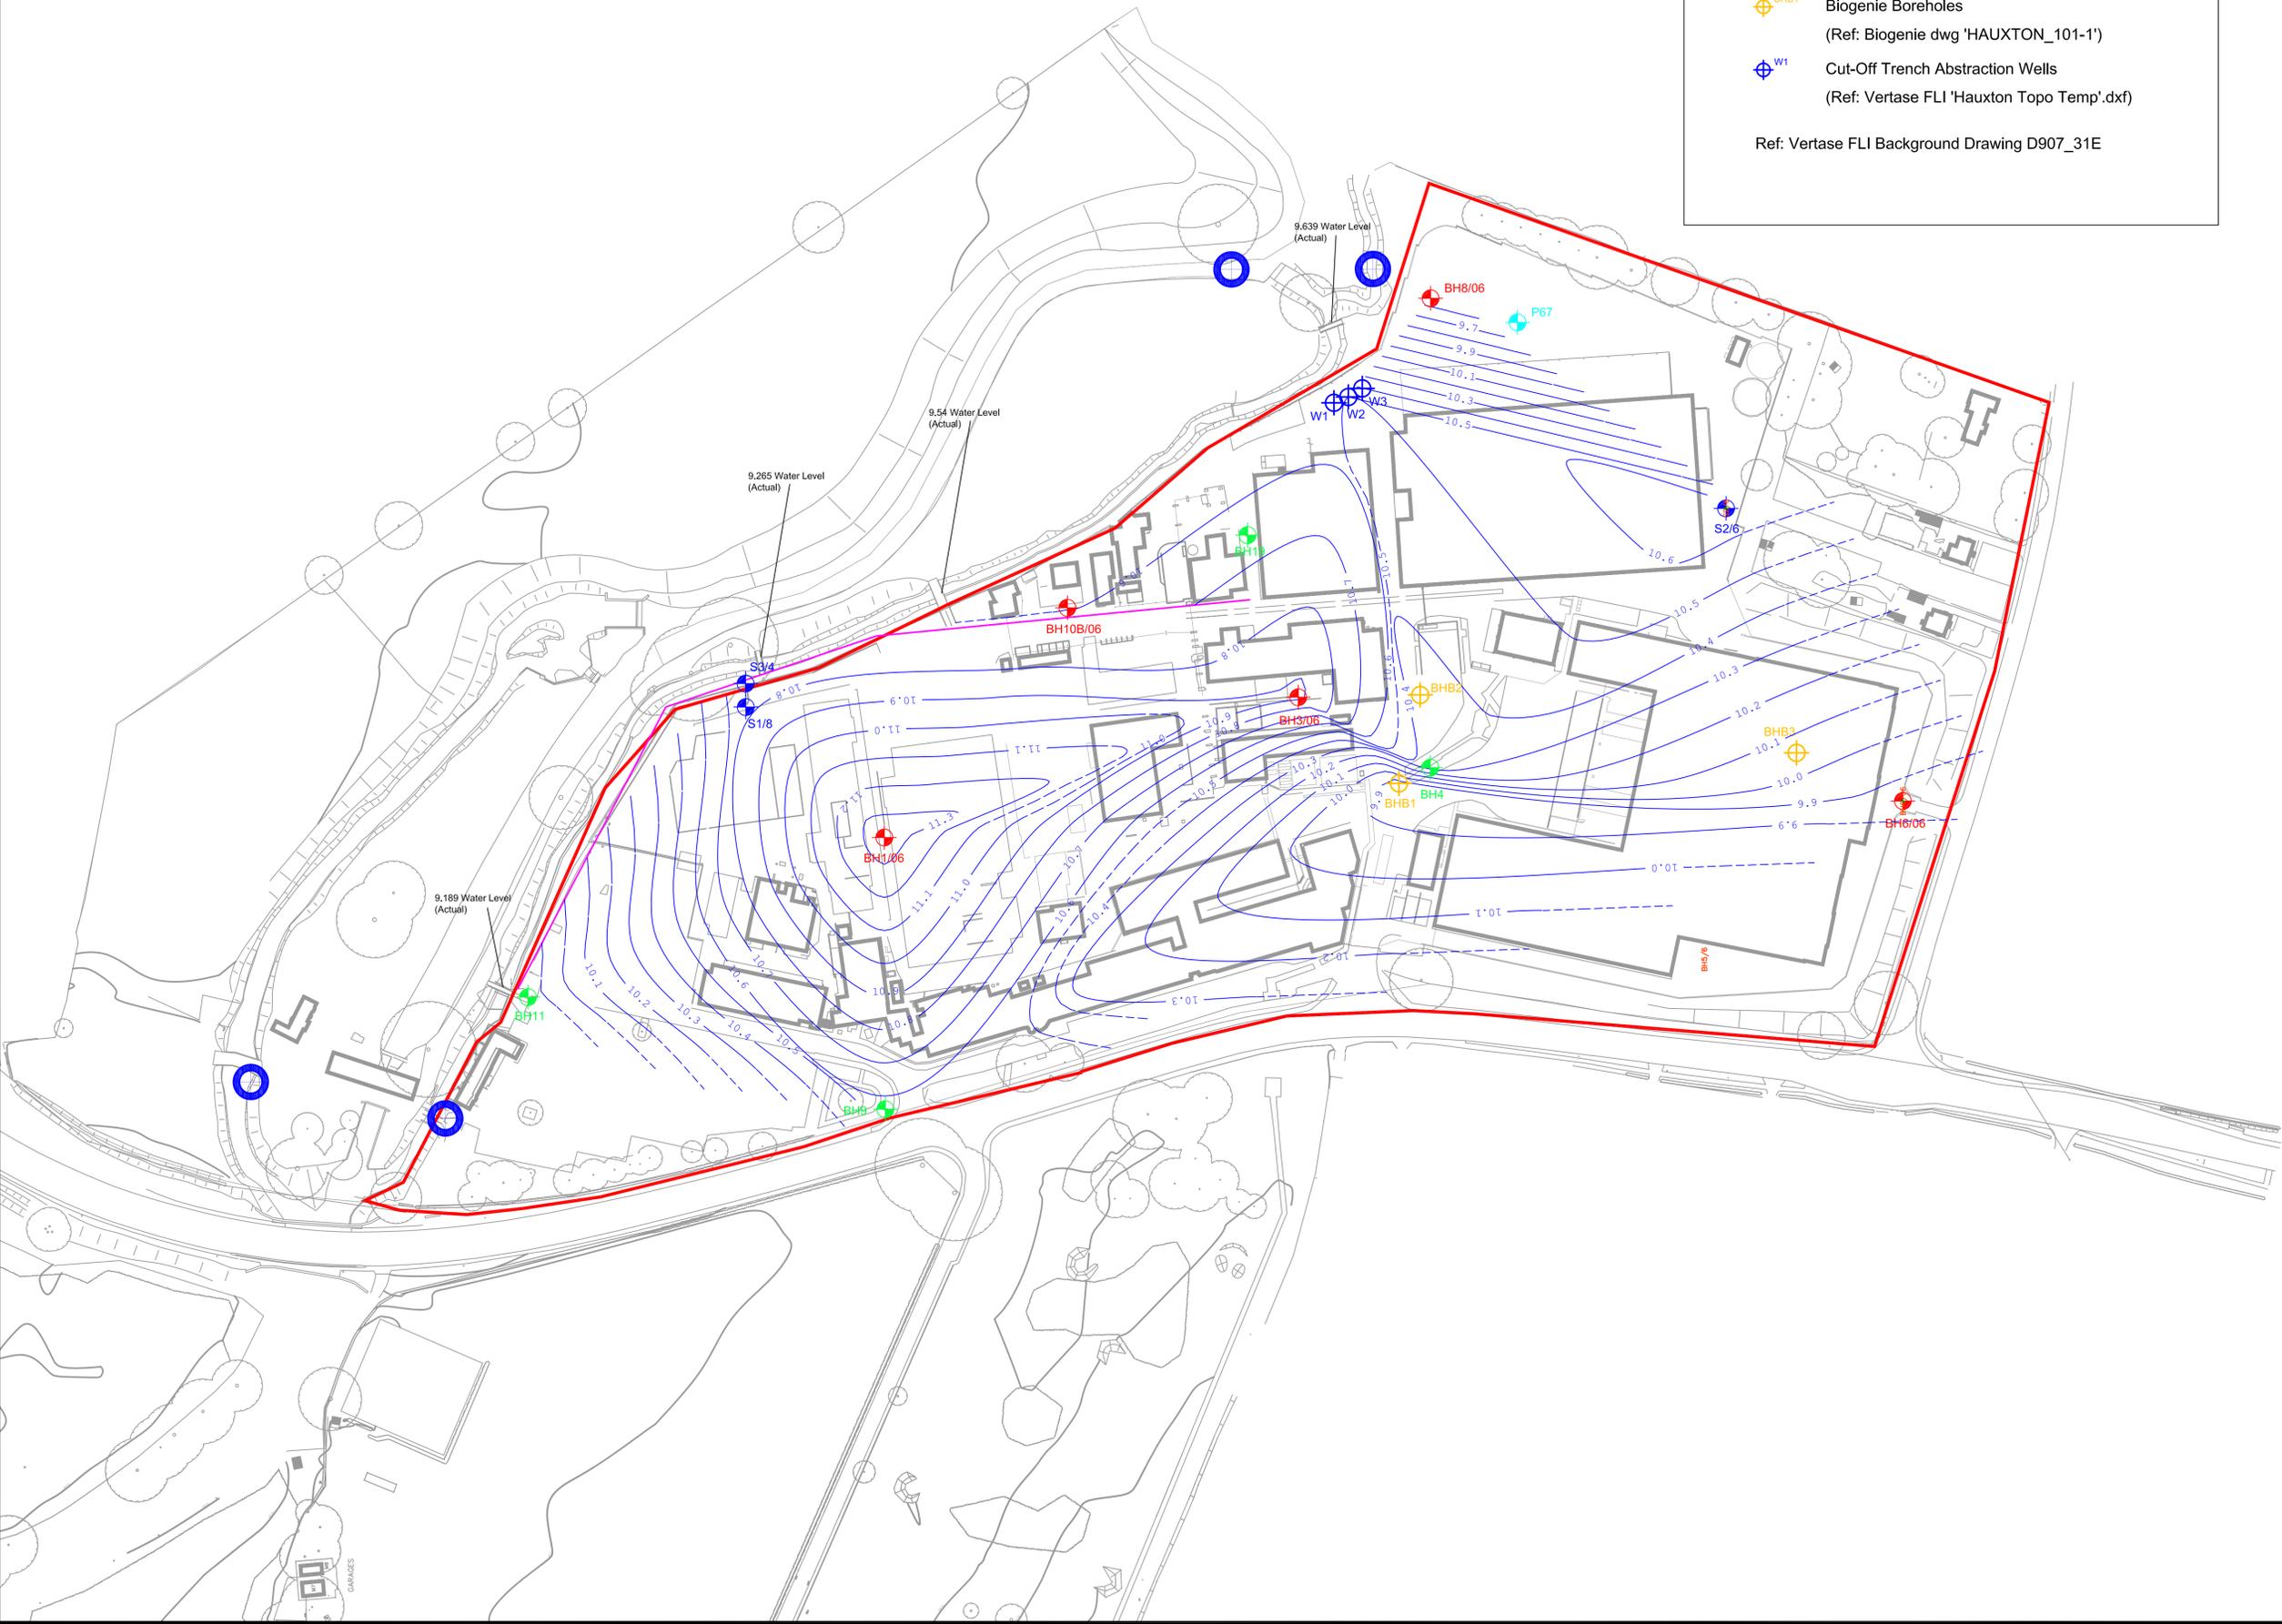
Ref: Vertase FLI Background Drawing D907\_31E

Rev.	Description	Revised By	Date
	FIRST ISSUE		15-06-10

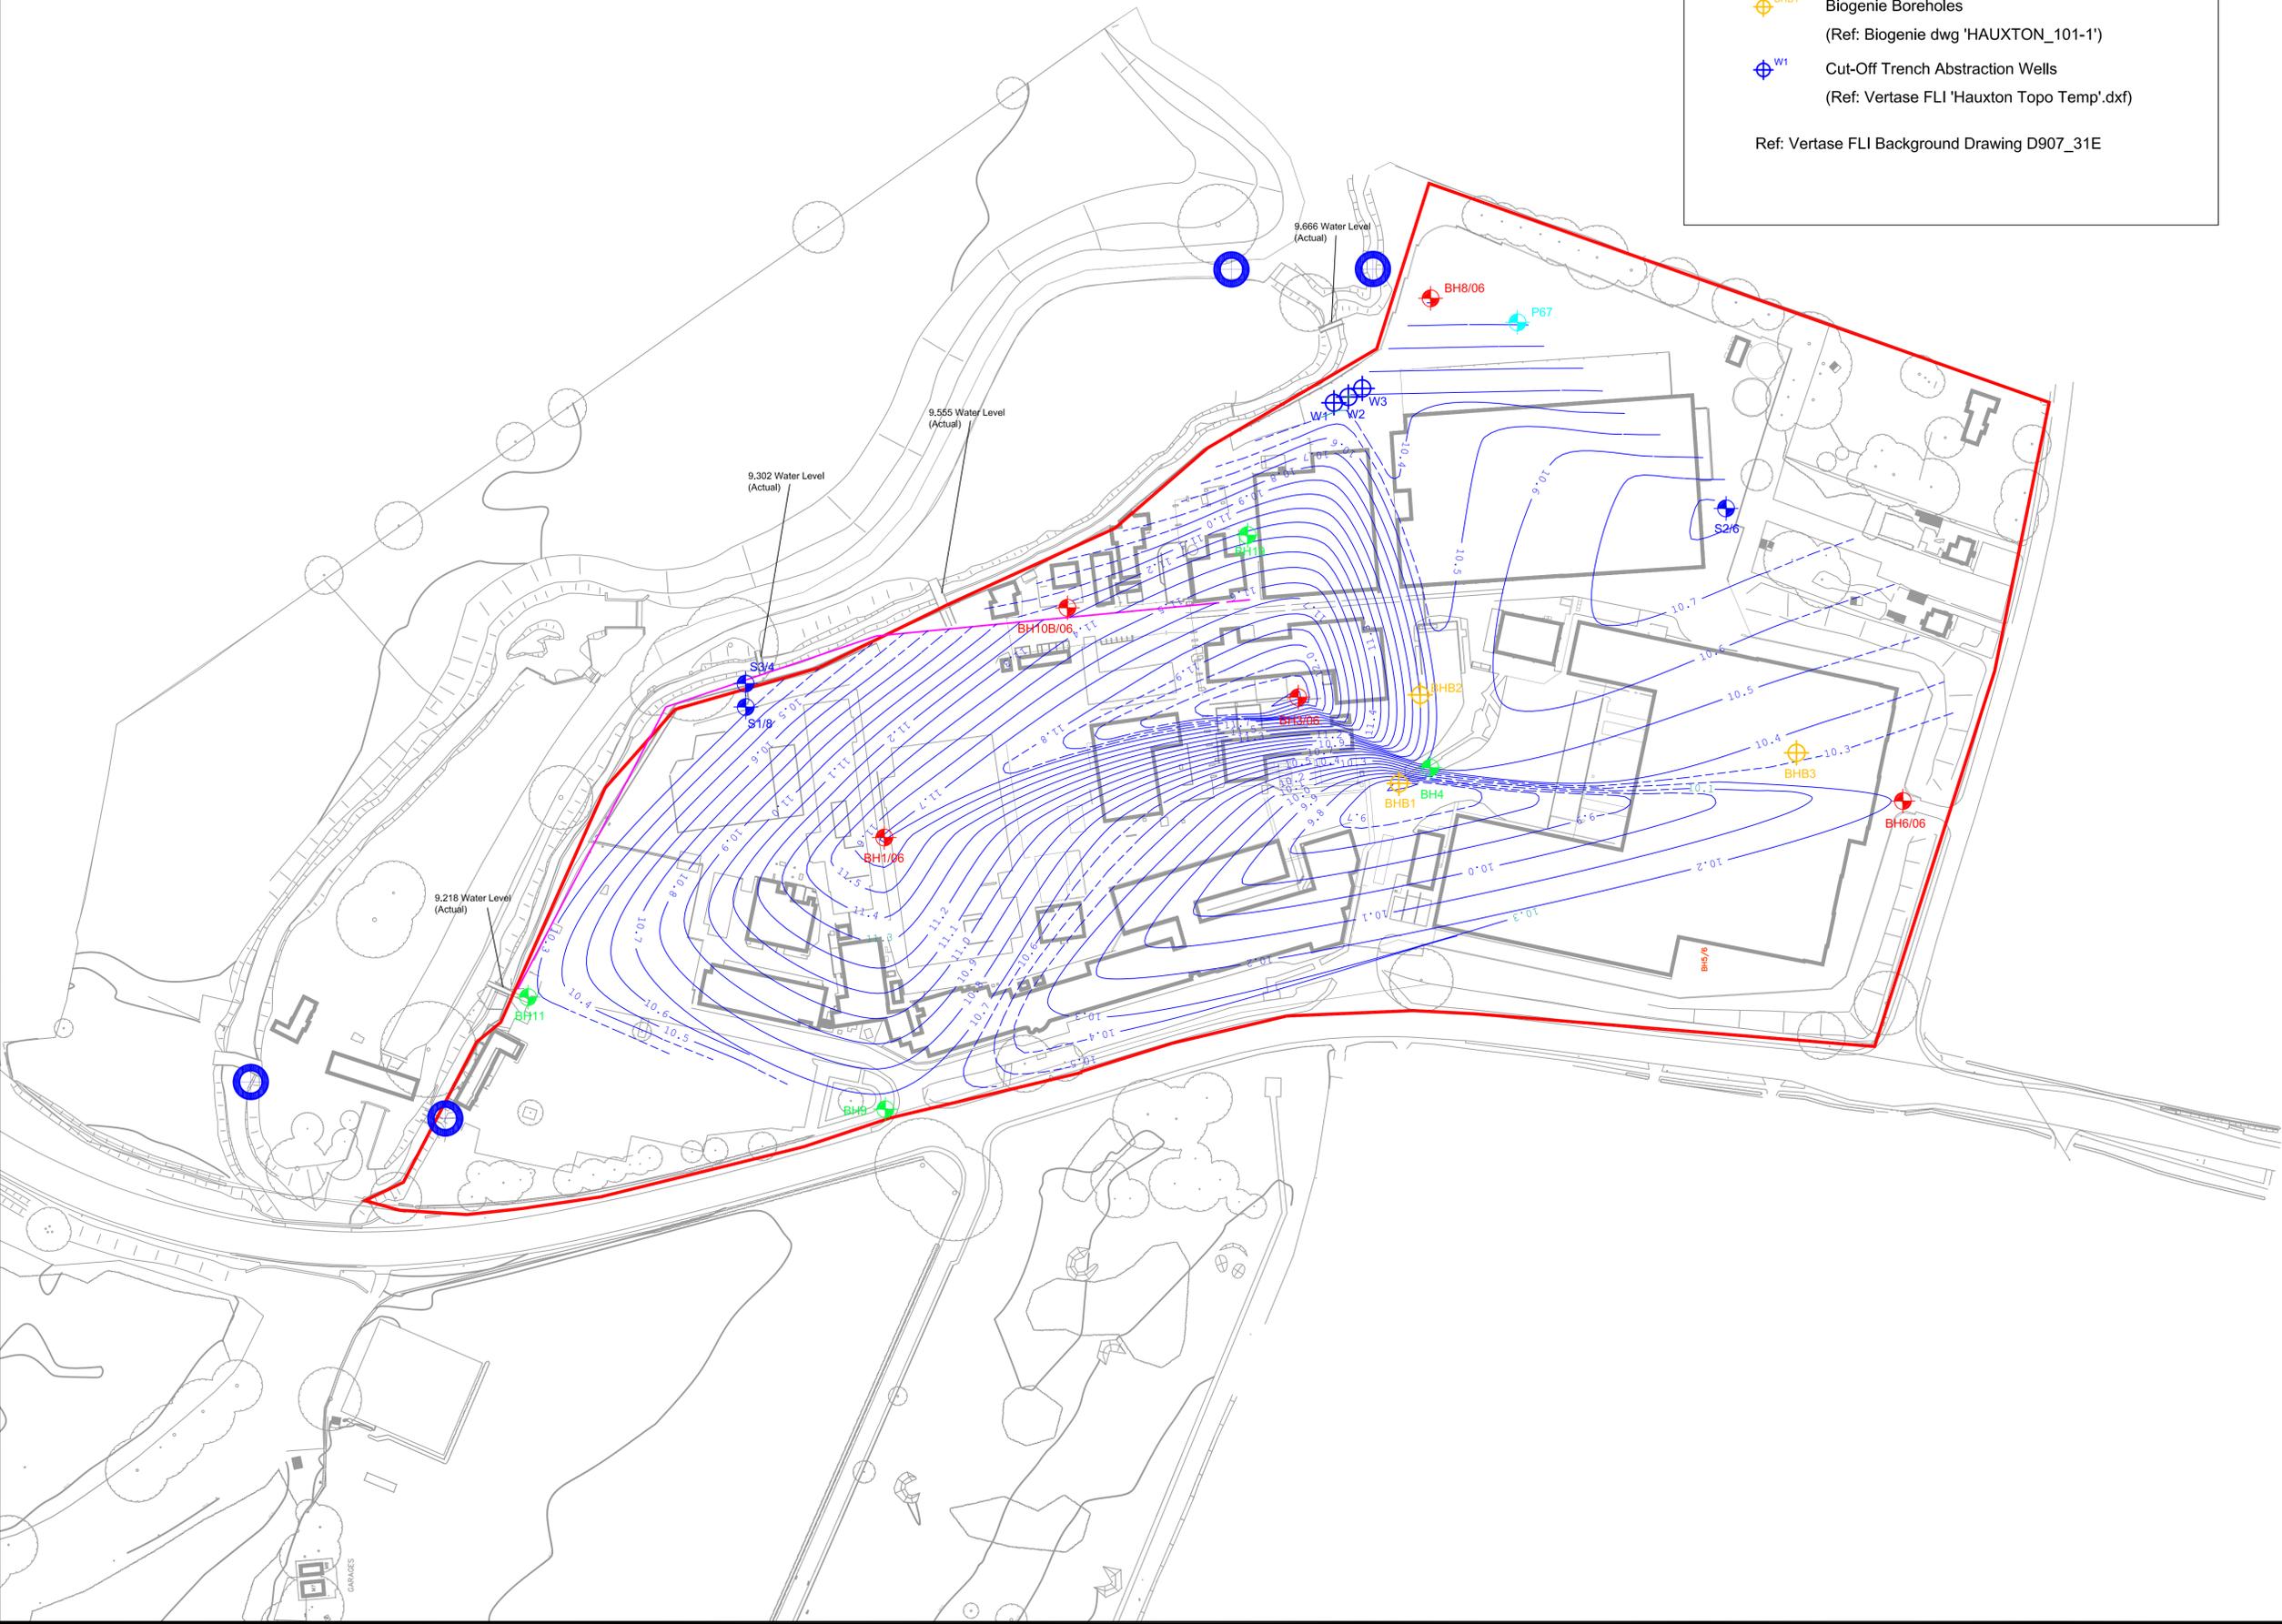
Ref: Vertase FLI Background Drawing D907\_31E

Rev.	Description	Revised By	Date
	FIRST ISSUE		18-06-10

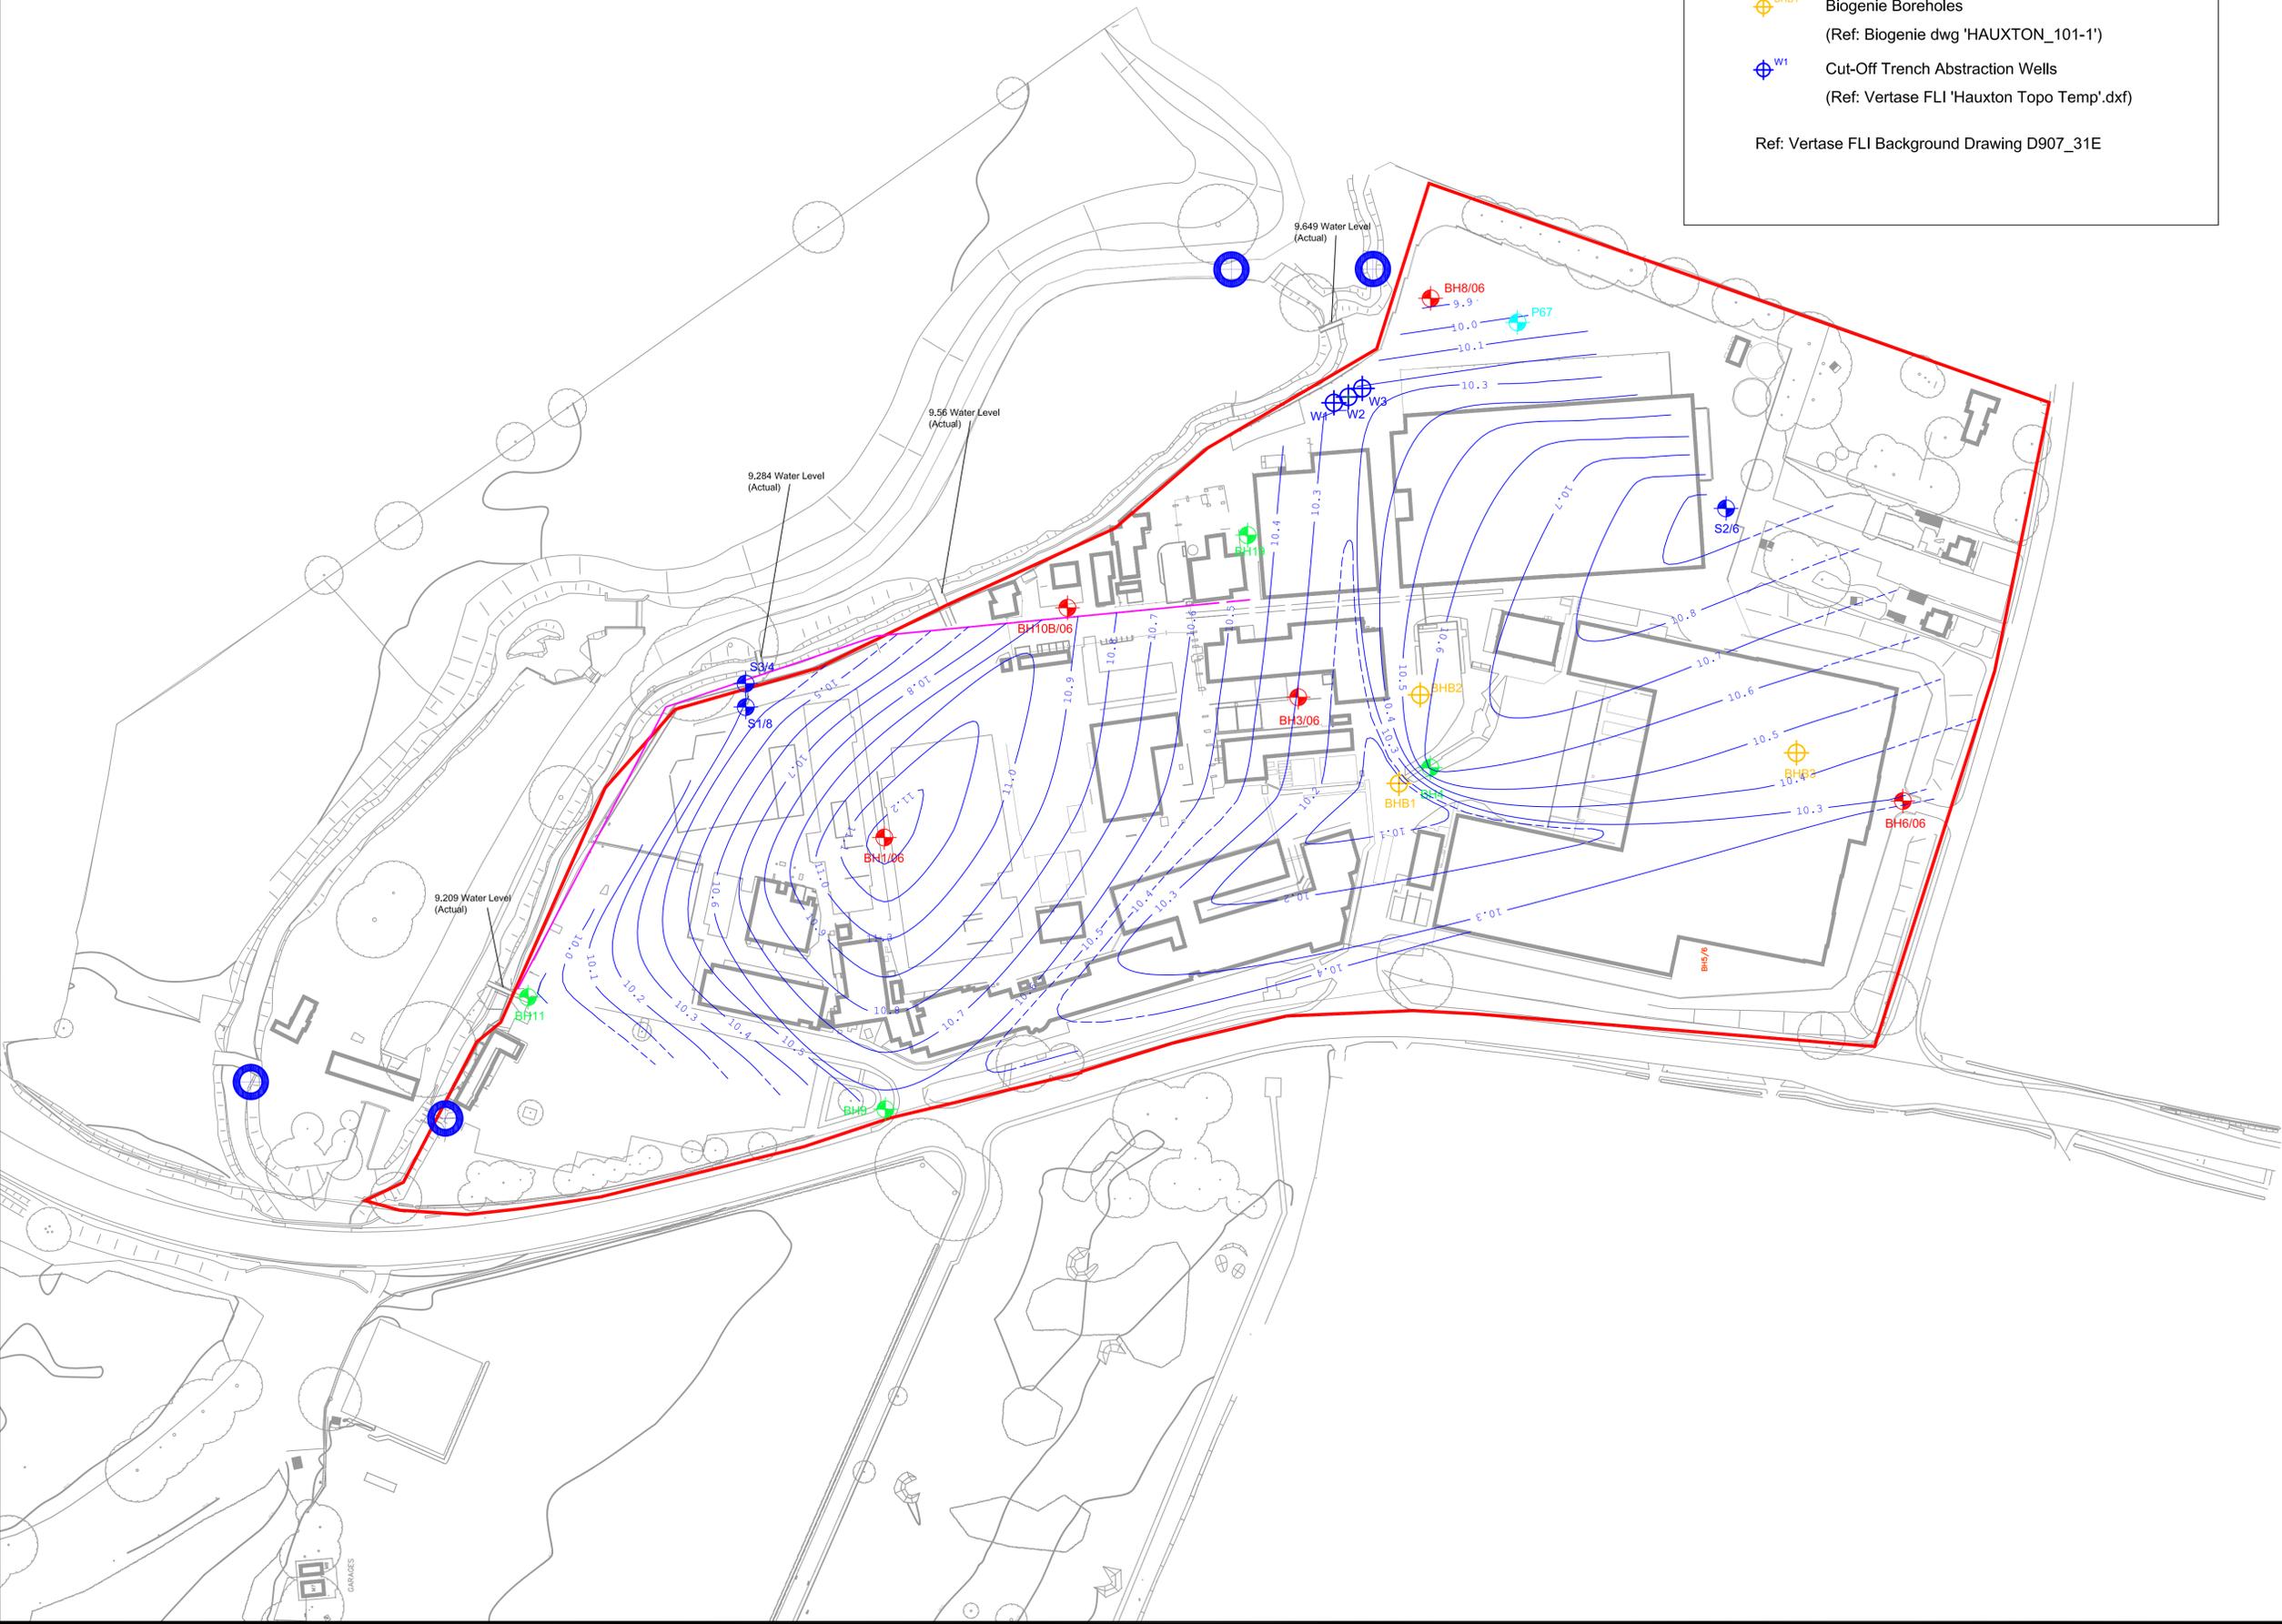
Ref: Vertase FLI Background Drawing D907\_31E

Rev.	Description	Revised By	Date
	FIRST ISSUE		22-06-10
