Environmental Monitoring Report

Reporting Period
03/01/2011-30/01/2011

Former Bayer Crop Science Site
Hauxton
Cambridgeshire

10th February 2011

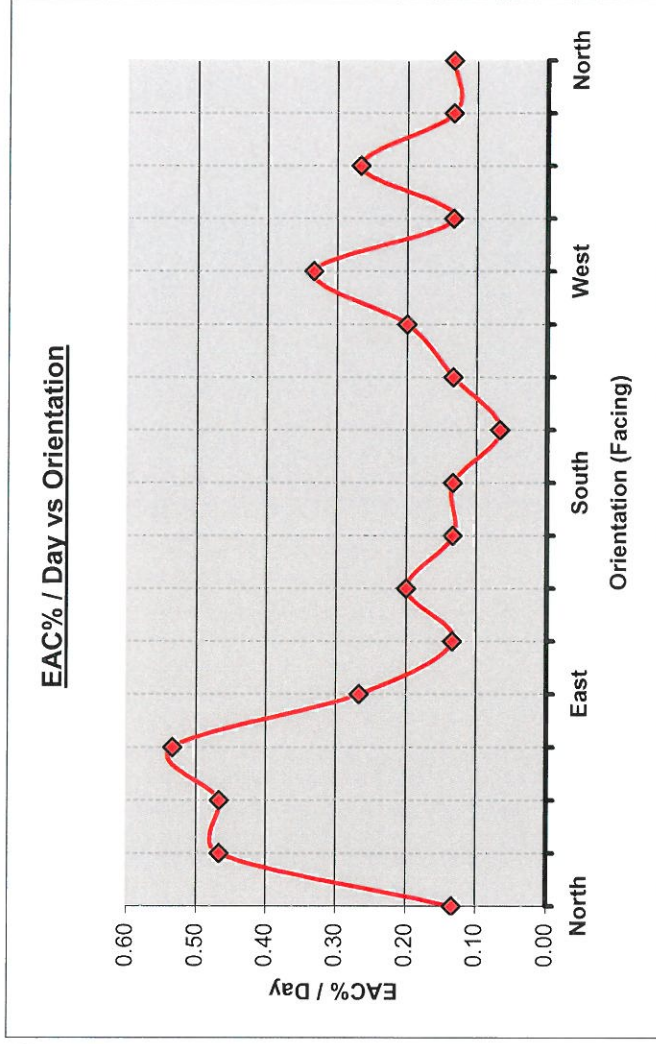
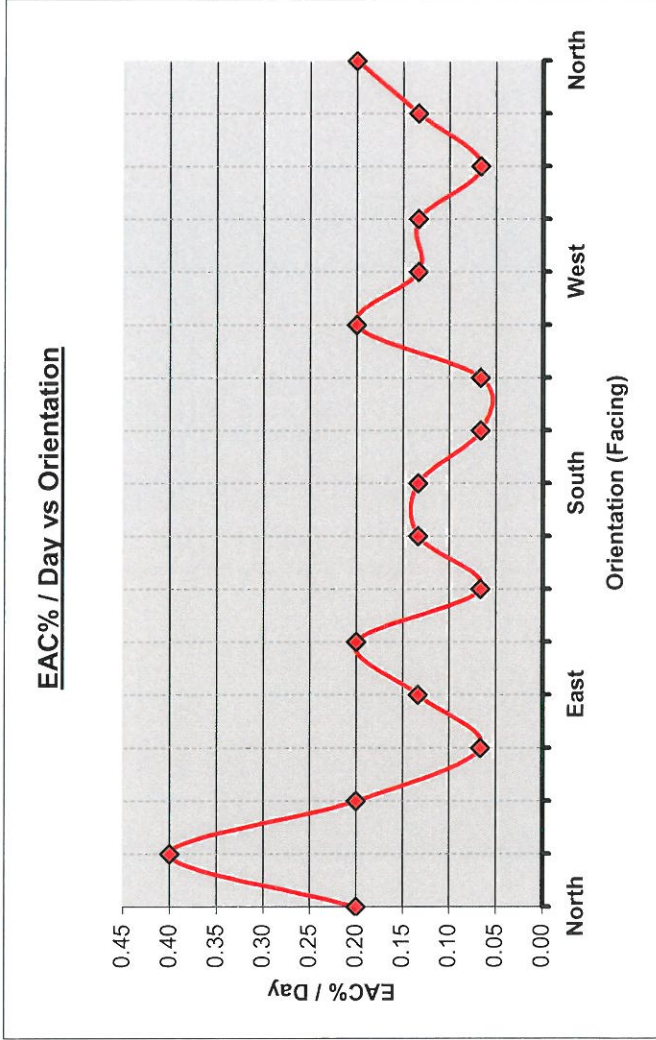
Directional dust deposition gauges at the six monitoring locations are analysed every fortnight for Effective Area Coverage (EAC) (percentage of dust deposition relating to the potential to cause nuisance), results generated by an external laboratory are presented in Appendix D.

Dust monitoring undertaken from the 10/01/2011 to 25/01/2011 (6 locations monitored) recorded a maximum dust deposition rate was 0.53%EAC at the west monitoring location. All other locations had a maximum dust deposition rate of 0.47%EAC, or less.

Dust deposition values of less than 2.5% are regarded as having a very low nuisance potential. Only when percentages rise from 2.5% – 5% EAC is dust considered to have a low nuisance causing potential. During the reported period dust, fibre and particle emissions have been low, and have not caused visual dusting off site.

Note: Cells coloured red are inputs.
The rest are either constants or calculated values.
The calculation is based on taking readings at 20mm intervals along the sticky pad.
