# Environmental Monitoring Report

Reporting Period  
28/02/2011-03/04/2011

Former Bayer Crop Science Site  
Hauxton  
Cambridgeshire

8<sup>th</sup> April 2011

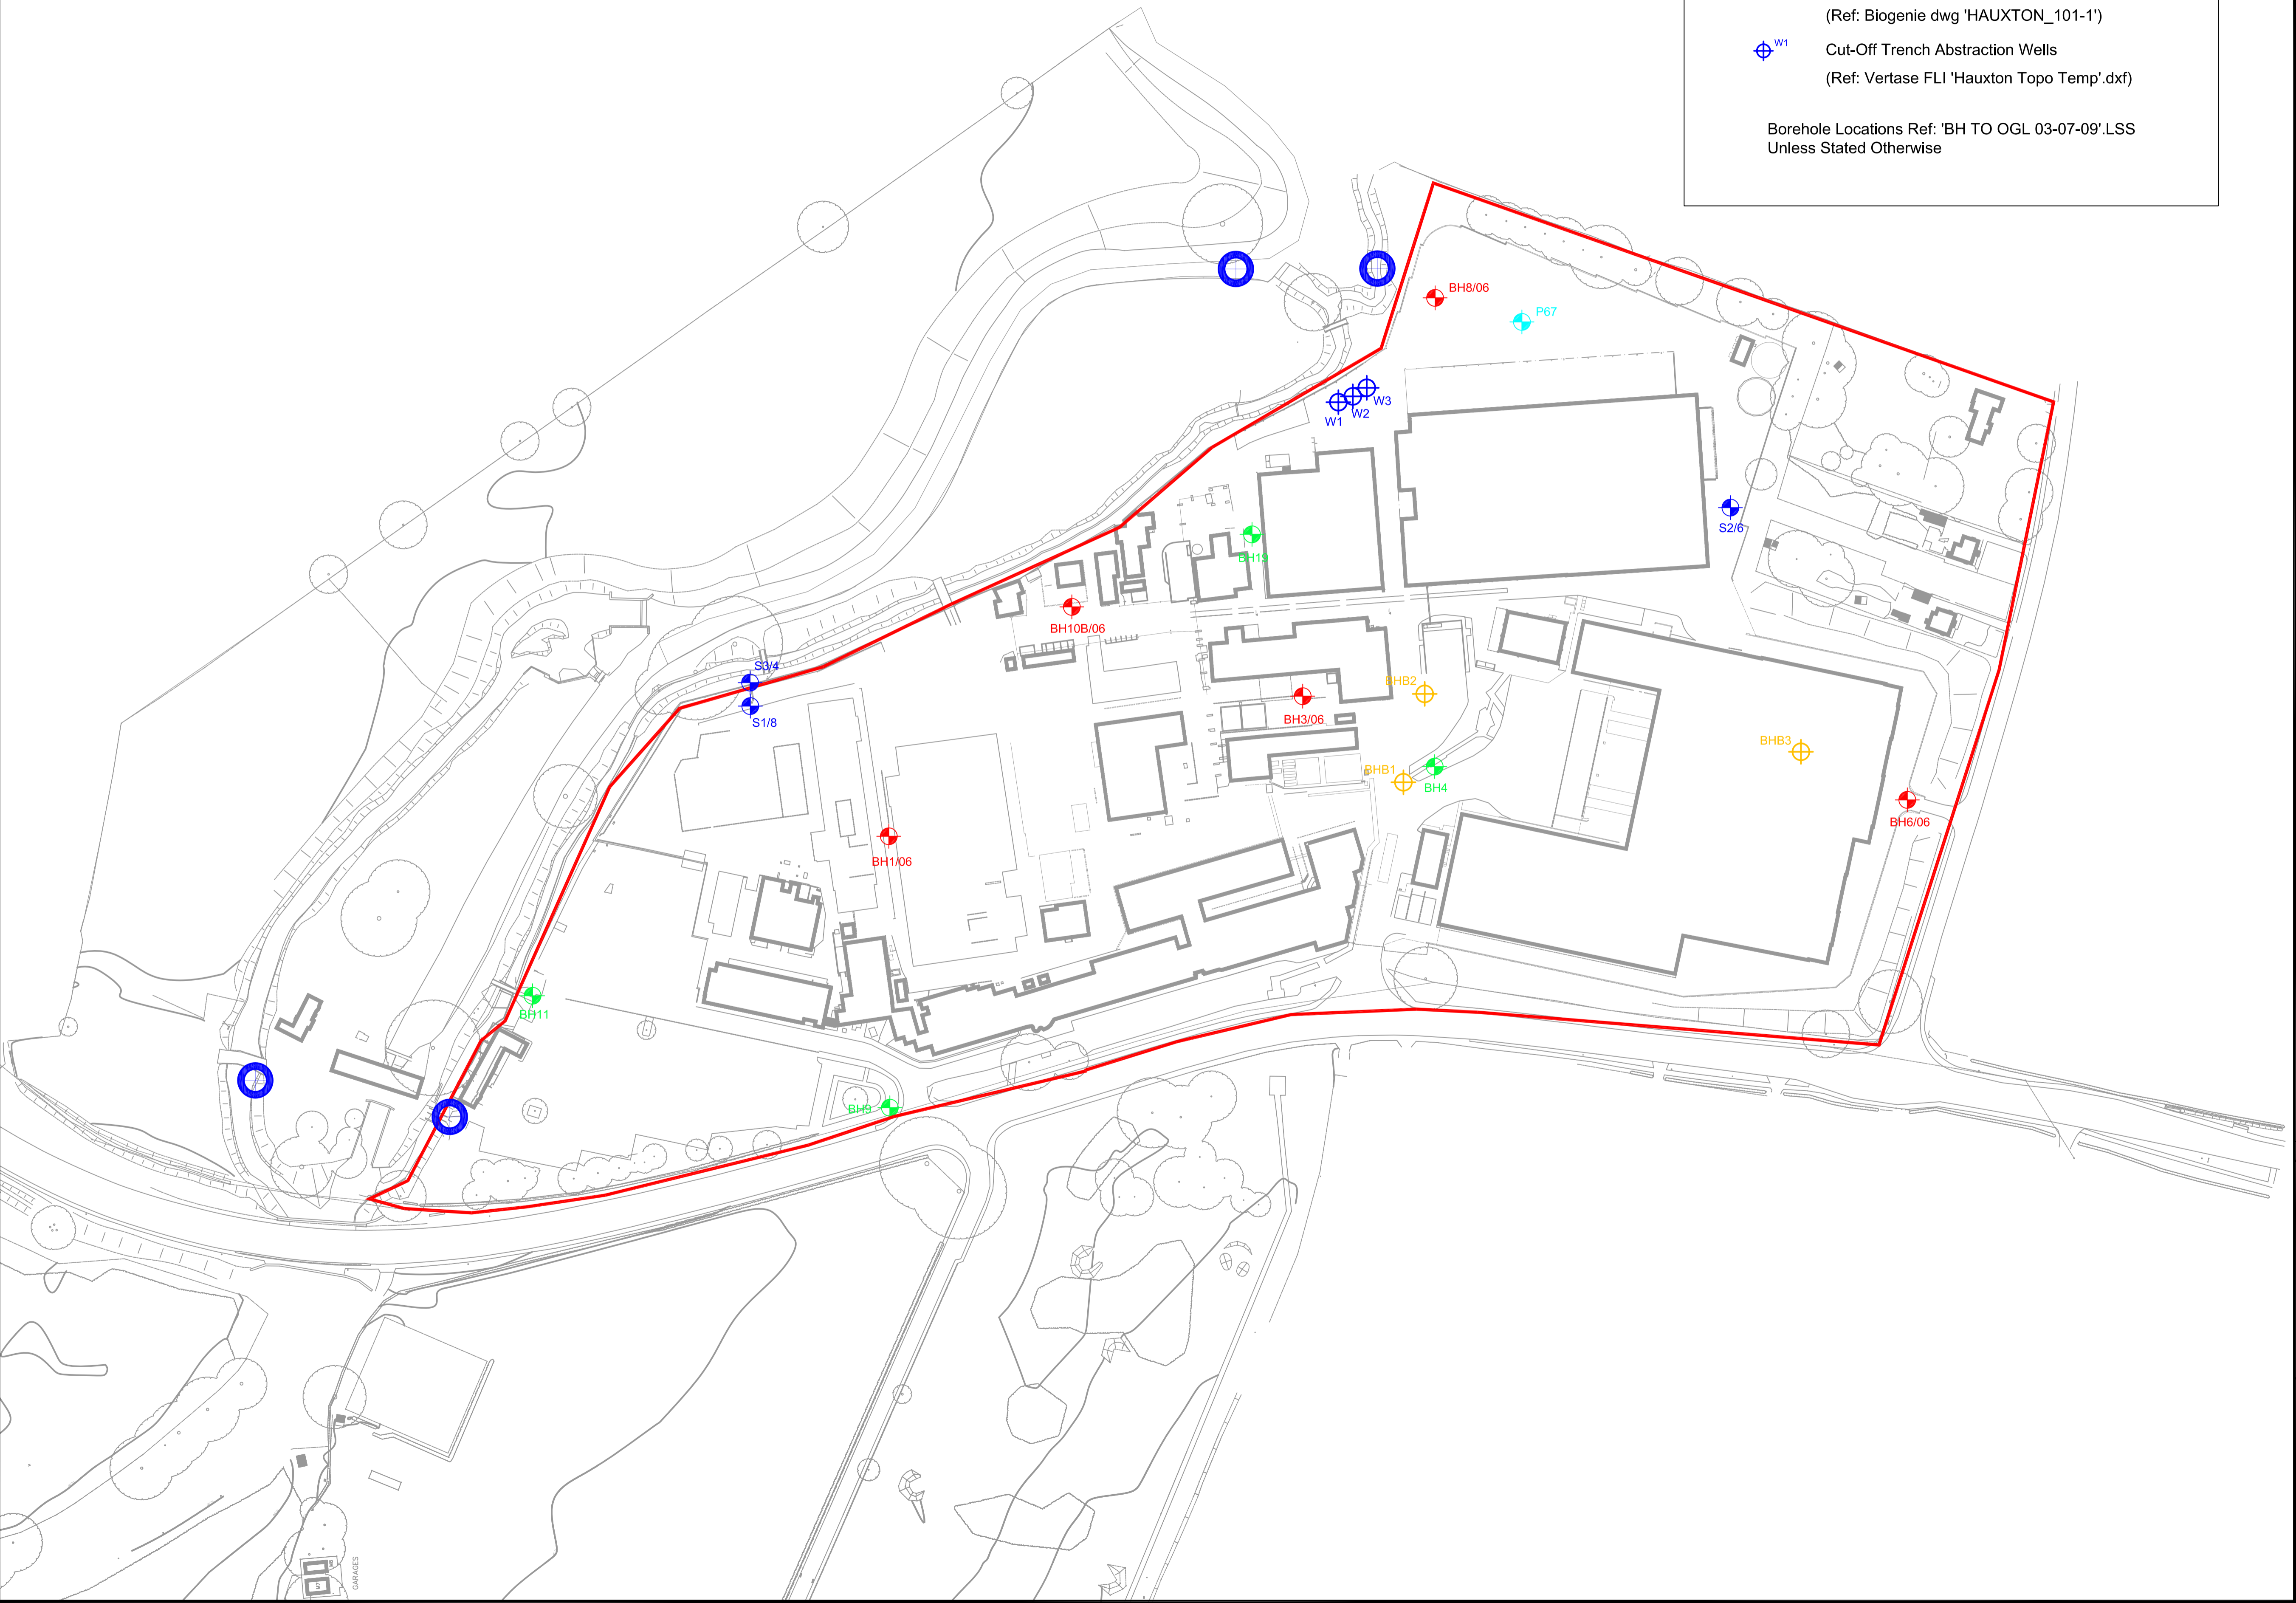
Dwg: D907_31	Contract: 907BRI	Scale: 1:1000
--------------	------------------	---------------

Groundwater levels are recorded within at least 11 borehole locations onsite on a daily basis, to ensure the groundwater beneath the site remains in a static condition during the remediation works and does not pose a risk to surface and groundwater bodies beyond the site boundary.
