# Environmental Monitoring Report

Reporting Period

04/04/2011-01/05/2011

Former Bayer Crop Science Site  
Hauxton  
Cambridgeshire

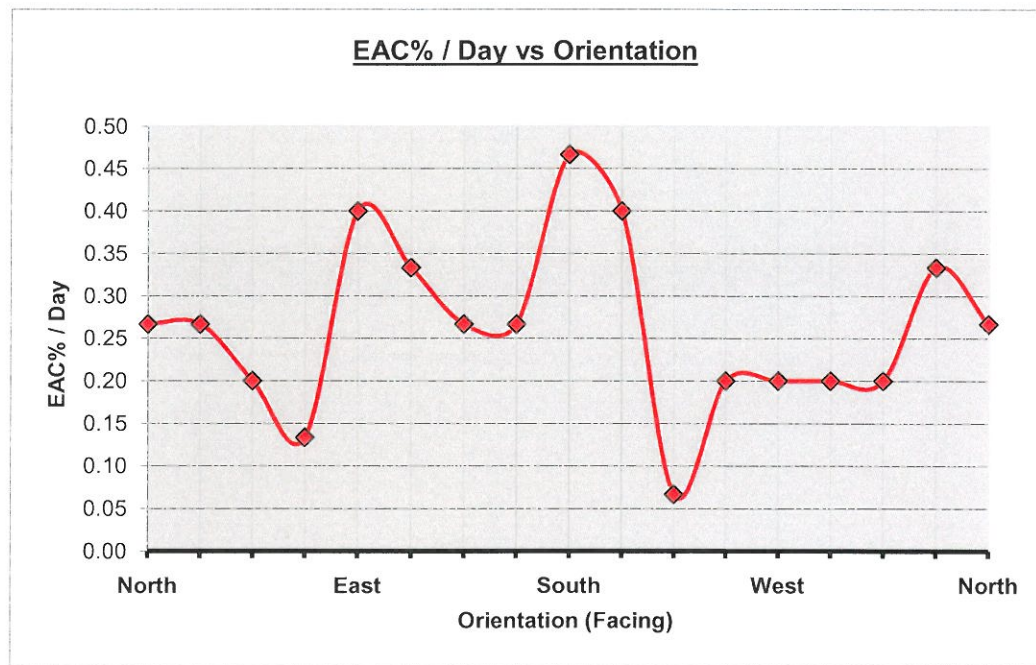
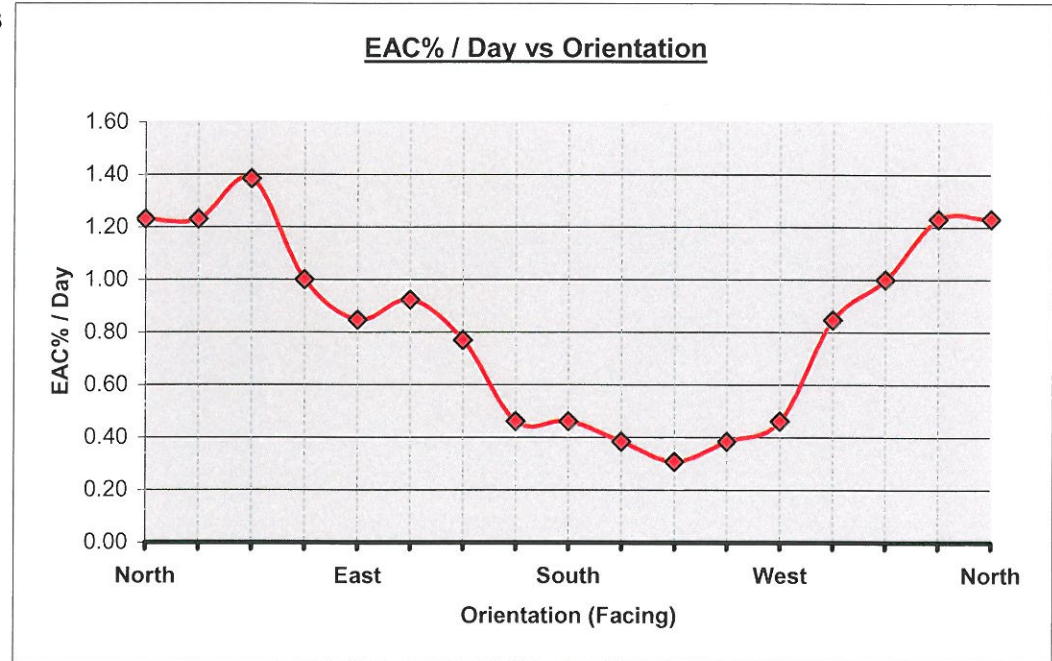
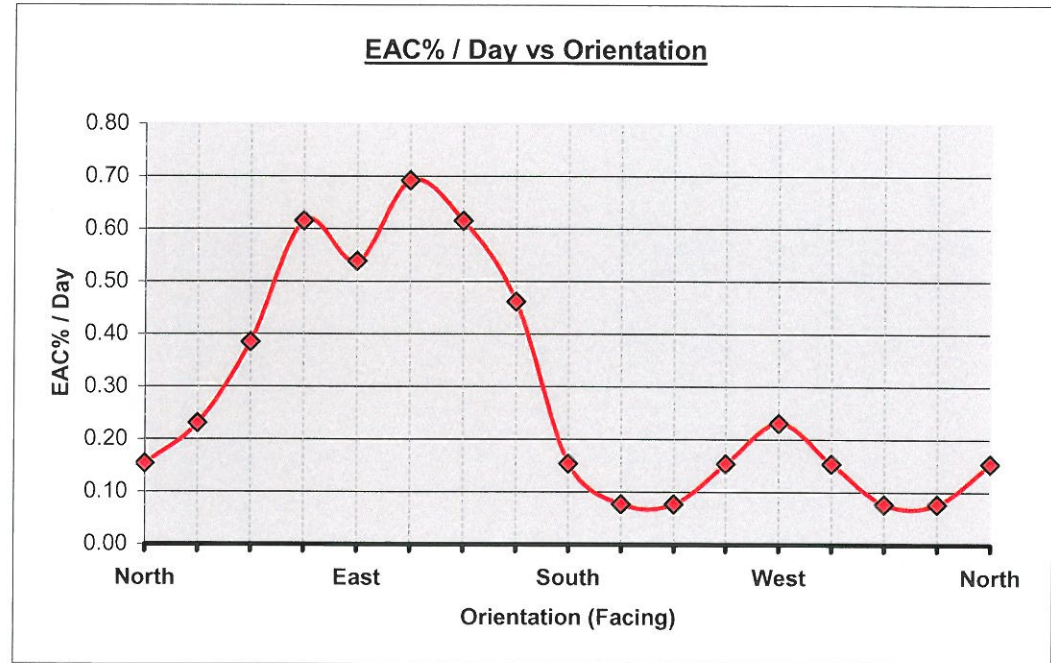
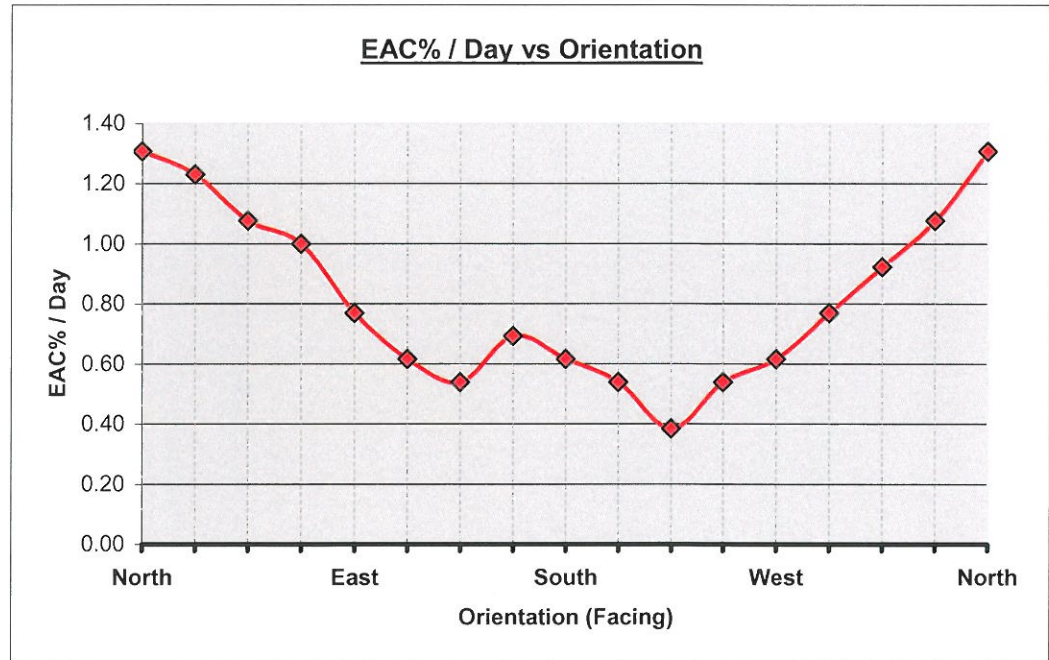
Directional dust deposition gauges at the six monitoring locations are analysed every fortnight for Effective Area Coverage (EAC) (percentage of dust deposition relating to the potential to cause nuisance), results generated by an external laboratory are presented in Appendix D.

Dust deposition values of less than 2.5% are regarded as having a very low nuisance potential. Only when percentages rise from 2.5% – 5% EAC is dust considered to have a low nuisance causing potential. During the reported period dust, fibre and particle emissions have been low, and have not caused visual dusting off site.

Note: Cells coloured red are inputs.  
The rest are either constants or calculated values.  
The calculation is based on taking readings at 20mm intervals along the sticky pad.
