Environmental Monitoring Report

Reporting Period
02/05/2011-29/05/2011
Supplemental

Former Bayer Crop Science Site
Hauxton
Cambridgeshire

24th June 2011

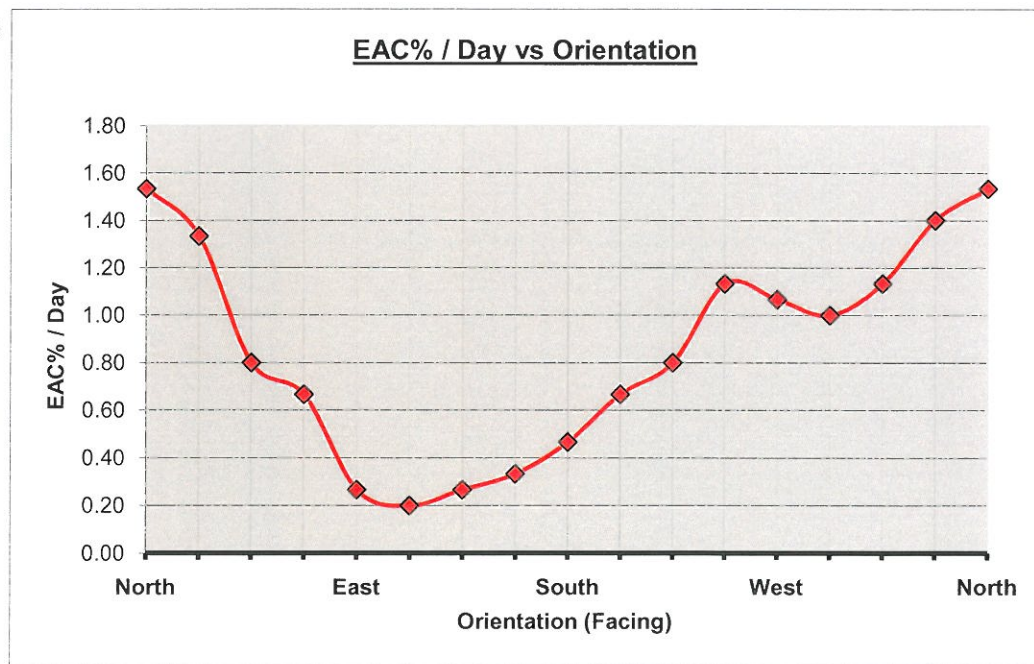
Gauge Number-West Location 907BRI

Date On 17/05/2011 Date Off 01/06/2011 Days = 15
Clean = 100

X Axis mm	Meter	Angle Deg	Orientation	EAC% / Day
0	77	360	North	1.53
20	79	337		1.40
40	83	314		1.13
60	85	291		1.00
80	84	269	West	1.07
100	83	246		1.13
120	88	223		0.80
140	90	200		0.67
160	93	177	South	0.47
180	95	154		0.33
200	96	131		0.27
220	97	109		0.20
240	96	86	East	0.27
260	90	63		0.67
280	88	40		0.80
300	80	17		1.33
315	77	0	North	1.53

Dust monitoring undertaken from the 17/05/2011 to 01/06/2011 (3 locations monitored only due to damage to monitoring equipment caused by high winds during the monitoring period) recorded a maximum dust deposition rate was 1.53%EAC at the east monitoring location. All other locations had a maximum dust deposition rate of 1.07%EAC, or less.
