Environmental Monitoring Report

04/07/2011-29/07/2011

Former Bayer Crop Science Site
Hauxton
Cambridgeshire

Harrow Estates Plc

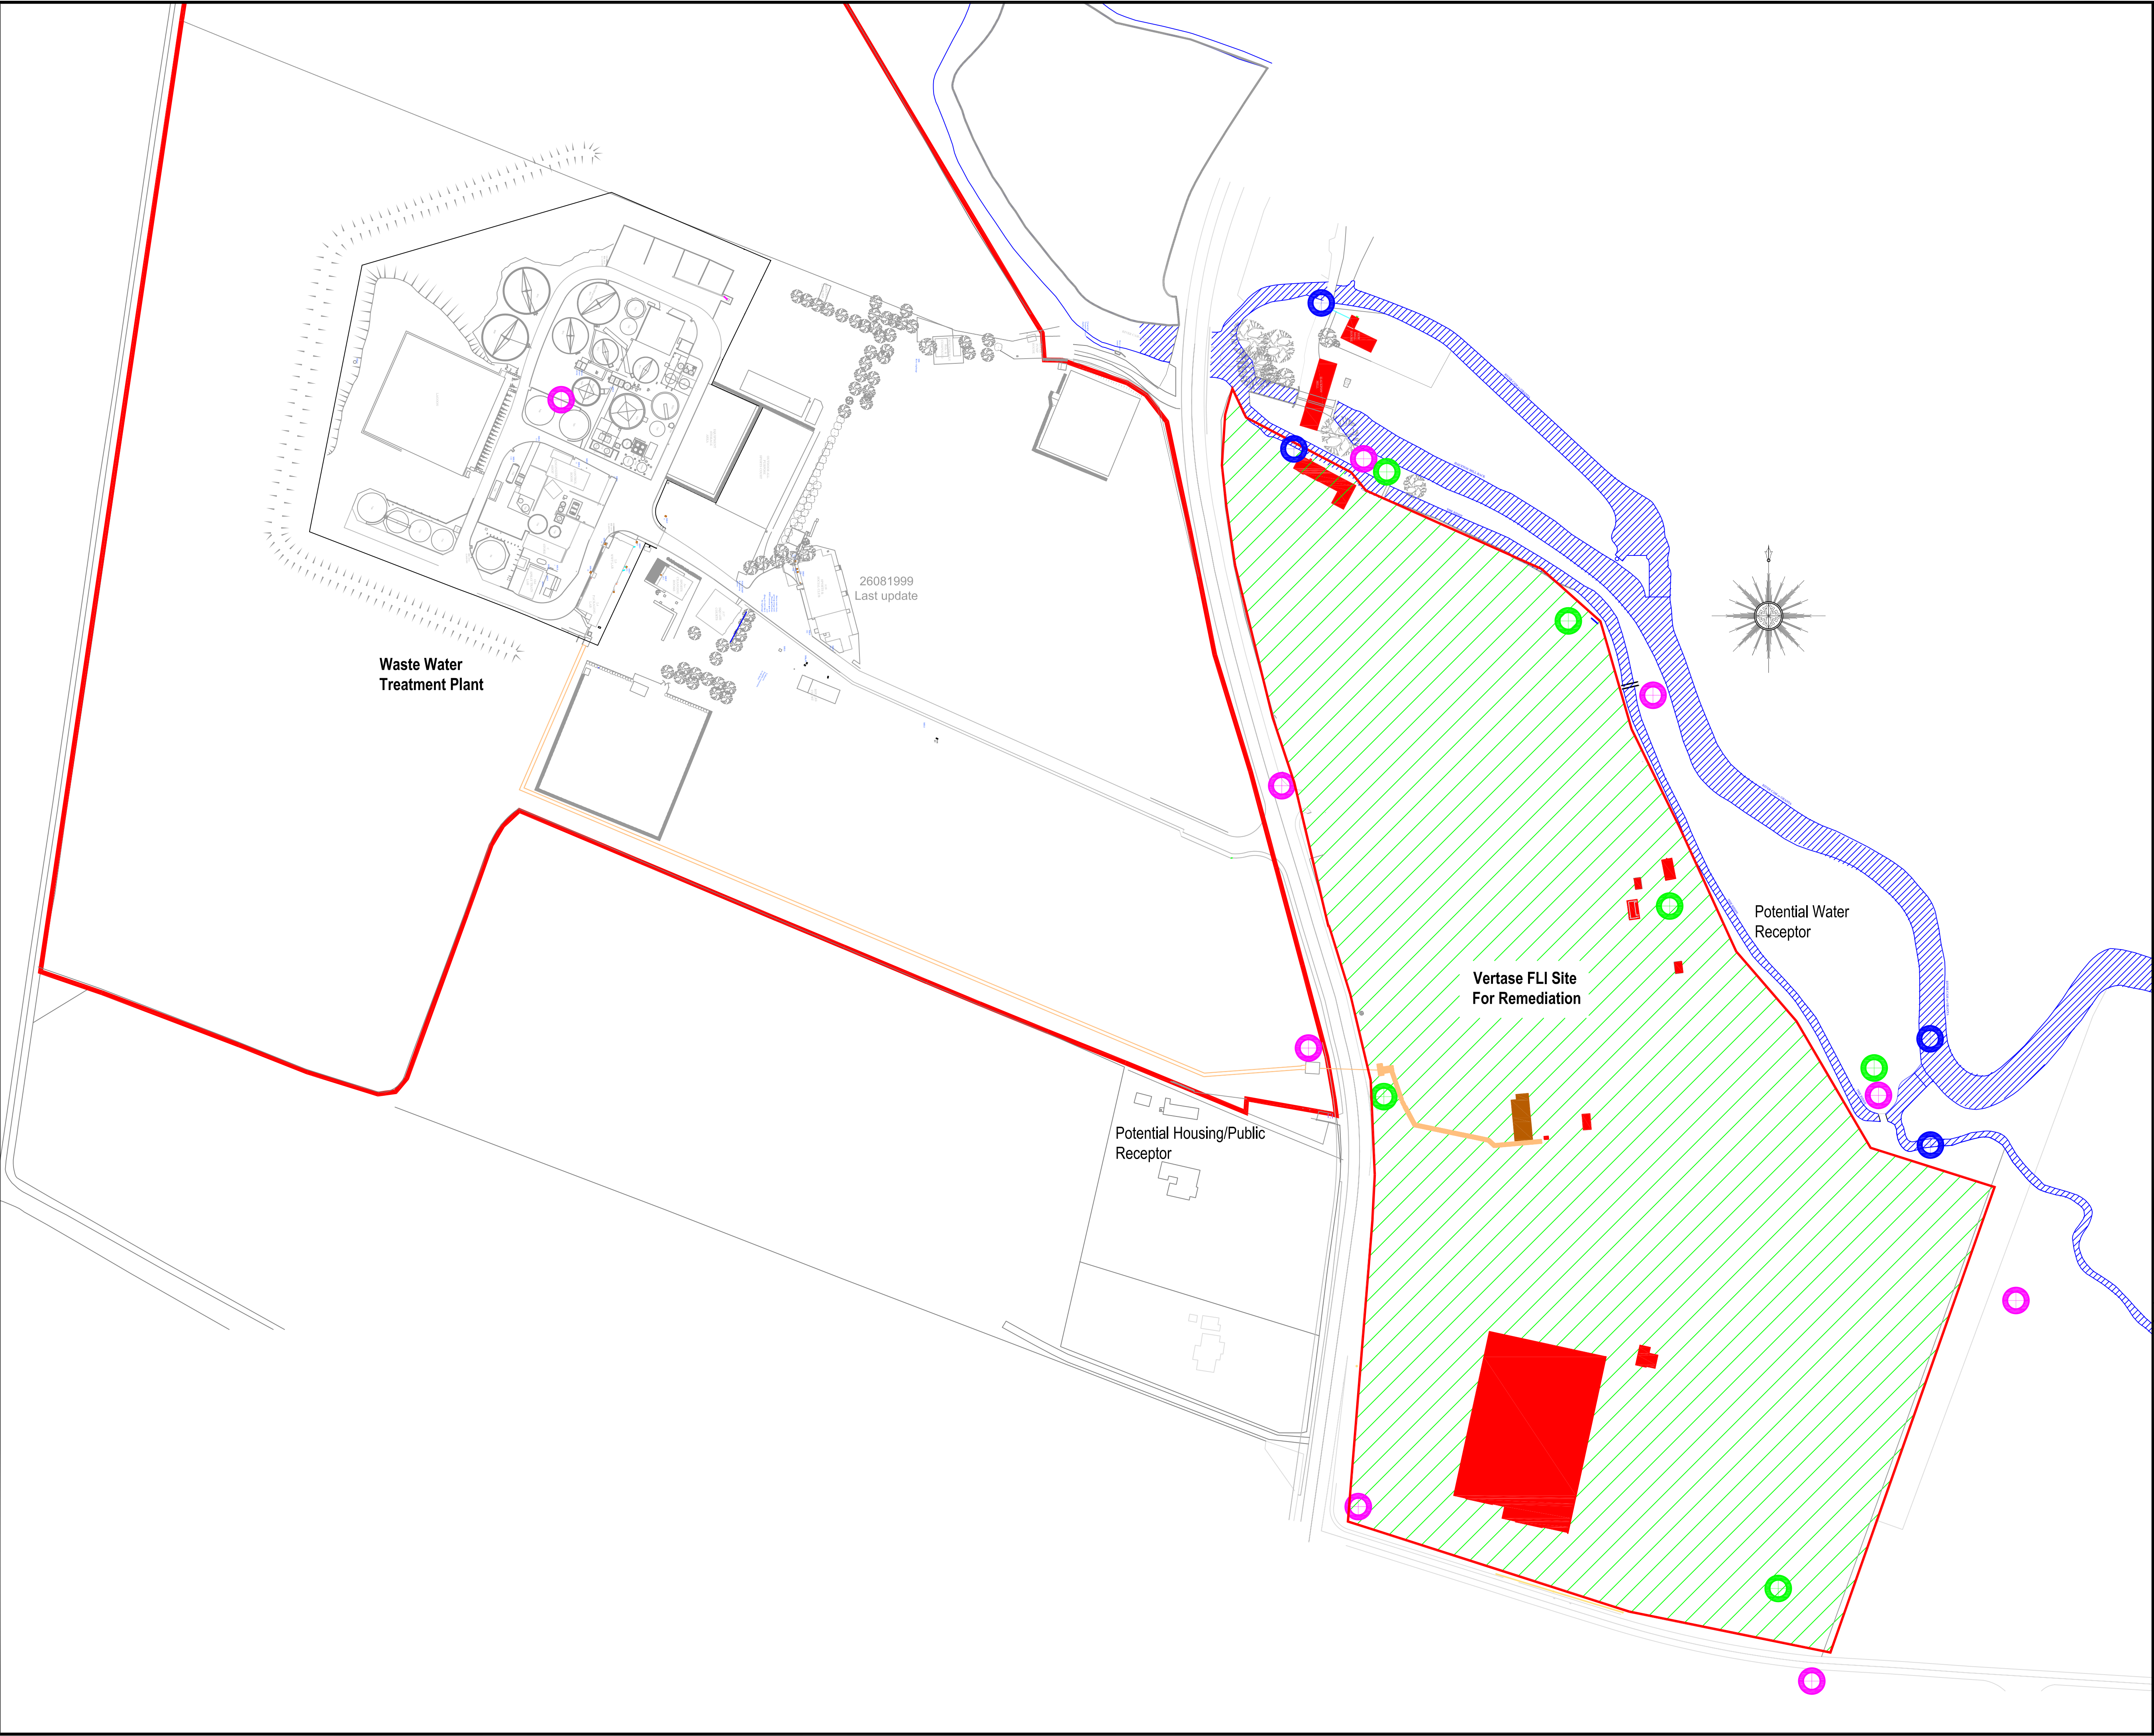
The environmental monitoring locations detailed in the Environmental Permit deployment form for the site are highlighted in drawing D907_33C in Appendix A.

Both real time dust measurement and long term dust deposition monitoring has been undertaken around the site boundary at six compass point locations, north, east, south, west with two monitoring positions in the northeast (drawing D907_30C, Appendix A).

Noise monitoring around the site boundary commenced on the 22nd March 2010 and has been undertaken twice daily as a minimum, recording findings at eight compass points around the site boundary in the public access areas (drawing D907_30C, Appendix A).

As part of the environmental monitoring programme, the Riddy Brook located to the east of the site (Drawing D907_33C, Appendix A) is inspected daily as a minimum at two locations up and down stream for general observations, on any discolouration, sedimentation etc. The observations are recorded on the Environmental Monitoring Data (Appendix B). Throughout the monitoring period there have been no visual signs that the remediation works on site are having any impact on the Riddy Brook.

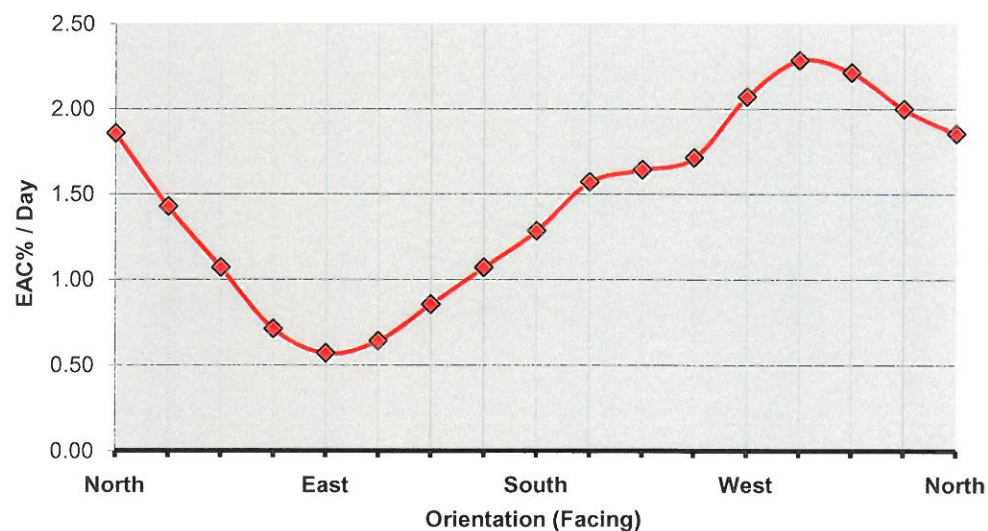
EAC% / Day vs Orientation

X Axis mm	Meter	Angle Deg	Orientation	EAC% / Day
0	74	360	North	1.86
20	72	337		2.00
40	69	314		2.21
60	68	291		2.29
80	71	269	West	2.07
100	76	246		1.71
120	77	223		1.64
140	78	200		1.57
160	82	177	South	1.29
180	85	154		1.07
200	88	131		0.86
220	91	109		0.64
240	92	86	East	0.57
260	90	63		0.71
280	85	40		1.07
300	80	17		1.43
315	74	0	North	1.86

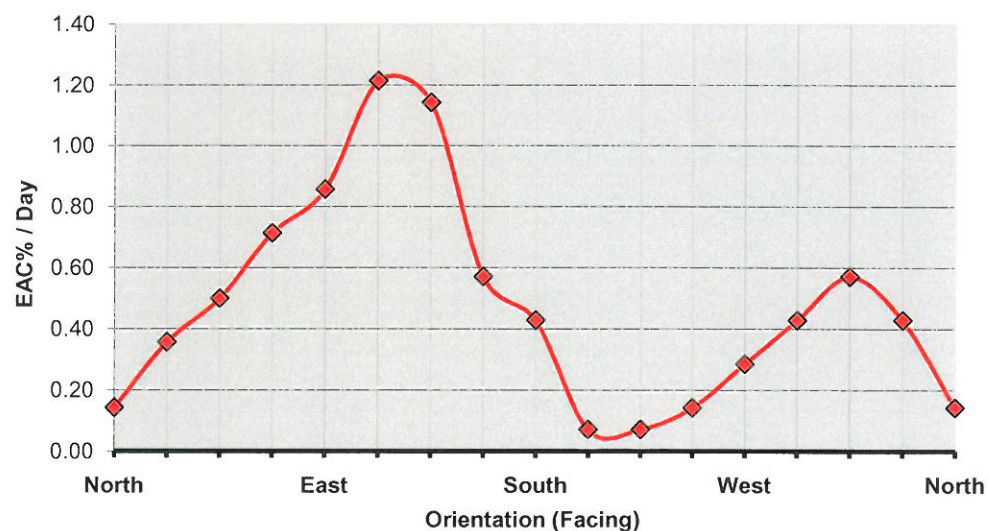
EAC% / Day vs Orientation

X Axis mm	Meter	Angle Deg	Orientation	EAC% / Day
0	98	360	North	0.14
20	94	337		0.43
40	92	314		0.57
60	94	291		0.43
80	96	269	West	0.29
100	98	246		0.14
120	99	223		0.07
140	99	200		0.07
160	94	177	South	0.43
180	92	154		0.57
200	84	131		1.14
220	83	109		1.21
240	88	86	East	0.86
260	90	63		0.71
280	93	40		0.50
300	95	17		0.36
315	98	0	North	0.14

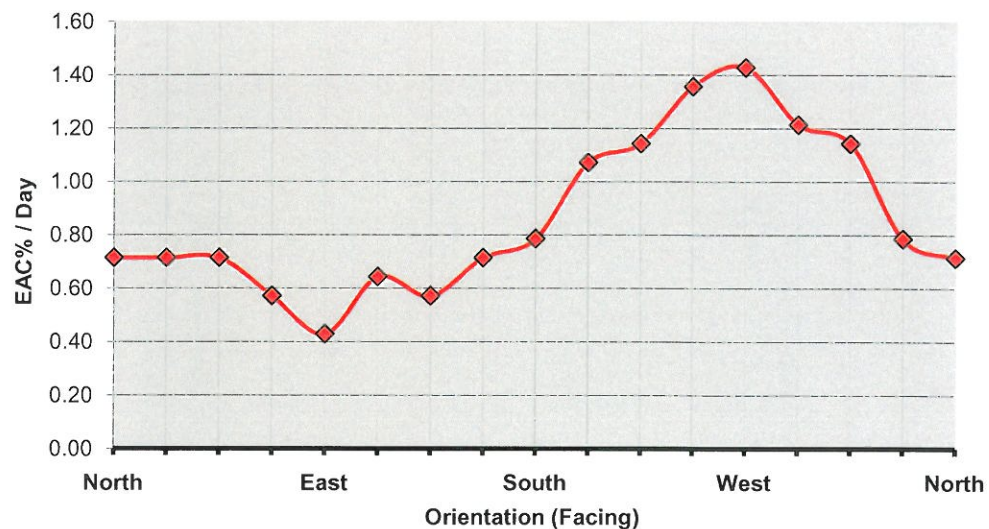
EAC% / Day vs Orientation

X Axis mm	Meter	Angle Deg	Orientation	EAC% / Day
0	90	360	North	0.71
20	89	337		0.79
40	84	314		1.14
60	83	291		1.21
80	80	269	West	1.43
100	81	246		1.36
120	84	223		1.14
140	85	200		1.07
160	89	177	South	0.79
180	90	154		0.71
200	92	131		0.57
220	91	109		0.64
240	94	86	East	0.43
260	92	63		0.57
280	90	40		0.71
300	90	17		0.71
315	90	0	North	0.71

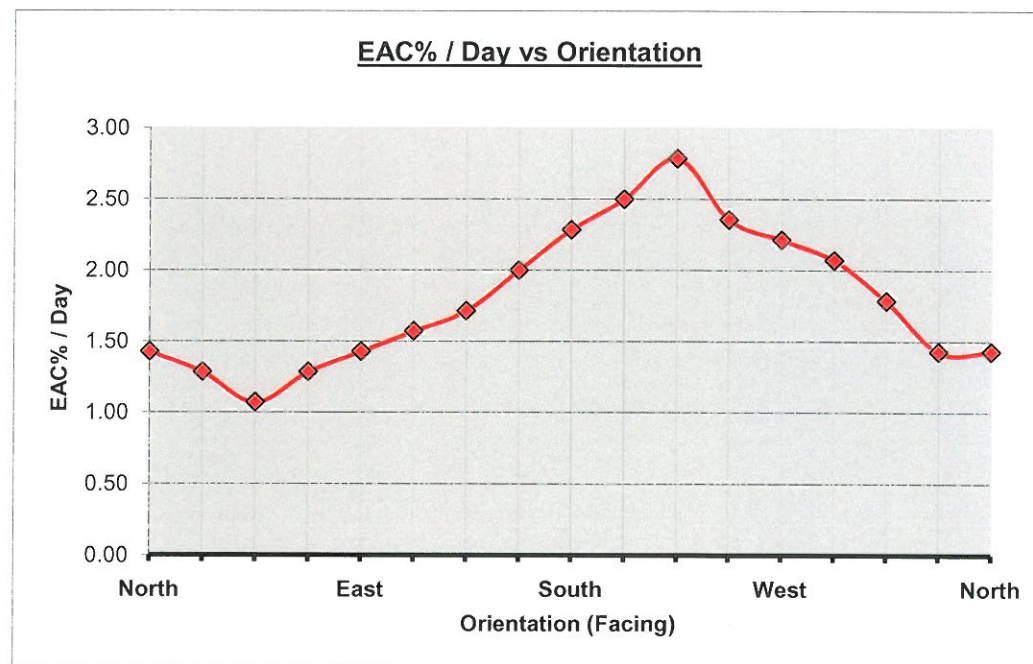
Dust monitoring undertaken from the 27/06/2011 to 11/07/2011 (4 locations monitored only due to 2# damaged monitoring stations) recorded a maximum dust deposition rate was 2.79%EAC at the south monitoring location. All other locations had a maximum dust deposition rate of 2.29%EAC, or less.

Date On 27/06/2011 Date Off 11/07/2011 Days = 14
Clean = 100

X Axis mm	Meter	Angle Deg	Orientation	EAC% / Day
0	80	360	North	1.43
20	80	337		1.43
40	75	314		1.79
60	71	291		2.07
80	69	269	West	2.21
100	67	246		2.36
120	61	223		2.79
140	65	200		2.50
160	68	177	South	2.29
180	72	154		2.00
200	76	131		1.71
220	78	109		1.57
240	80	86	East	1.43
260	82	63		1.29
280	85	40		1.07
300	82	17		1.29
315	80	0	North	1.43

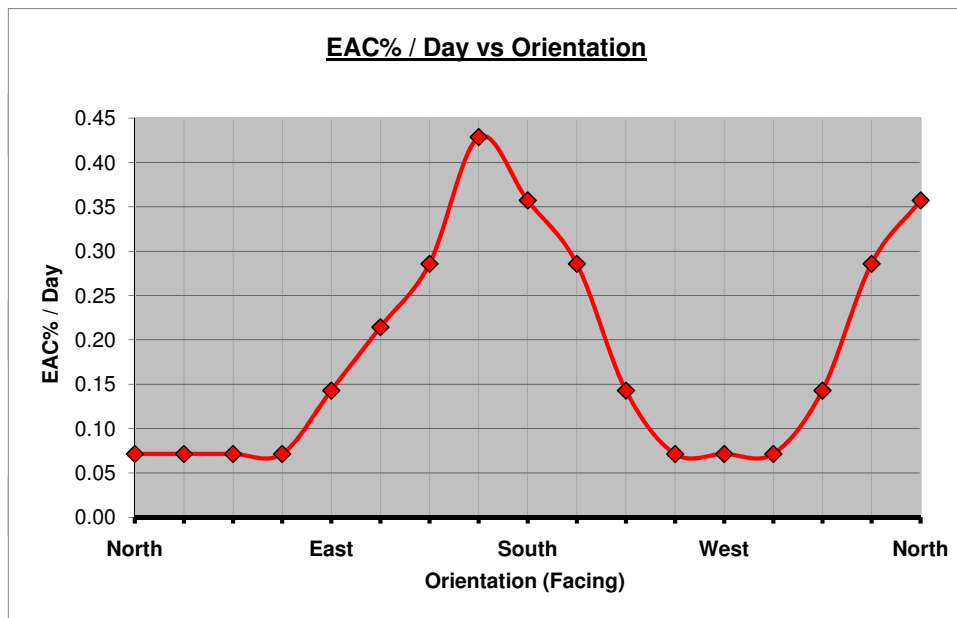
Date On **11/07/2011** Date Off **25/07/2011** Days = 14
Clean = 100

X Axis mm	Meter	Angle Deg	Orientation	EAC% / Day
0	95	360	North	0.36
20	96	337		0.29
40	98	314		0.14
60	99	291		0.07
80	99	269	West	0.07
100	99	246		0.07
120	98	223		0.14
140	96	200		0.29
160	95	177	South	0.36
180	94	154		0.43
200	96	131		0.29
220	97	109		0.21
240	98	86	East	0.14
260	99	63		0.07
280	99	40		0.07
300	99	17		0.07
315	99	0	North	0.07

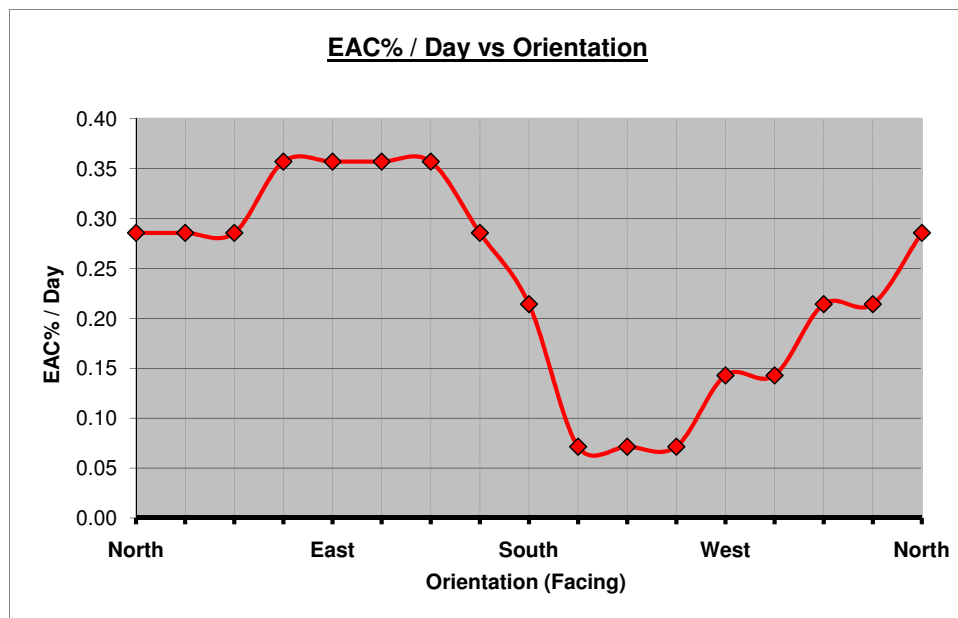
Date On 11/07/2011 Date Off 25/07/2011 Days = 14
Clean = 100

X Axis mm	Meter	Angle Deg	Orientation	EAC% / Day
0	96	360	North	0.29
20	97	337		0.21
40	97	314		0.21
60	98	291		0.14
80	98	269	West	0.14
100	99	246		0.07
120	99	223		0.07
140	99	200		0.07
160	97	177	South	0.21
180	96	154		0.29
200	95	131		0.36
220	95	109		0.36
240	95	86	East	0.36
260	95	63		0.36
280	96	40		0.29
300	96	17		0.29
315	96	0	North	0.29

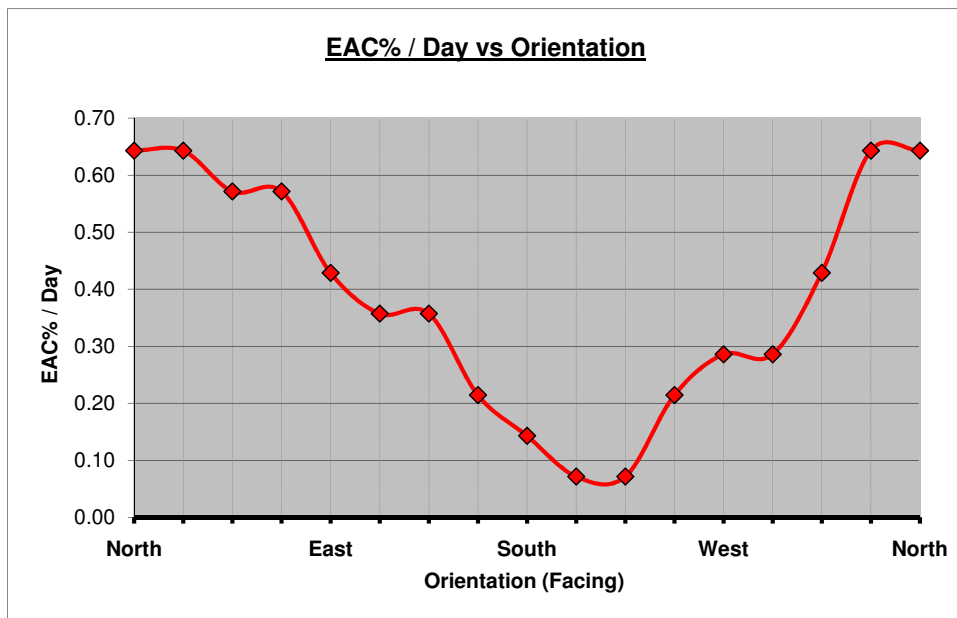
Date On 11/07/2011 Date Off 25/07/2011 Days = 14
Clean = 100

X Axis mm	Meter	Angle Deg	Orientation	EAC% / Day
0	91	360	North	0.64
20	91	337		0.64
40	94	314		0.43
60	96	291		0.29
80	96	269	West	0.29
100	97	246		0.21
120	99	223		0.07
140	99	200		0.07
160	98	177	South	0.14
180	97	154		0.21
200	95	131		0.36
220	95	109		0.36
240	94	86	East	0.43
260	92	63		0.57
280	92	40		0.57
300	91	17		0.64
315	91	0	North	0.64

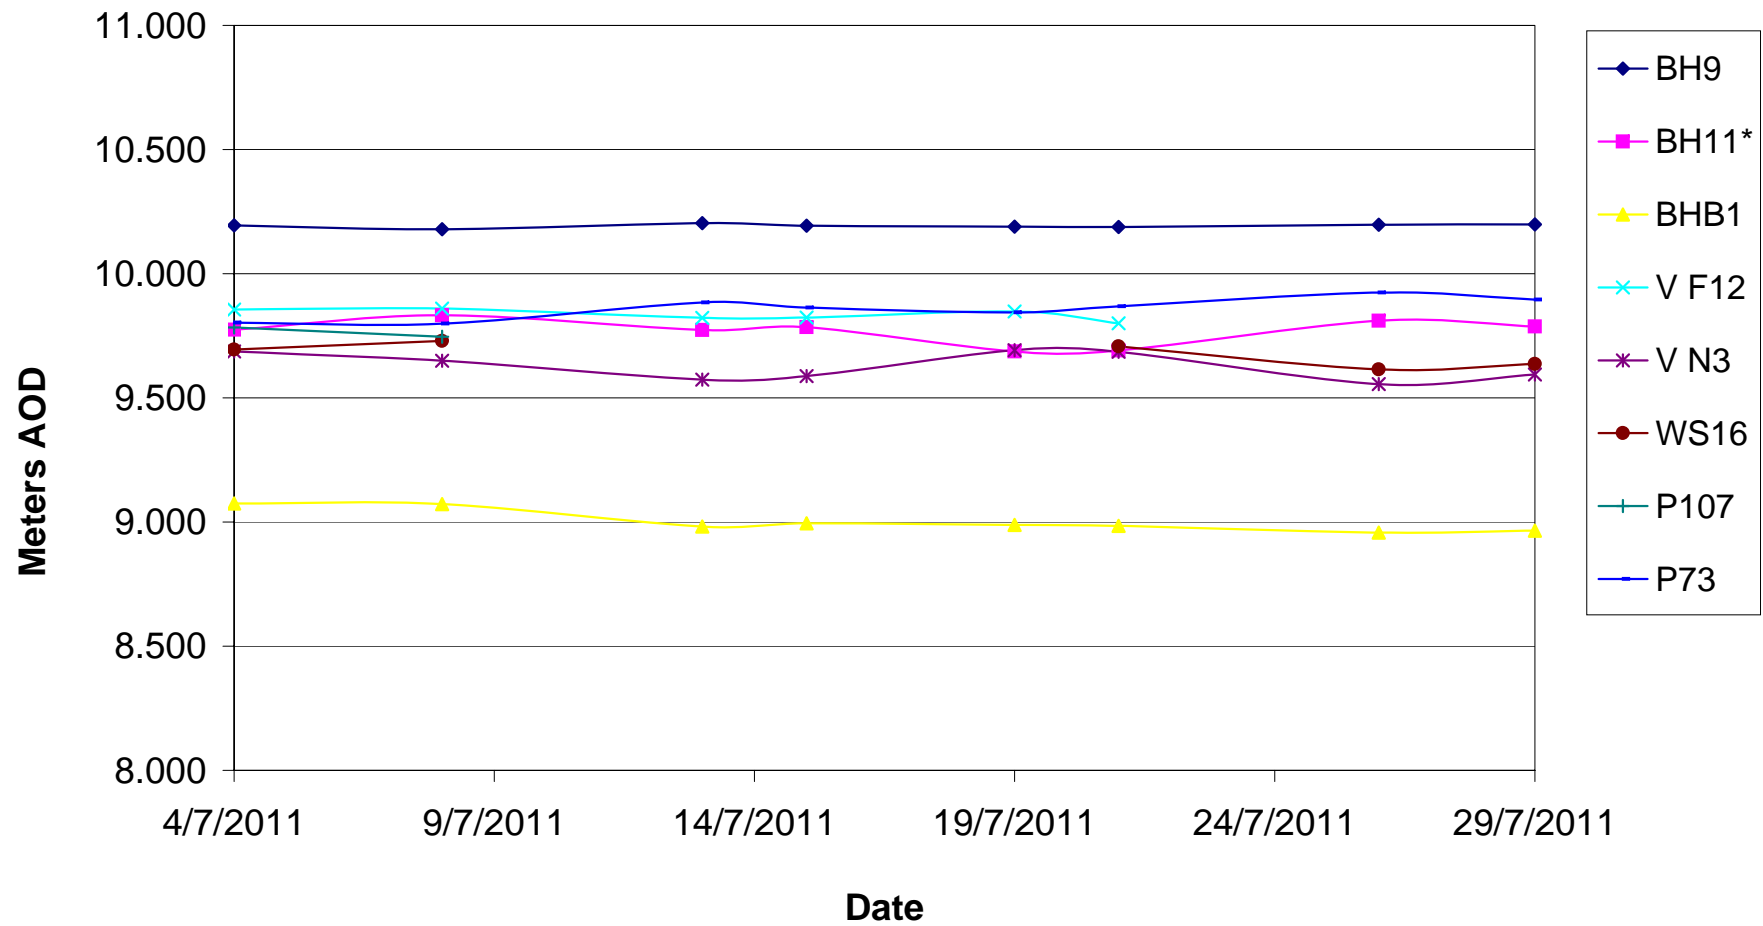
Hauxton Groundwater Level Data July 2011

Groundwater levels are recorded within at least 11 borehole locations onsite on a daily basis, to ensure the groundwater beneath the site remains in a static condition during the remediation works and does not pose a risk to surface and groundwater bodies beyond the site boundary.
