Environmental Monitoring Report

Reporting Period
01/08/2011-28/08/2011

Former Bayer Crop Science Site
Hauxton
Cambridgeshire

14th September 2011

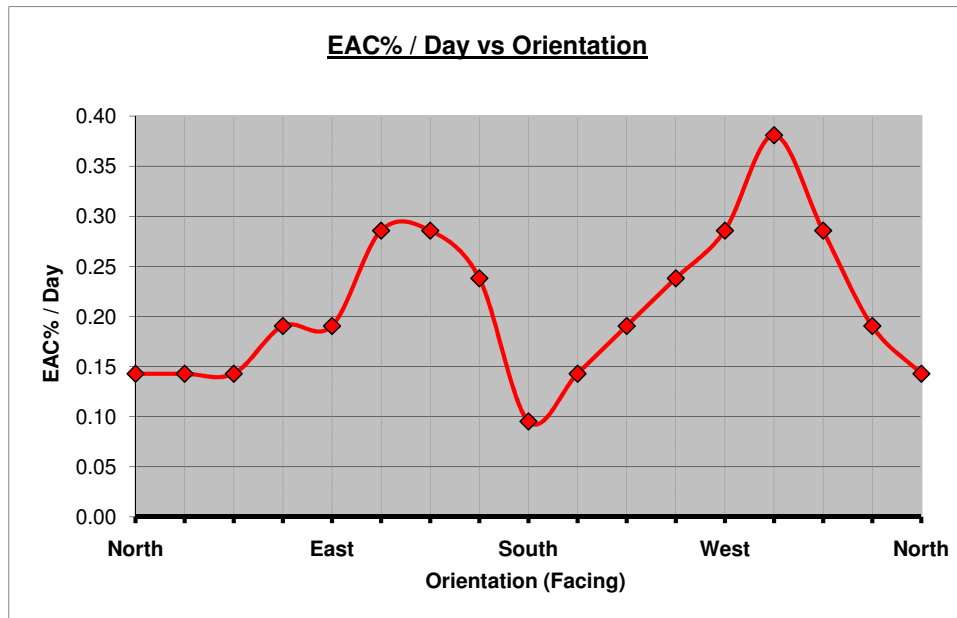
Gauge Number- North offsite Location 907BRI

Dust monitoring undertaken from the 25/07/2011 to 15/08/2011 (6 locations monitored) recorded a maximum dust deposition rate was 1.05%EAC at both the north and south monitoring locations. All other locations had a maximum dust deposition rate of 0.76%EAC, or less.

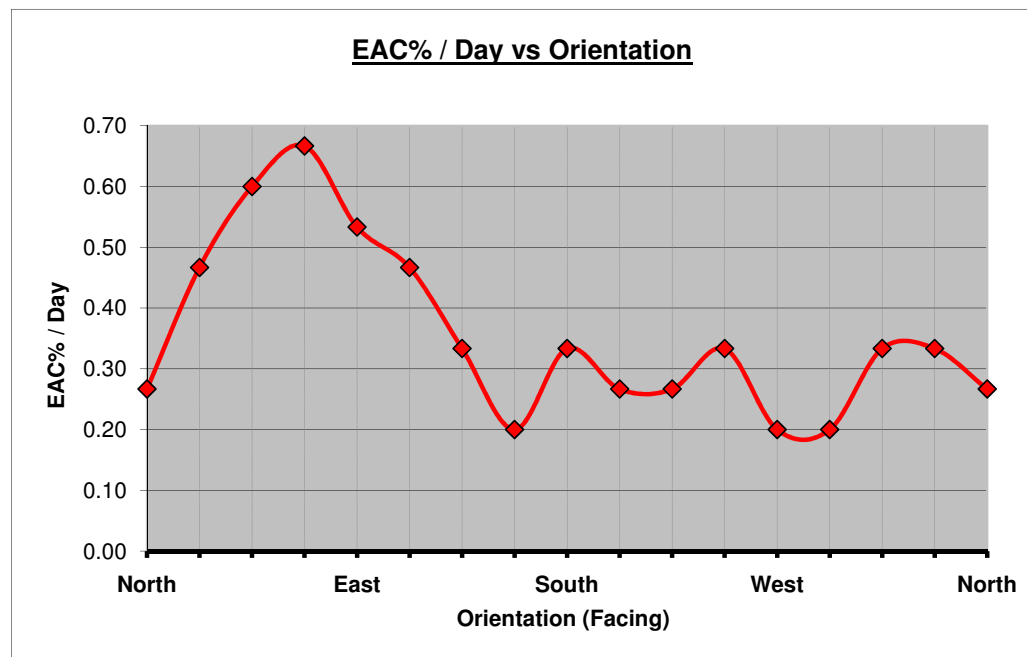
Gauge Number-South Location 907BRI

Dust monitoring undertaken from the 15/08/2011 to 30/08/2011(5 locations monitored only due to 1# damaged on site) recorded a maximum dust deposition rate was 1.40%EAC at the south monitoring location. All other locations had a maximum dust deposition rate of 0.67%EAC, or less.

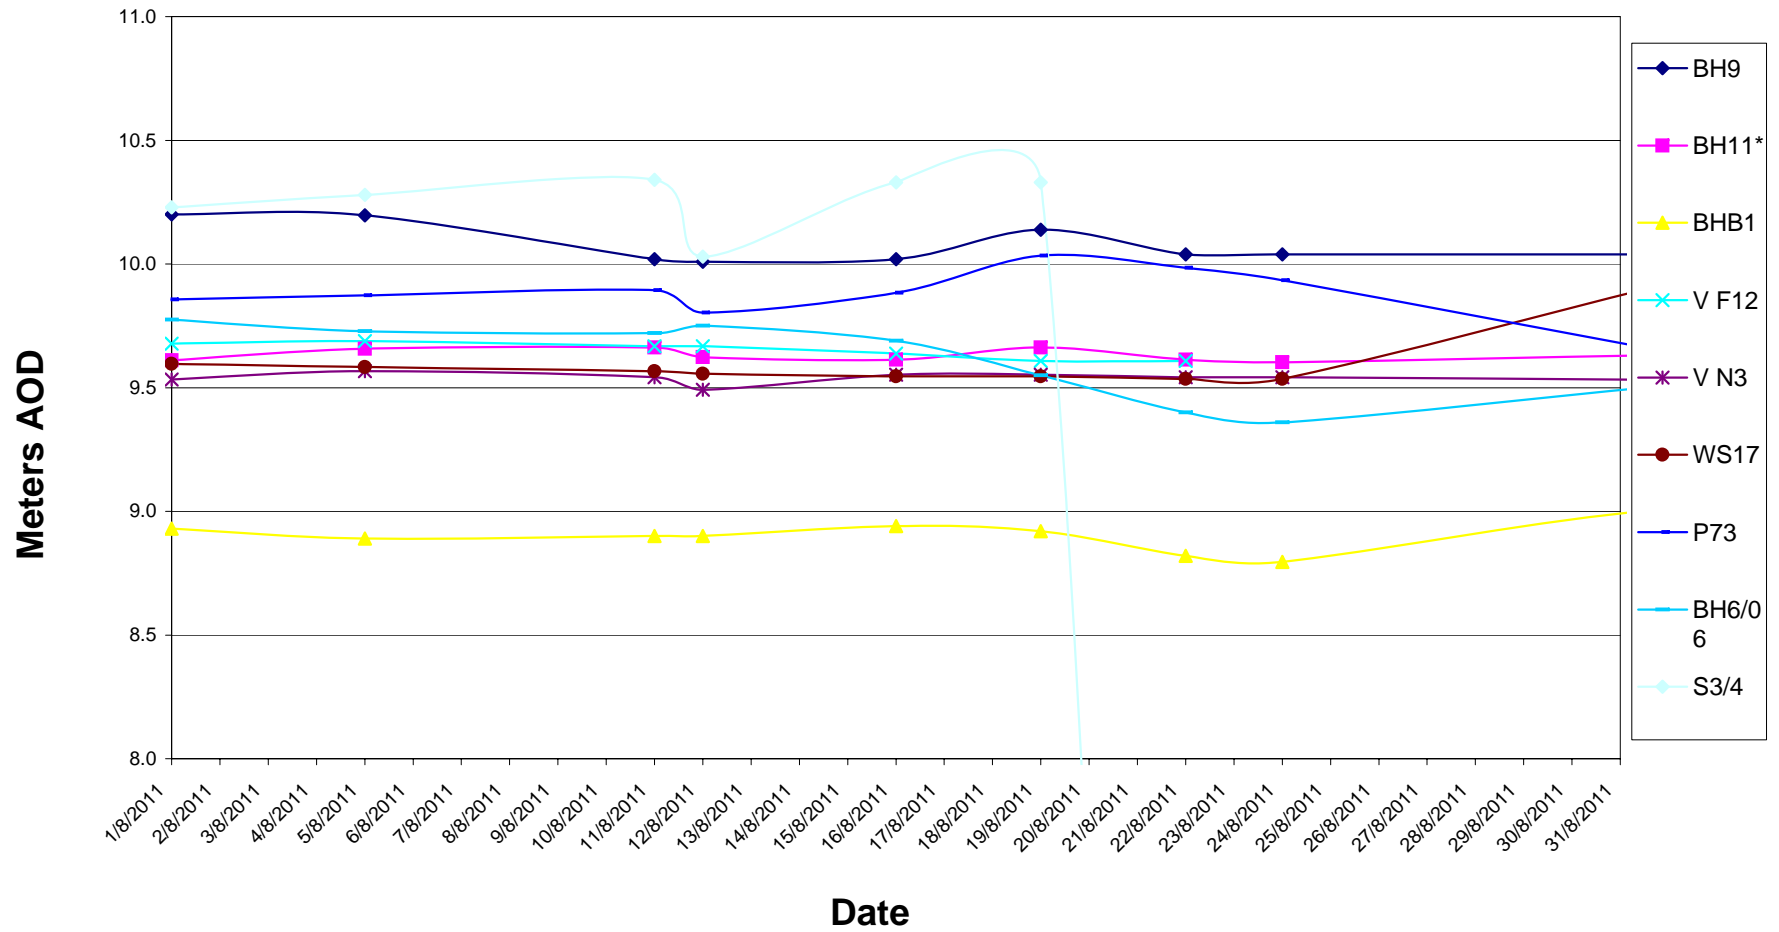
Hauxton Groundwater Level Data August 2011

Groundwater levels are recorded within at least 11 borehole locations onsite on a daily basis, to ensure the groundwater beneath the site remains in a static condition during the remediation works and does not pose a risk to surface and groundwater bodies beyond the site boundary.
