In their letter, 28<sup>th</sup> May 2021, Cambridgeshire County Council LLFA have requested the following further Information be provided in respect of the proposed outfall for surface water.

A walk over visit was carried out on the 7<sup>th</sup> June 2021 to determine the above.

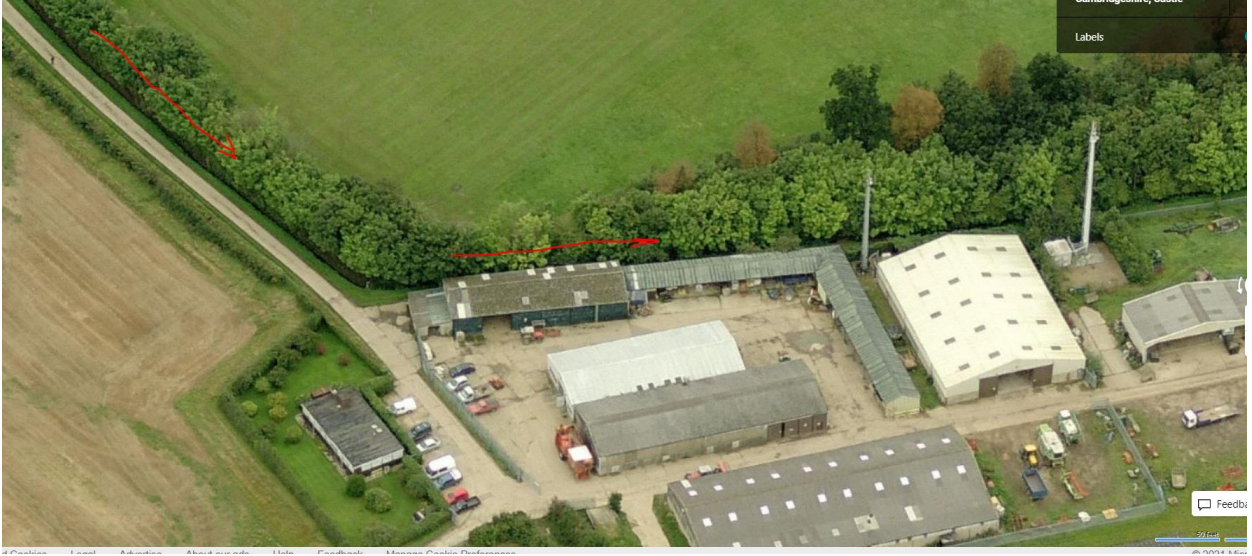
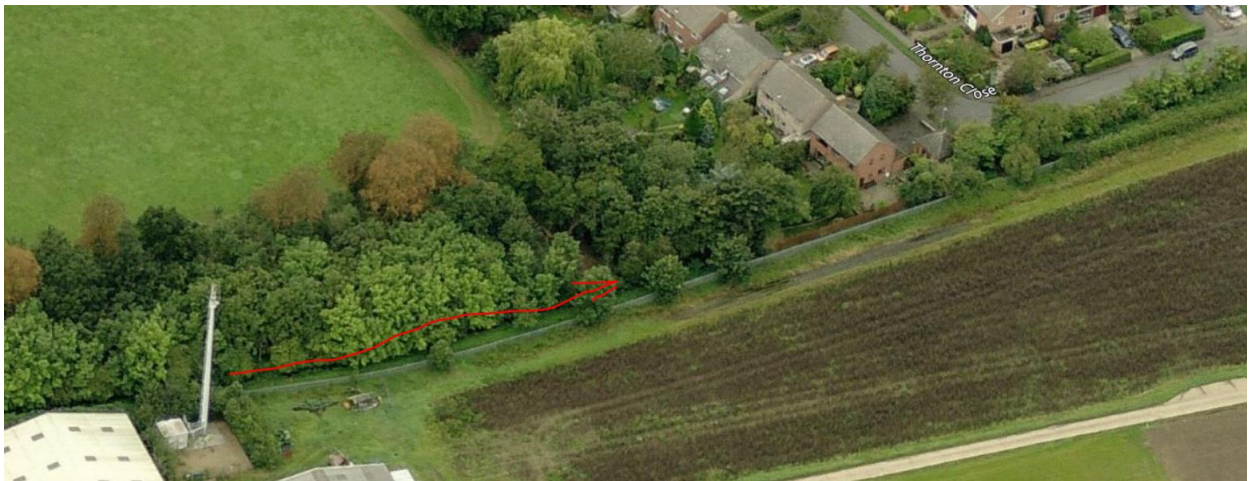
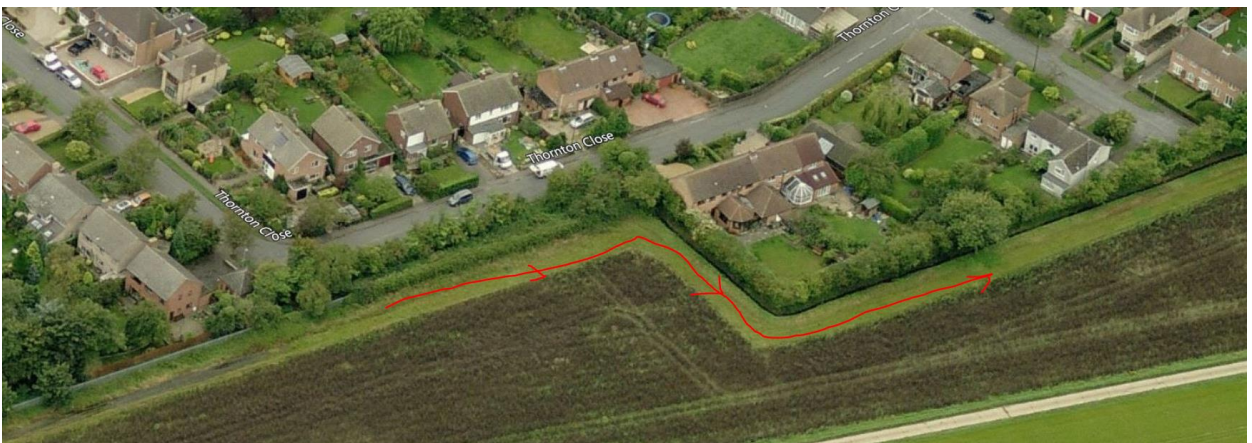
FIG 1. WIDER CONTEXT

The watercourse was found to run from the known discharge point at Whitehouse Lane and follows the line of the mapped drainage which ultimately flows under the A14, as shown in the wider context map in fig 1.
