## Viewpoint 12 - Rampton Road, north of Cottenham, facing south west

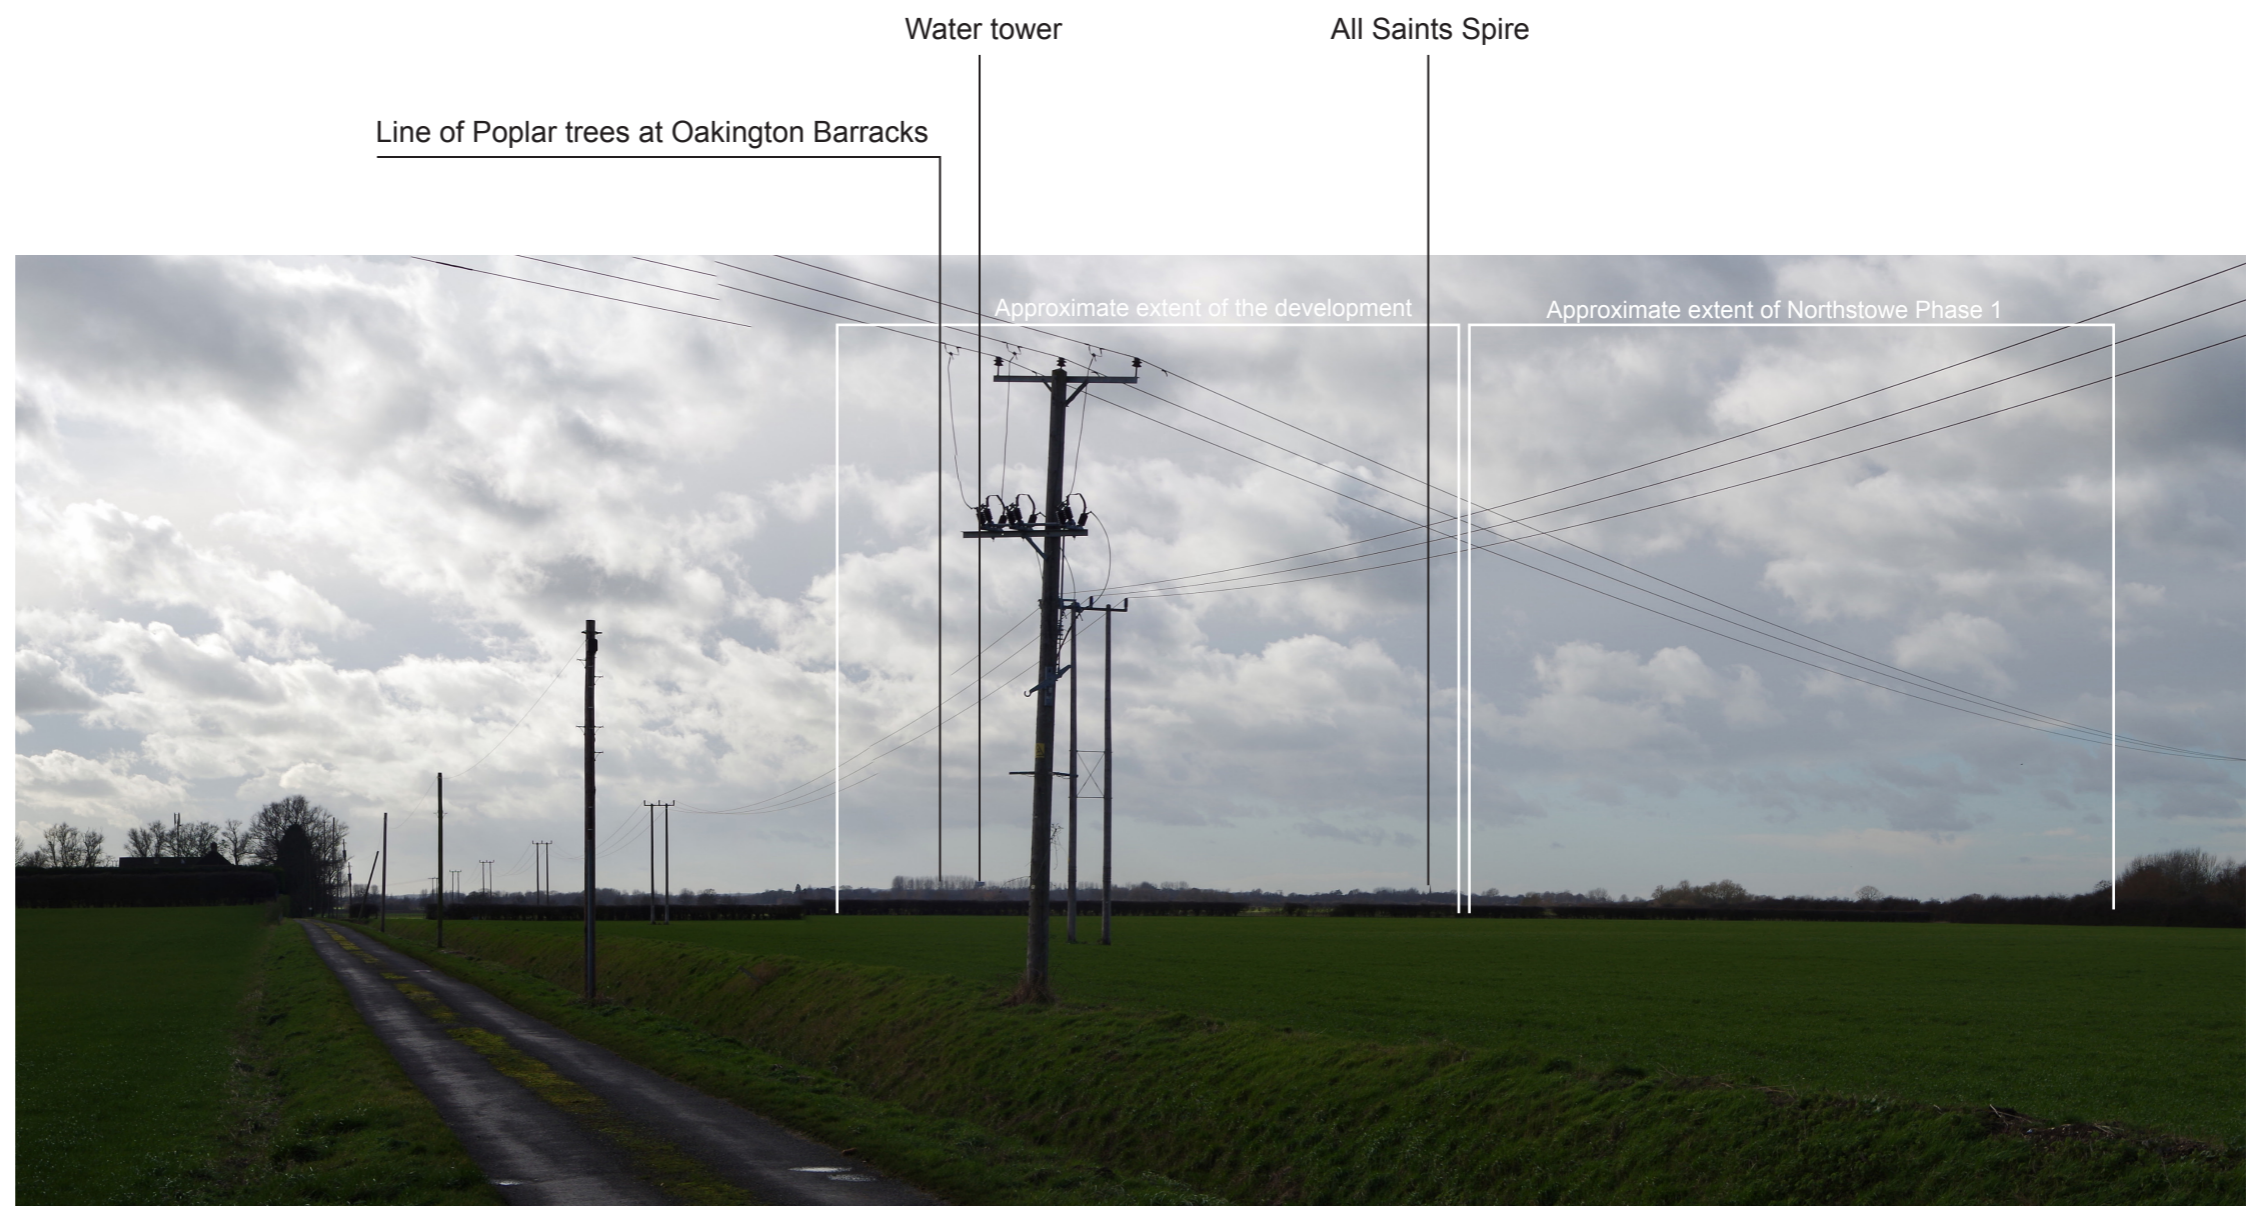
The removal of the dominant line of poplars as well as other mature vegetation including the dense mature trees adjacent to the water tower would allow views into the construction site.

The rooftops of the 3-5 storeys proposed residential dwellings and town centre would be clearly visible above the line of proposed vegetation and would screen views of the All Saints Church spire, the water tower and the mature tree belt on the skyline.

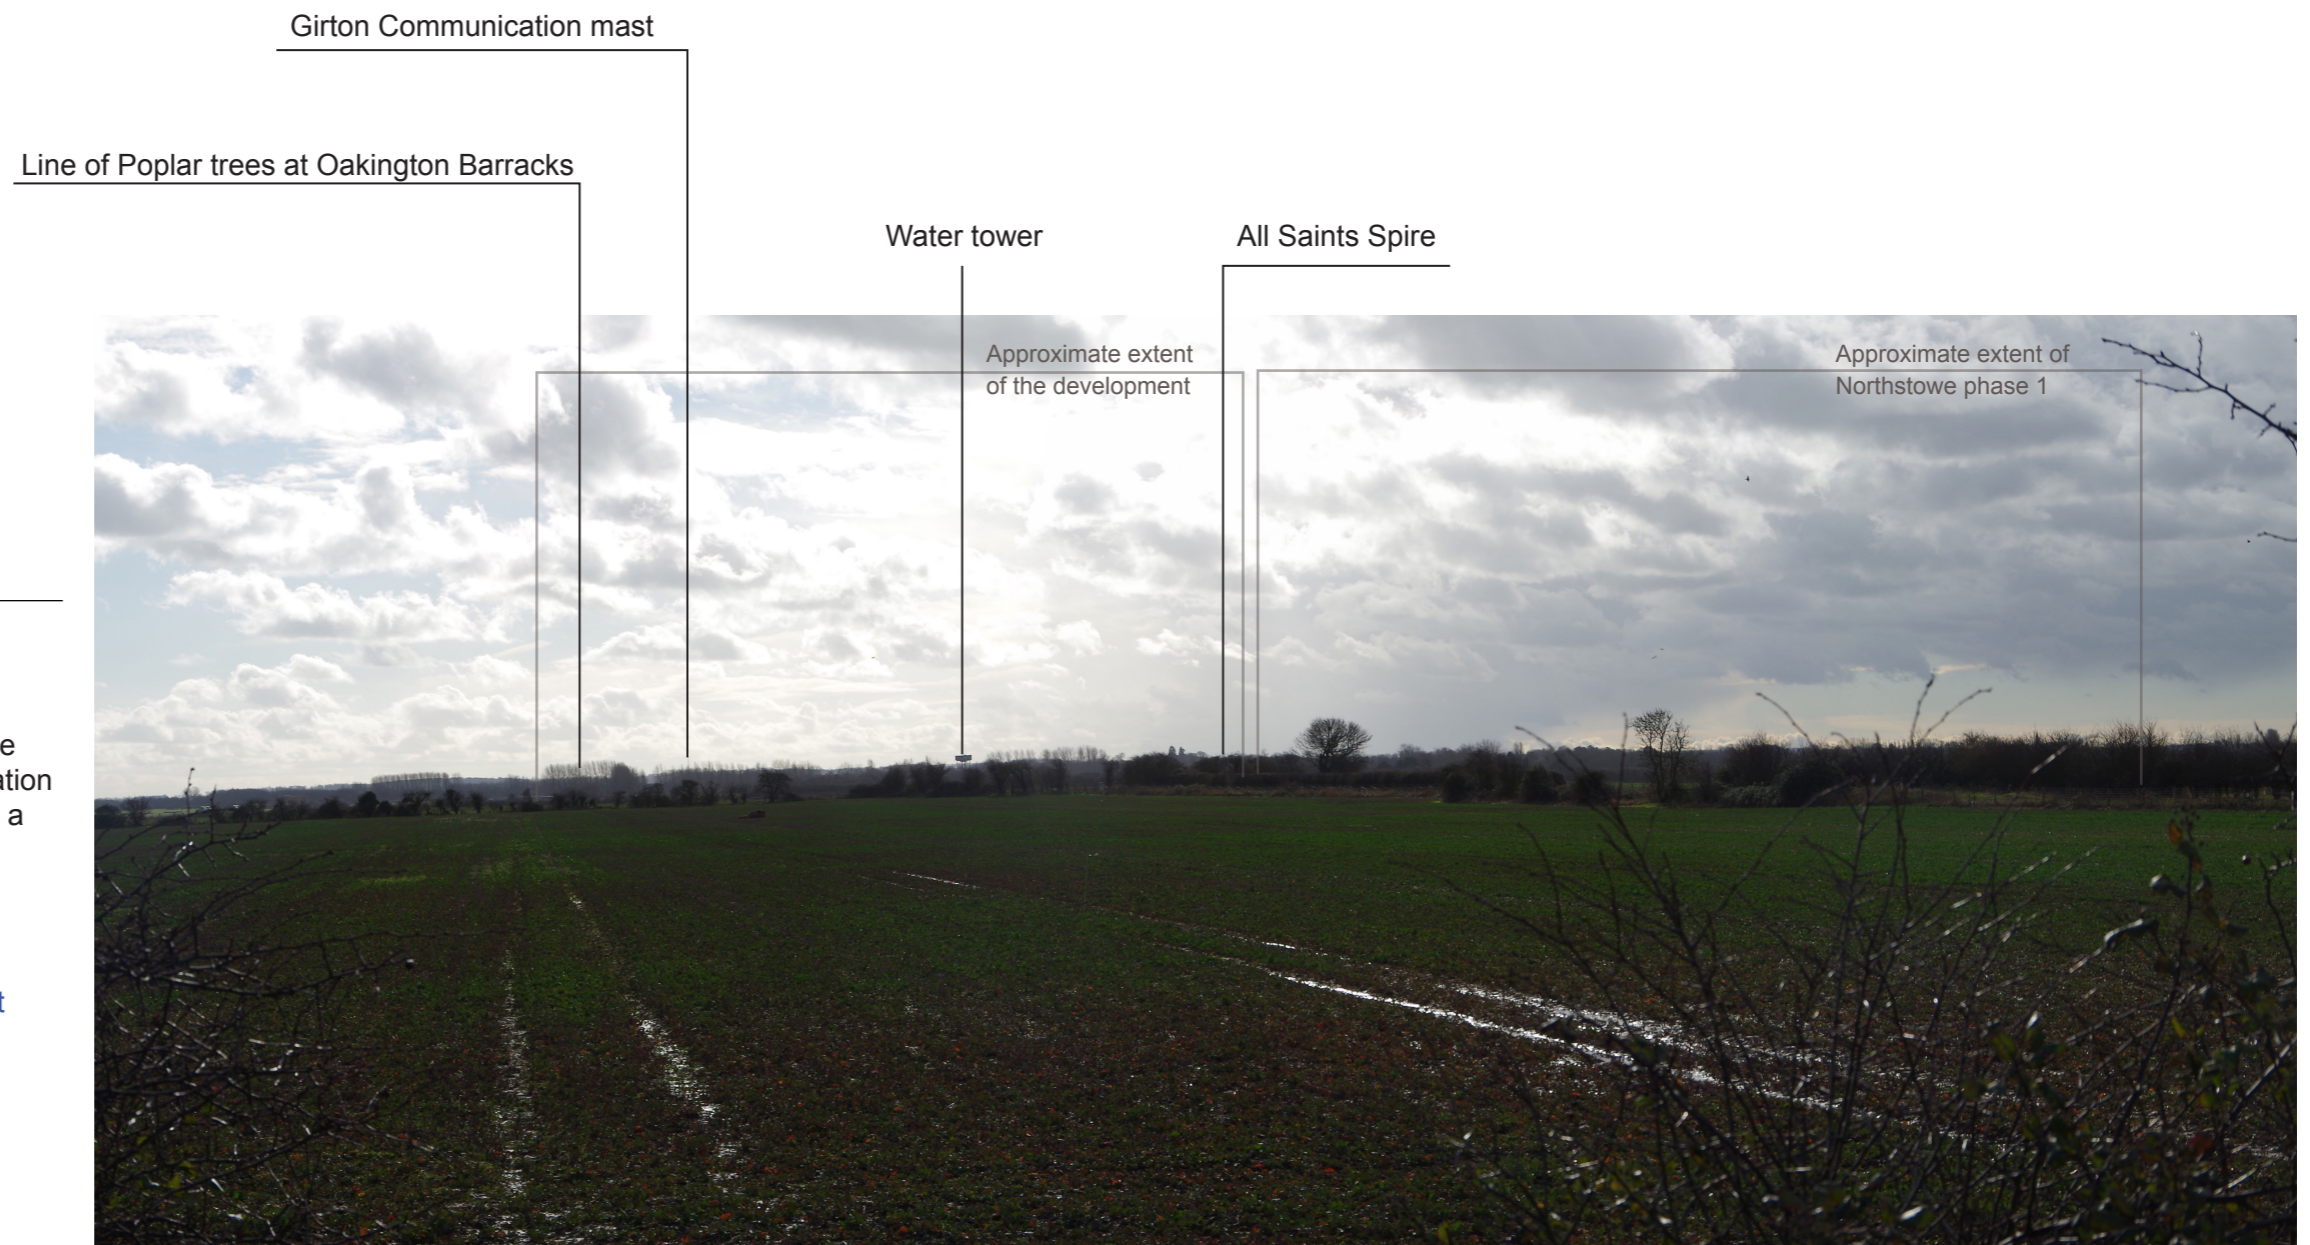
## Viewpoint 13- Rampton Road, south of Rampton, facing south-east

Construction activity would be visible in the background, beyond the fragmented hedge in the middle ground. The removal of the existing mature vegetation in the middle ground would be a substantial loss to a key characteristic of the view.

The new development would add new features that would be visible in the back ground of the view.

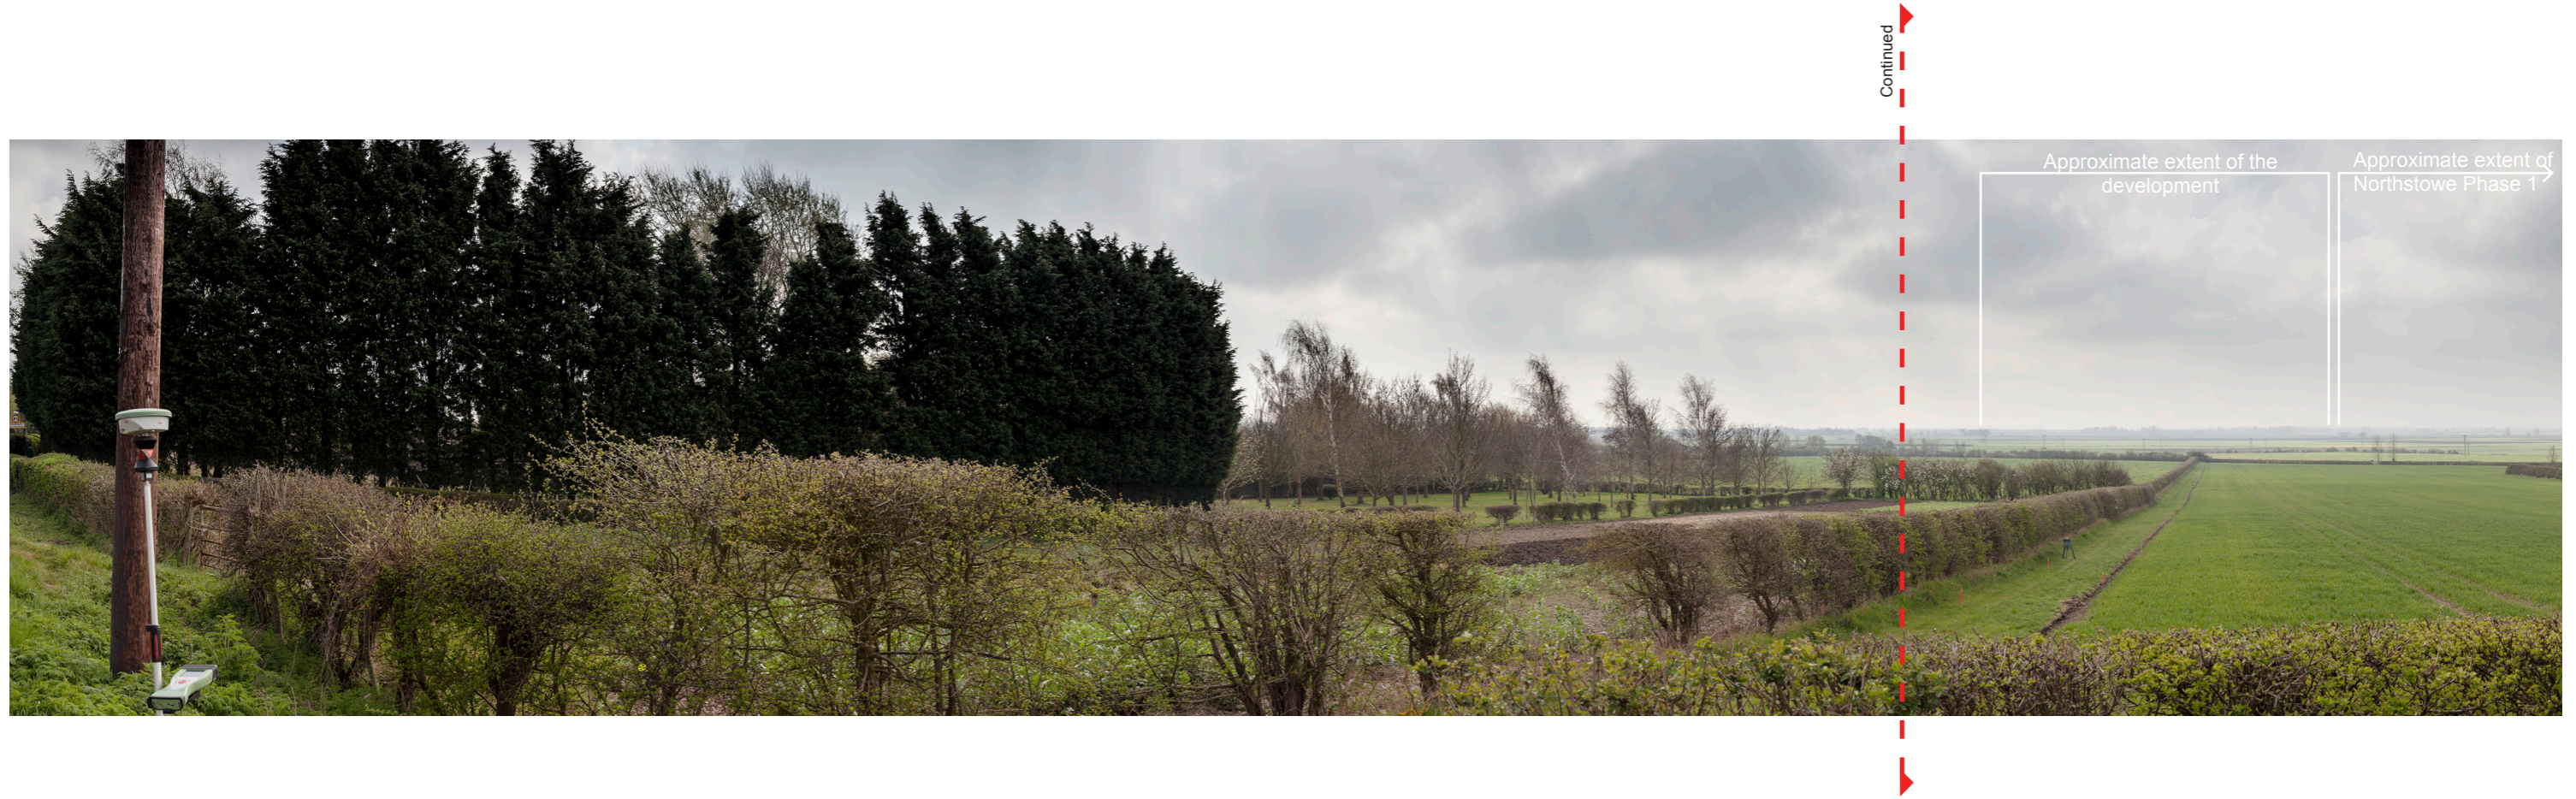
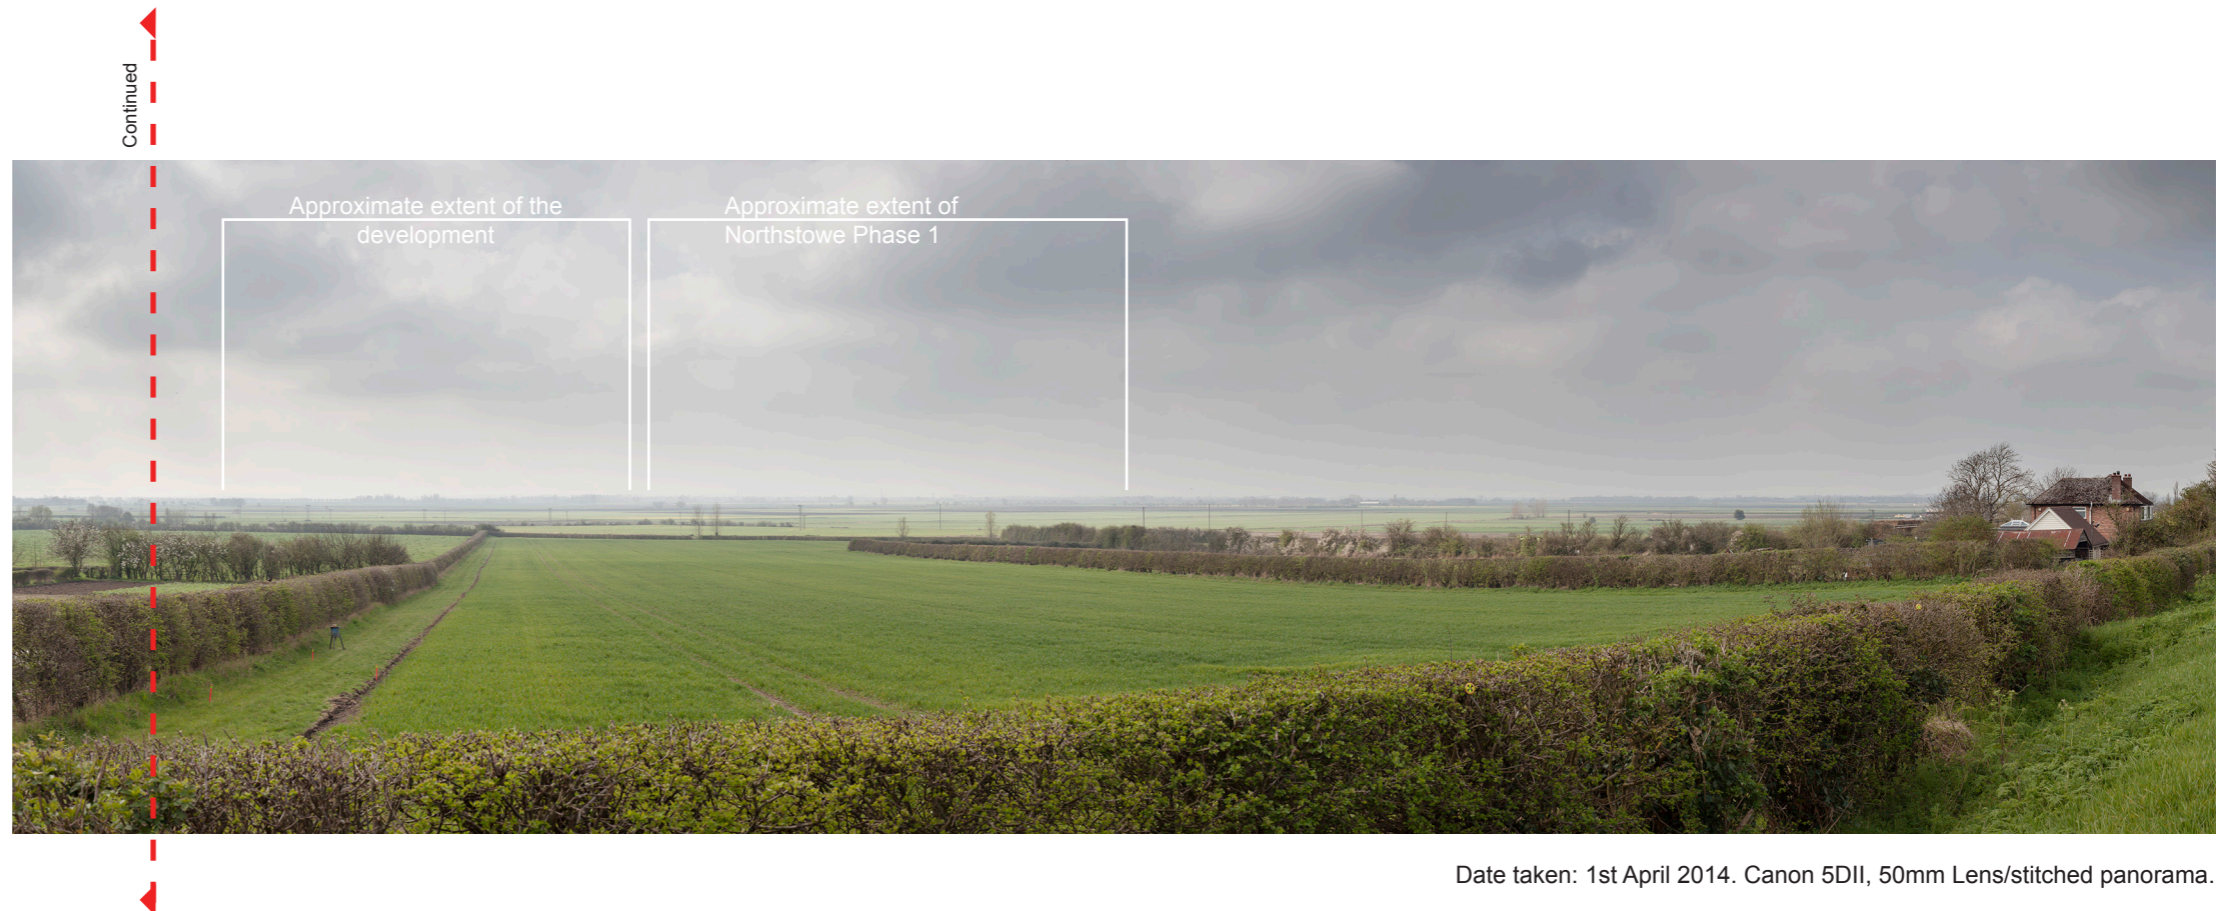
## Viewpoint 14- Hill Row Causeway, Haddenham Ridge, facing south

Approximate extent of the development

Approximate extent of Northstowe Phase 1

Due to the distance of the viewpoint from the proposed development (approximately 8km), the intervening vegetation aligning the embankments of the River Ouse and field boundaries the proposed development would not be visible from this location.
